STARBOARD PROPERTY INSPECTIONS LLC

PROPERTY INSPECTION REPORT

1234 Main Street
Stow, OH 44224

05/18/2023 9:00AM

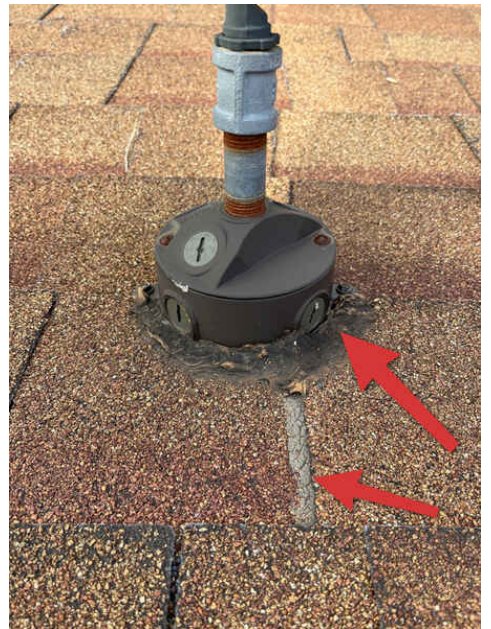
Failing sealant

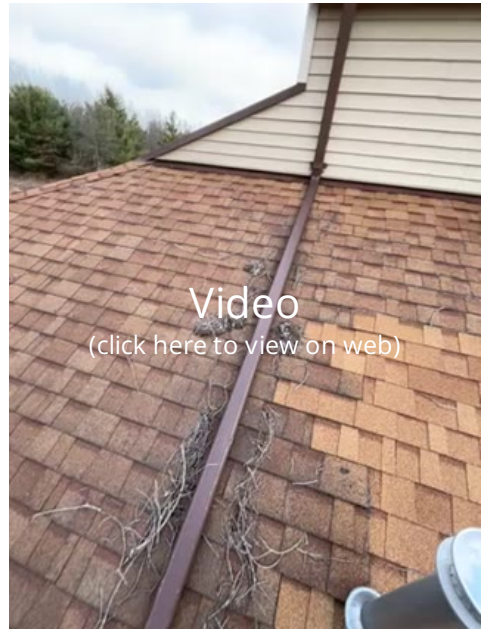
Failing sealant and moss growth

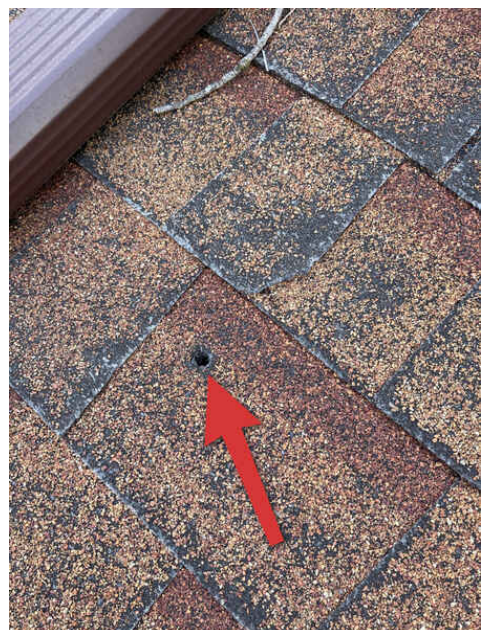
Damaged shingles

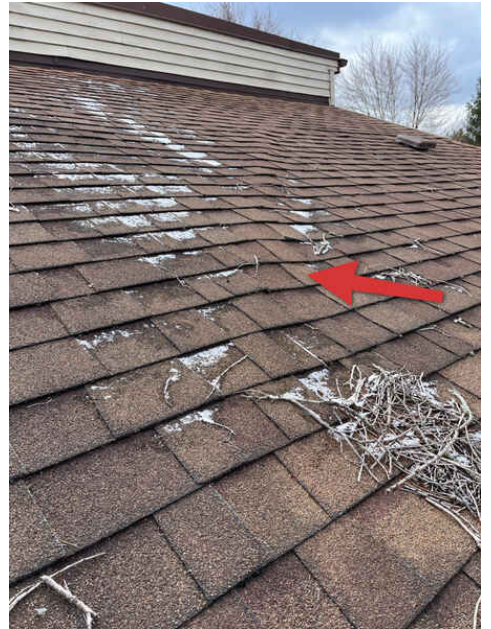
Shingles not laying flat

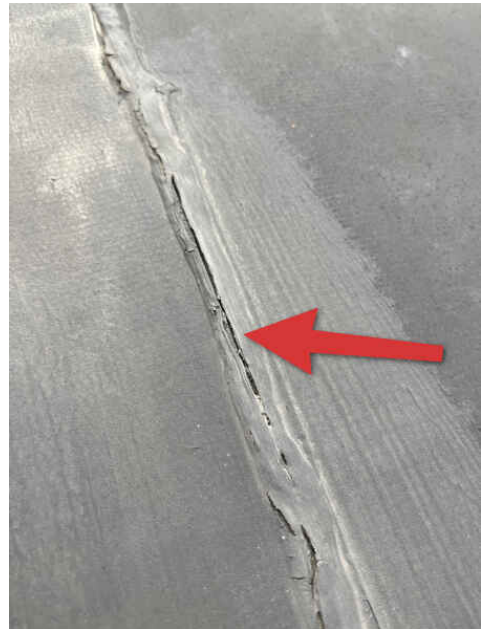
Failing sealant

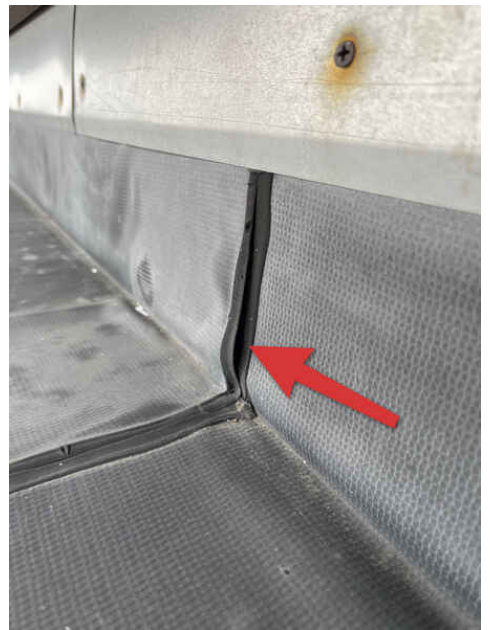
Failing sealant

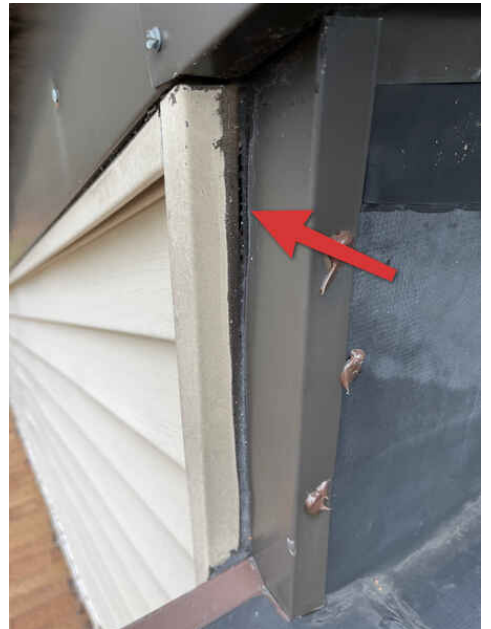
Failing sealant

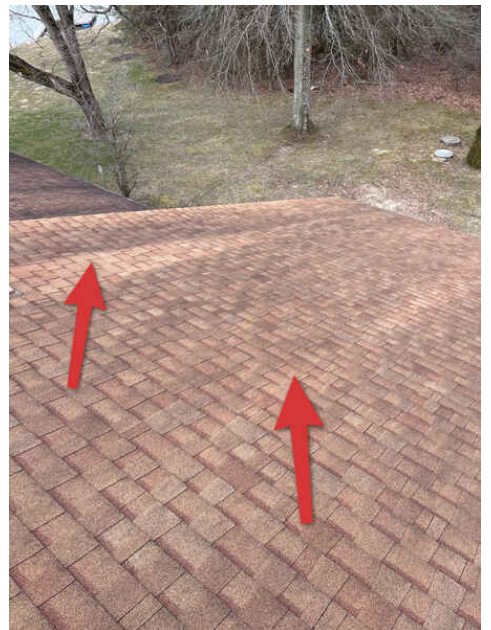
Moderate granule loss

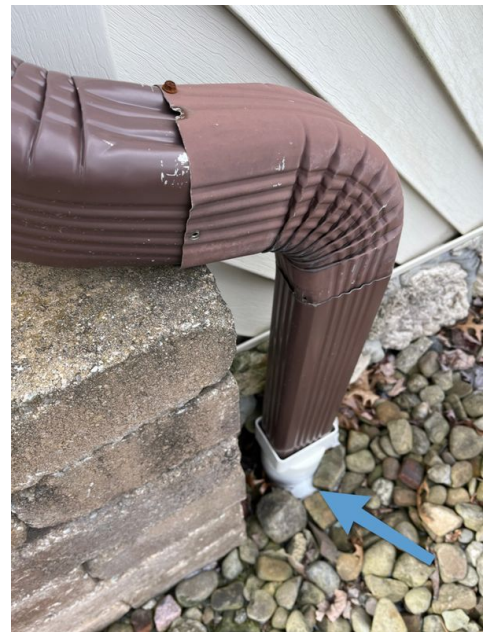
A downspout(s) was routed below grade. I was not able to determine whether it extended away from the foundation or not. I recommend verifying the underground drainage system is properly routing water away from the foundation or installing above-ground downspout extensions.

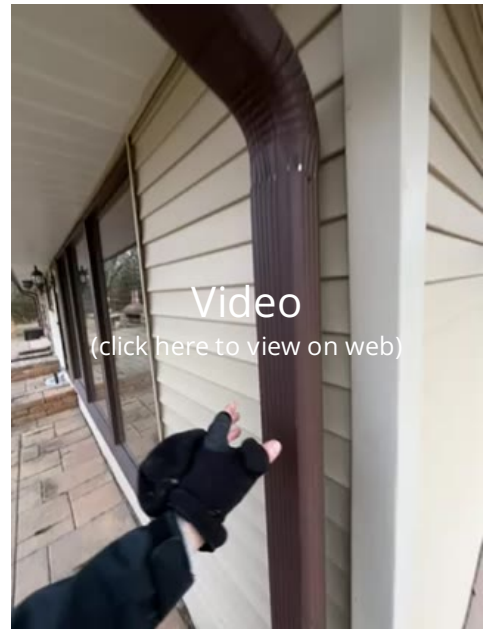
A gutter downspout(s) is not properly secured. This will allow for moisture intrusion into the foundation. I recommend a qualified contractor.

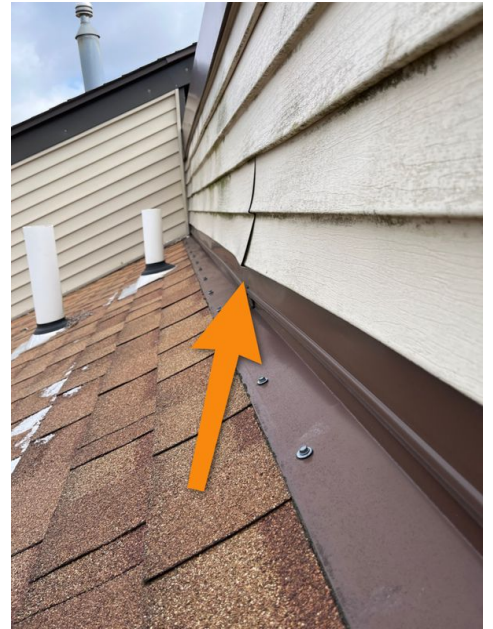
Right

The siding was observed to be loose in area(s) on the exterior. This will allow for moisture and pest intrusion. I recommend a qualified contractor.

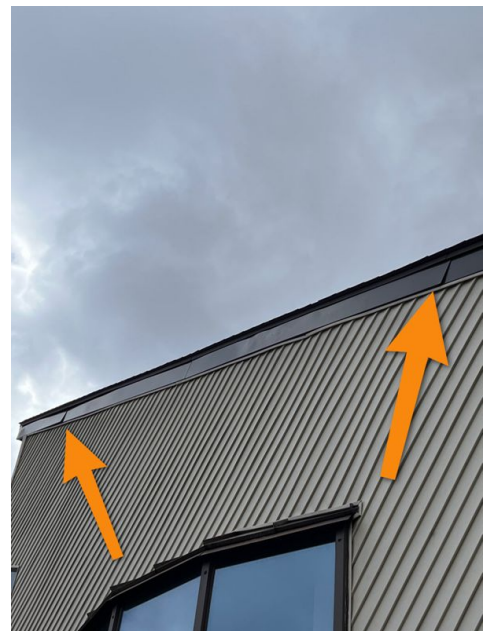
Front

The flashing was observed to be loose/not secured in area(s) on the exterior. This will allow for moisture and pest intrusion. I recommend a qualified contractor.

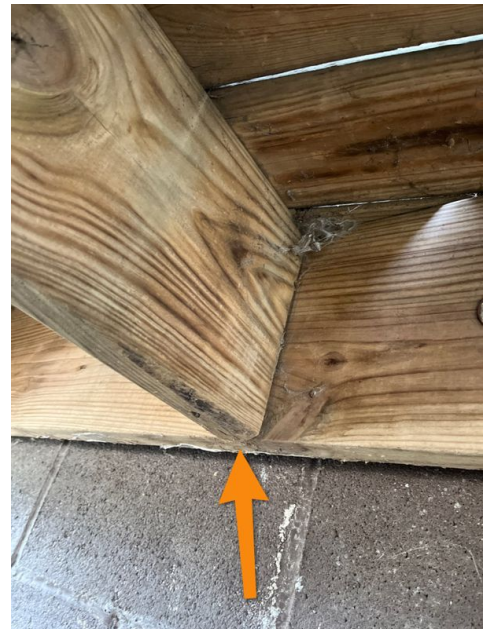
A joist hanger(s) on a deck/porch was observed to be missing in area(s) on the exterior. In order to provide adequate support, I recommend a qualified contractor.

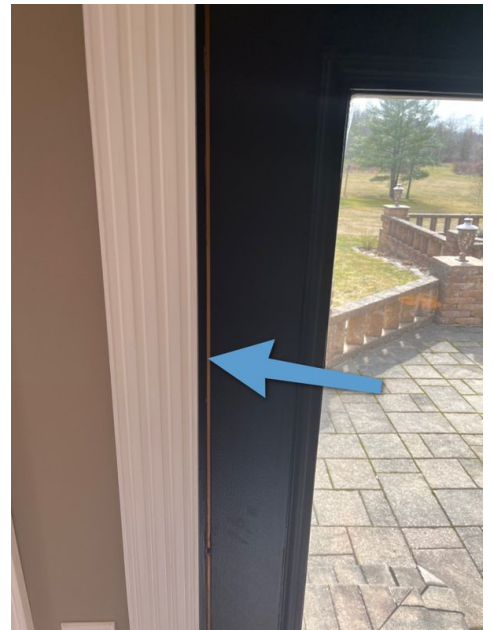
Family Room

An exterior door had missing weatherstripping. In order to prevent energy loss as well as moisture and pest intrusion, I recommend having the proper weatherstripping installed around the doors.

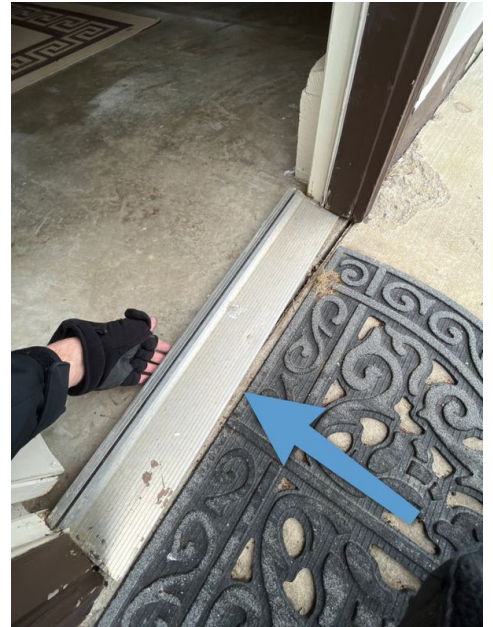
Left

The threshold on the exterior door(s) is not properly supported. When stepped on, the threshold has excessive movement. I recommend having the threshold supported from underneath by a qualified contractor.

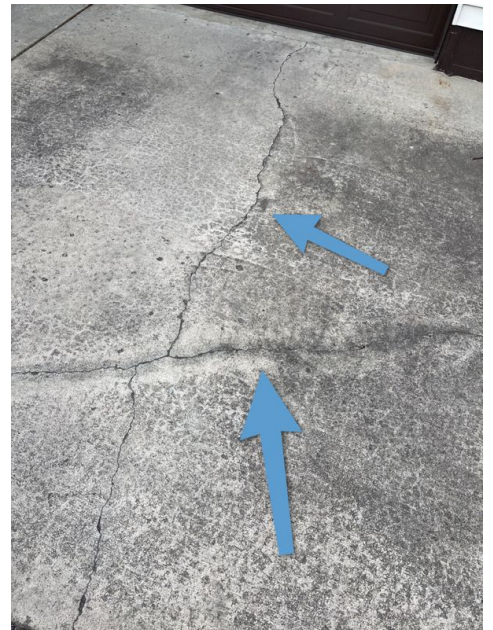
Cracking was observed in various areas of the concrete. In order to prevent the cracking from getting worse, I recommend having the cracks properly sealed with concrete caulking.

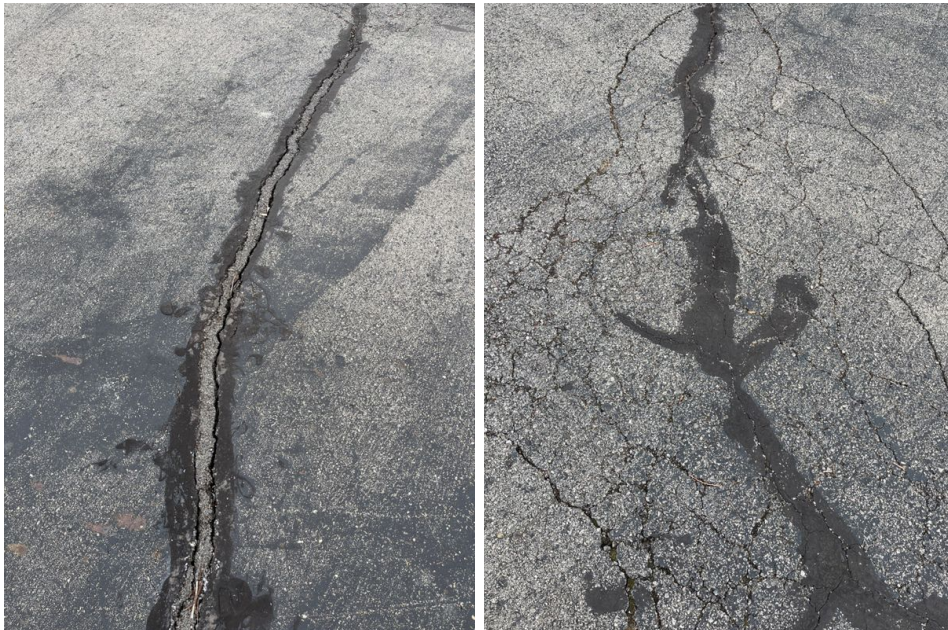
Cracking/deterioration was observed in areas of the asphalt. In order to extend the life of the asphalt, I recommend a qualified contractor.

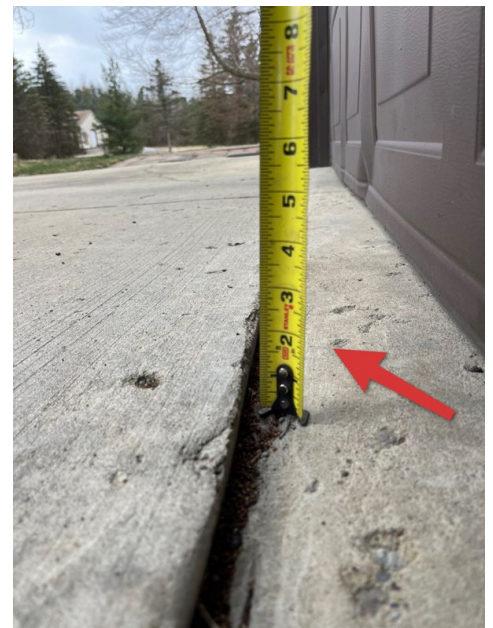
Areas of the hardscape are heaving. This is a trip hazard. I recommend a qualified contractor.

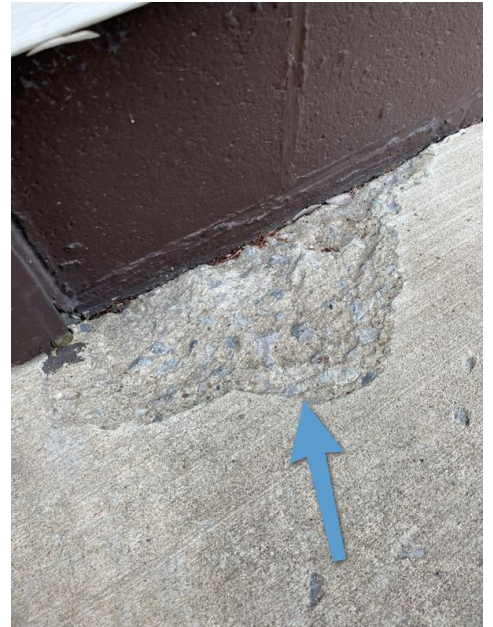
Areas of the concrete were deteriorated/spalling and in need of repair. In order to extend the life of the concrete, I recommend a qualified contractor.

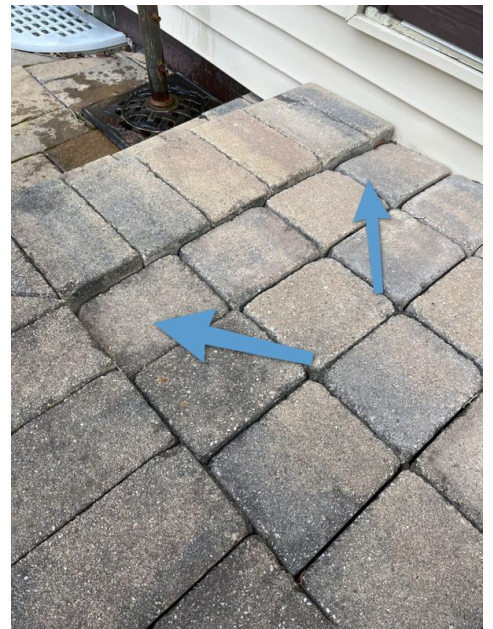
Areas of the pavers were heaving/settling. This will allow for moisture intrusion. I recommend repairing the heaving/settled pavers and replacing any damaged pavers.

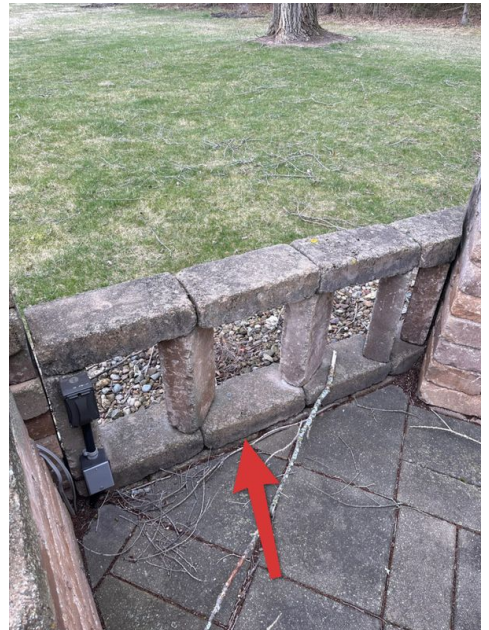
Back

Various pavers were observed to be loose/improperly secured. This is a safety hazard. I recommend a qualified contractor.

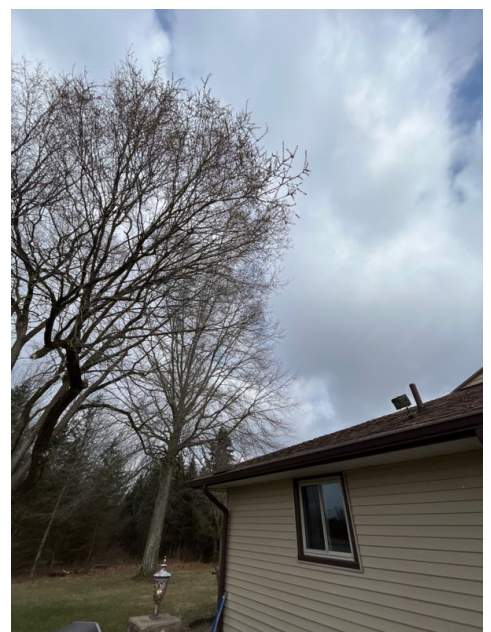
Tree branches were overhanging the roof in area(s). This will allow for moisture and pest intrusion. In addition, this will shorten the lifespan of the roofing material. I recommend a qualified contractor.

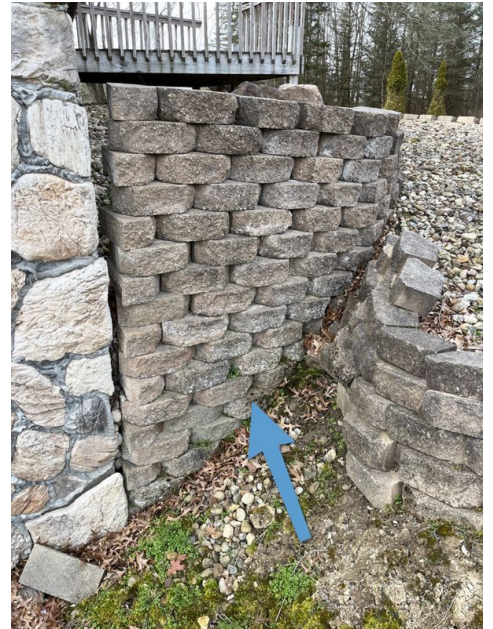
Front Right

A retaining wall was observed to be missing weep holes. Weep holes allow for water to drain at the bottom of the retaining wall in order to prevent hydrostatic pressure/the wall from leaning/failing. Although the retaining wall appeared to be in good working condition as of the inspection date, I recommend a qualified contractor.

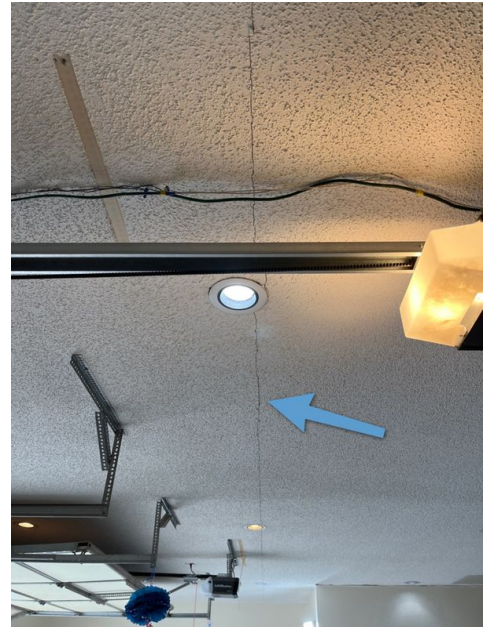
Areas of drywall are damaged and in need of repair. Although the damage appears to be strictly cosmetic, I recommend a qualified contractor.

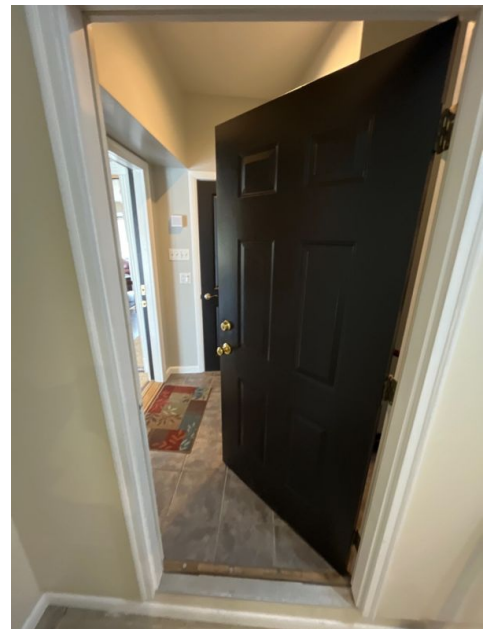
The garage man door is not self-closing. This could allow for harmful gasses such as carbon monoxide to escape into the home. I recommend installing a self-closing device on the door.

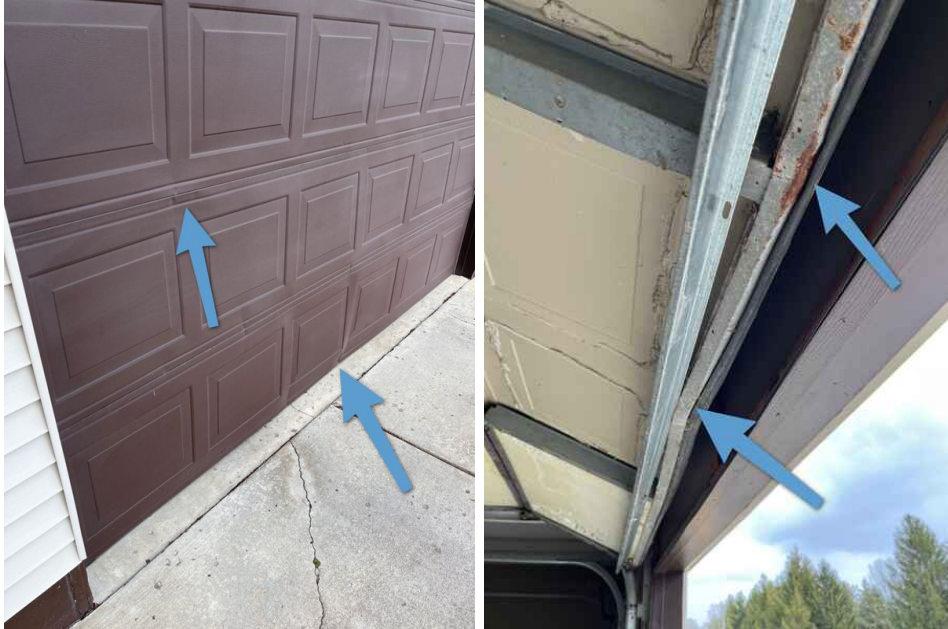
Areas of the garage doors have damage present that does not effect the function of the door. In addition, rust was present. In order to extend the life of the garage doors, I recommend a qualified contractor as necessary.

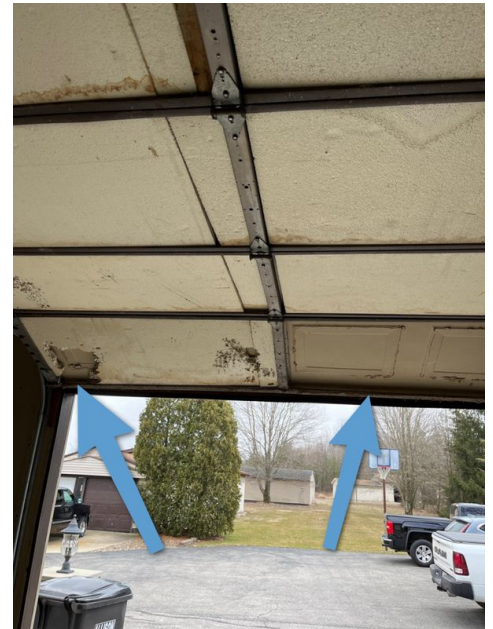
Areas of the garage door insulation was damaged/missing. In order to maintain the insulations efficiency, I recommend a qualified contractor.

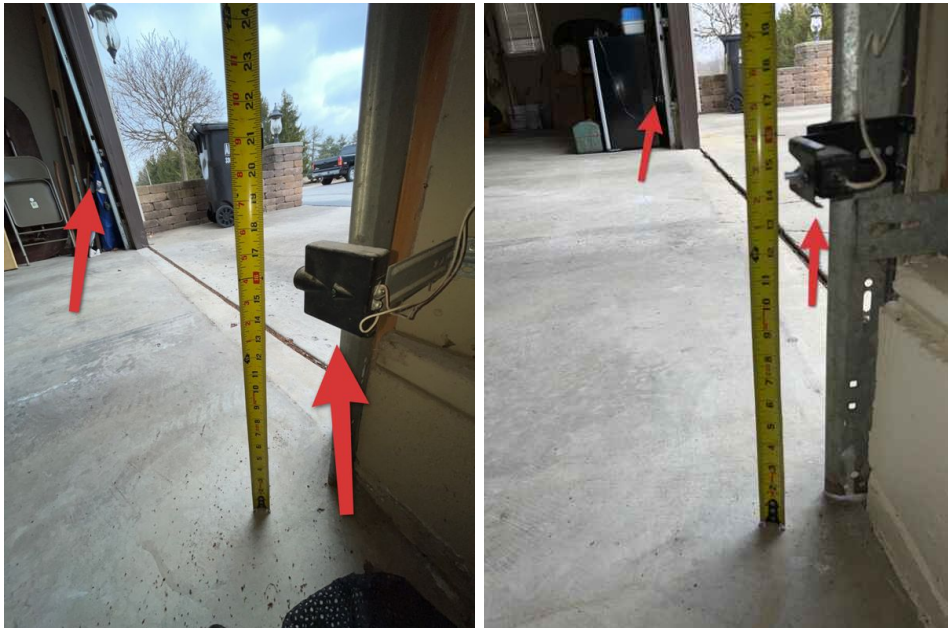
The photocells for the garage doors were located higher than 6 inches above the floor, which is the maximum recommended height. In order to prevent any accidents, injuries, or damage to property, I recommend having the sensors adjusted to the appropriate height by a qualified contractor.

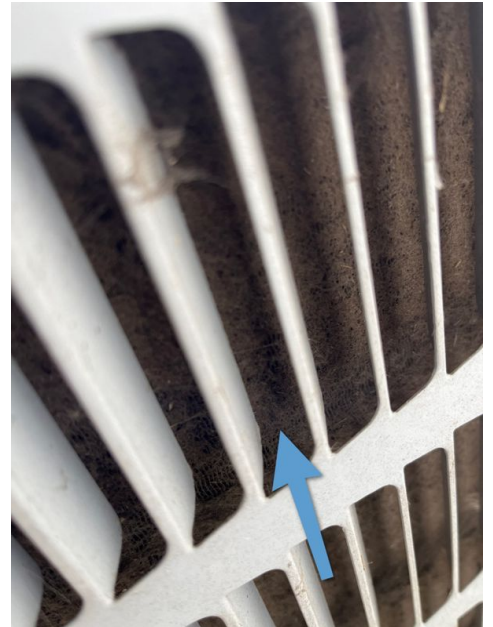
The air conditioner condensers appeared to have debris present, which will negatively effect the airflow. In order to ensure the AC has sufficient air flow, I recommend removing all debris from around the AC units.

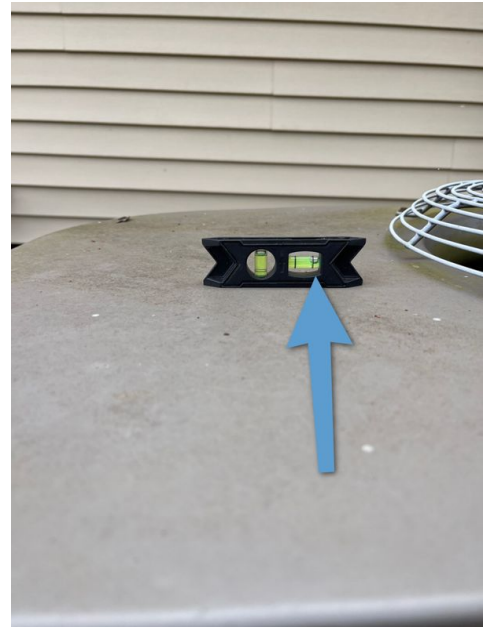
The air conditioner condenser is not level. If the unit is not level, then the oil level inside the compressor will not be level either. This can lead to one side of the compressor's motor not being properly lubricated. In order to prevent a shortened lifespan of the AC components, I recommend leveling the AC unit.

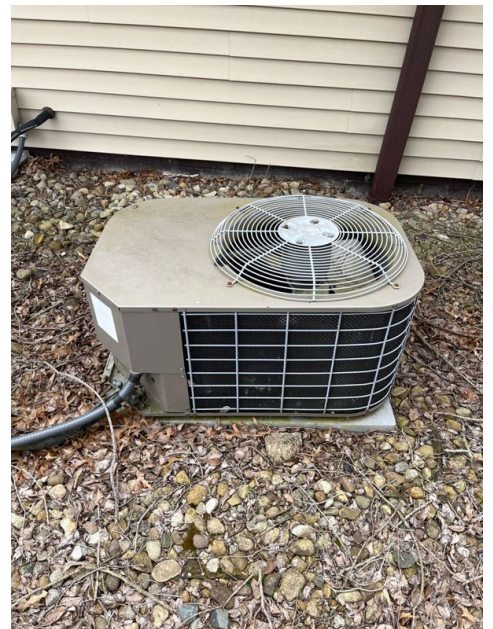
The air conditioner does not appear to have had regular services or maintenance, which can shorten the life of the equipment. I recommend having the system cleaned, serviced, and certified by a reputable licensed HVAC contractor.

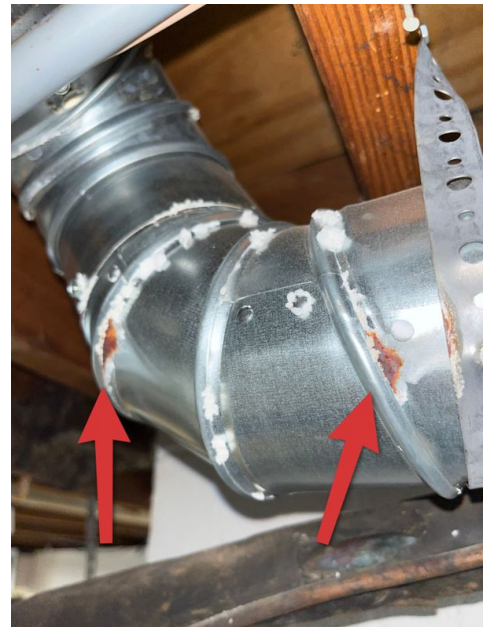
The furnace flue was observed to have corrosion/rust present in areas. This could be an indication of a leak, therefore, in order to prevent harmful gasses such as carbon monoxide from escaping into the basement, I recommend a licensed HVAC contractor.

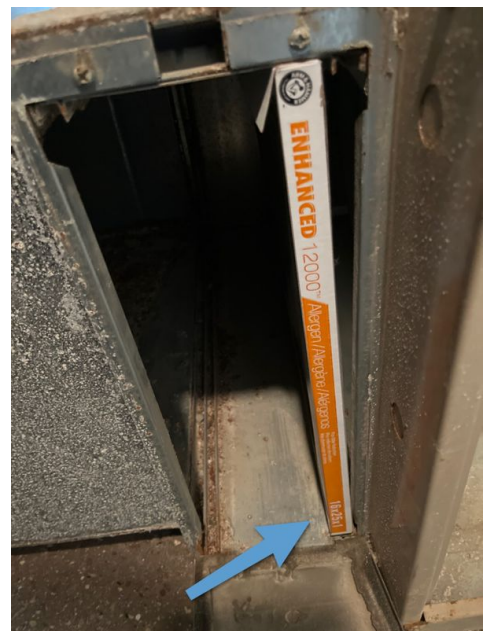
The furnace filter was observed to be the wrong size at the time of the inspection. Using the wrong size filter will allow for dust and debris to enter the unit and shorten the lifespan of the furnace. I recommend contacting Comfortmaker or referring to your furnace User's Manual for the correct filter size.

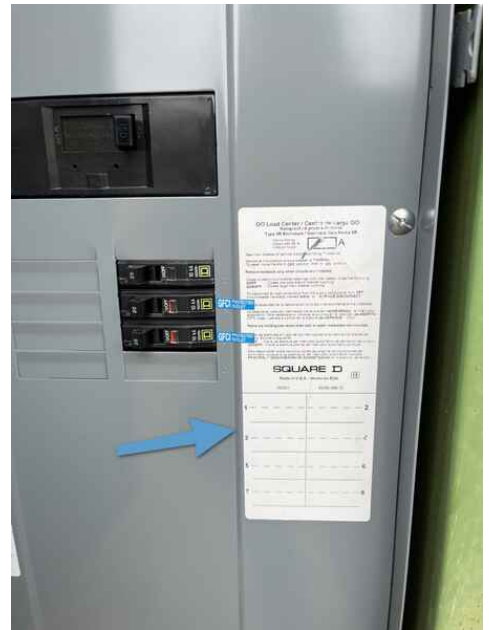
The circuits on the service panel were not all clearly labeled on the panel. I recommend properly labeling all breakers.

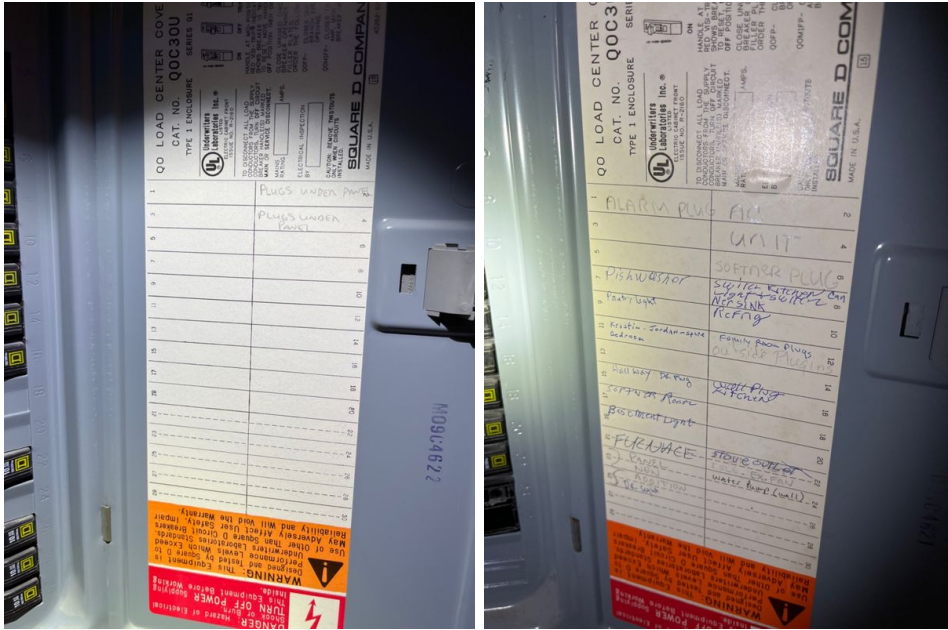
The circuits on a sub panel were not all clearly labeled. I recommend properly labeling all breakers.

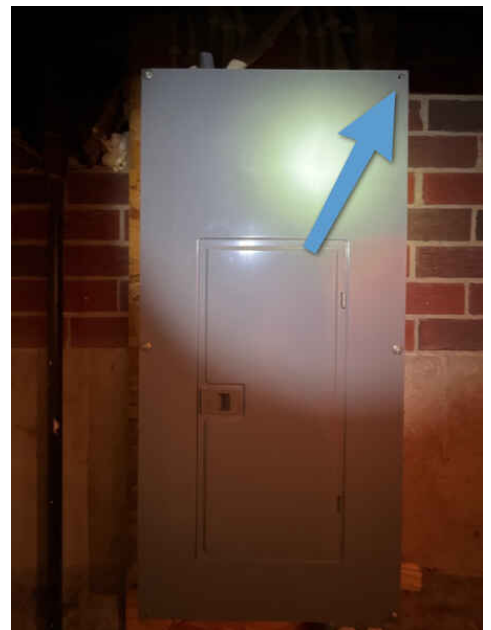
The dead front cover does not have all the screws securing it. In order to prevent a shock hazard, I recommend having the proper blunt tip screws added by a qualified contractor.

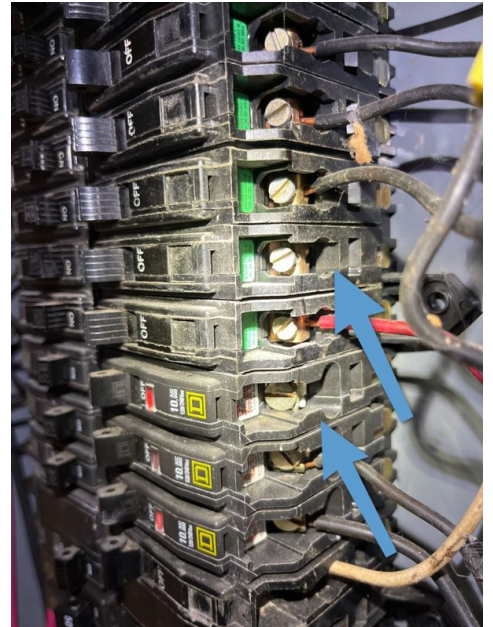
A breaker was observed to be installed but not wired. In order to maximize safety, I recommend a licensed electrical contractor evaluate and repair as necessary.

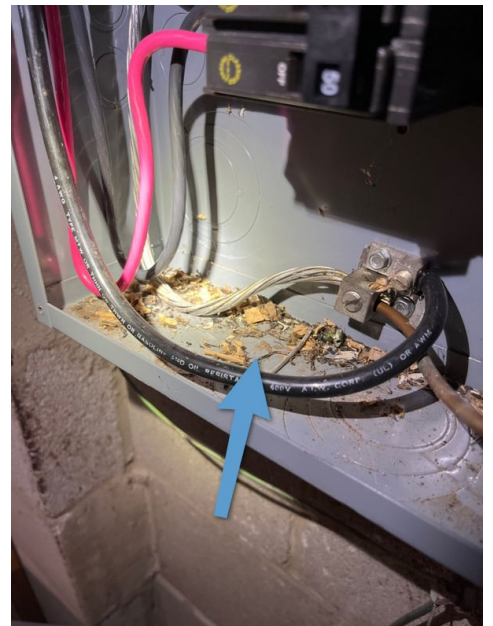
Sub

Minor debris was observed in the main service panel. I recommend having the debris removed from the service panel.

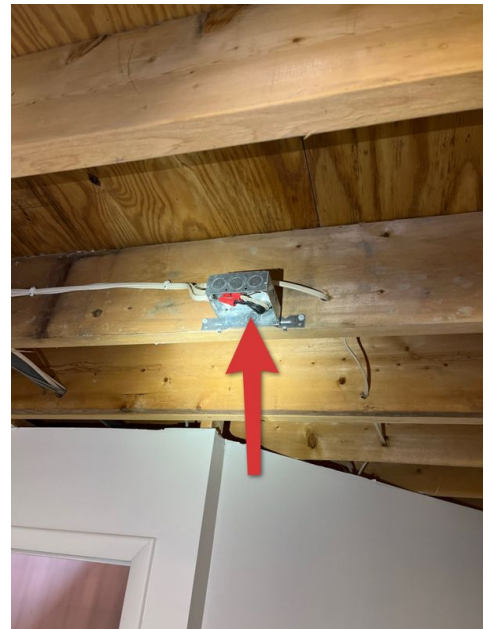
Basement

A junction box(es) did not have a proper cover plate installed. This is a fire hazard and shock hazard. I recommend a licensed electrical contractor.

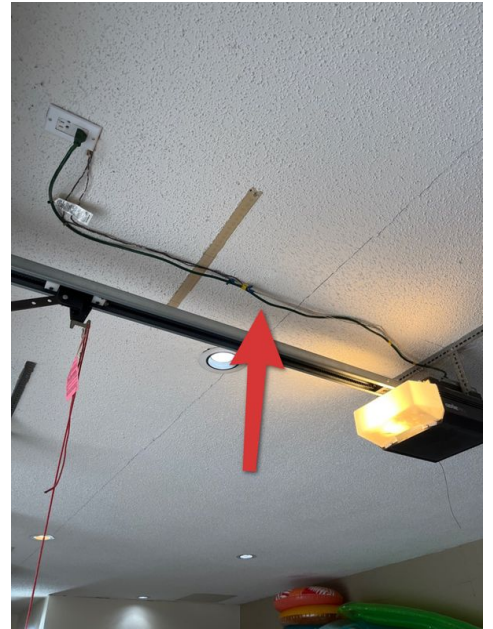
Garage

An extension cord was observed to be utilized for permanent use. This is a fire hazard. I recommend a licensed electrical contractor.

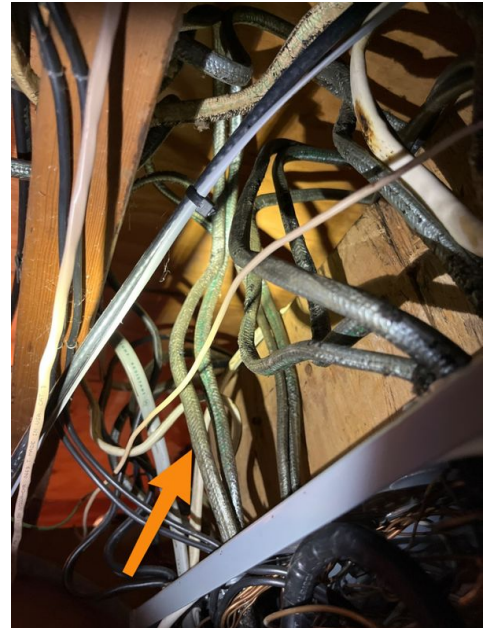
Cloth wiring was observed. This type of wiring is typically not grounded, and may be a fire hazard. I recommend having the wiring evaluated and repaired as necessary by a licensed electrical contractor.

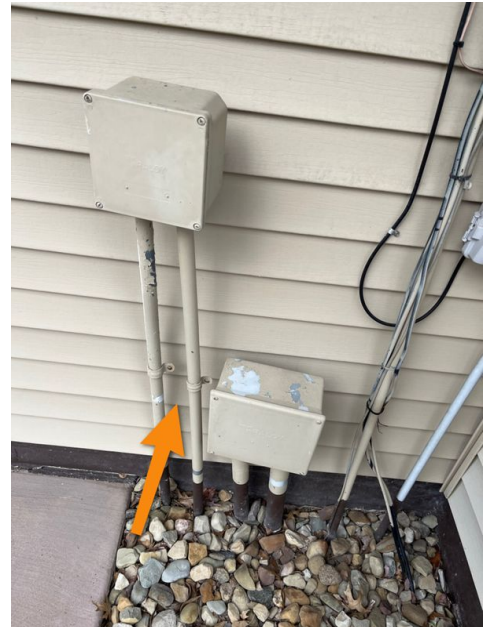
Sections of electrical conduit did not appear to have sufficient supports. In order to prevent moisture intrusion, I recommend a qualified contractor.

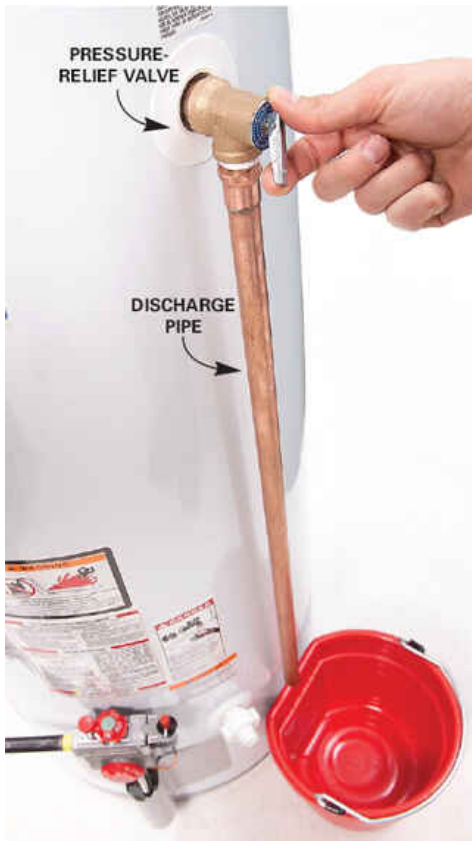
A water heater temperature and pressure relief valve (TPR valve) did not have a proper discharge pipe installed. This is a safety hazard. I recommend a licensed plumbing contractor.

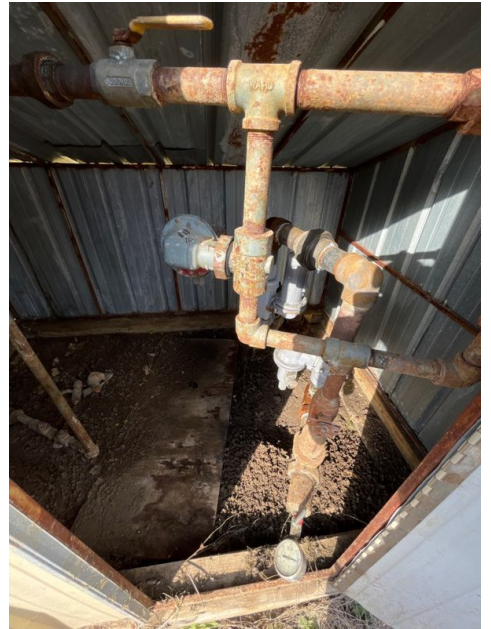
A gas leak was observed in an exterior shed where the main gas line was located. This is a safety hazard. I recommend consulting immediately with a licensed plumbing contractor. Continue to monitor.

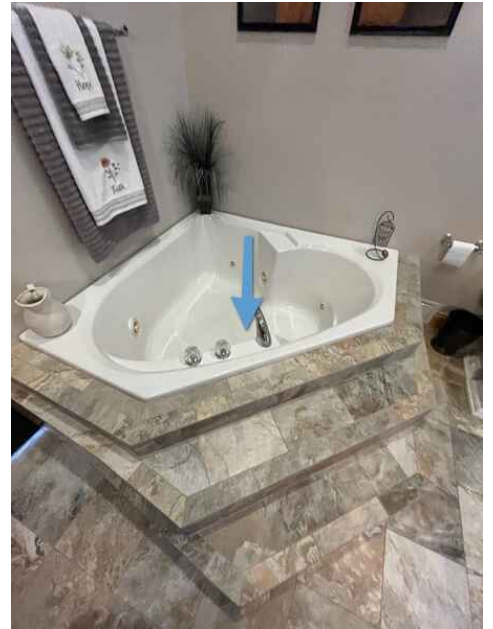
A drain stopper was observed to be inoperable. I recommend repairing the drain stopper.

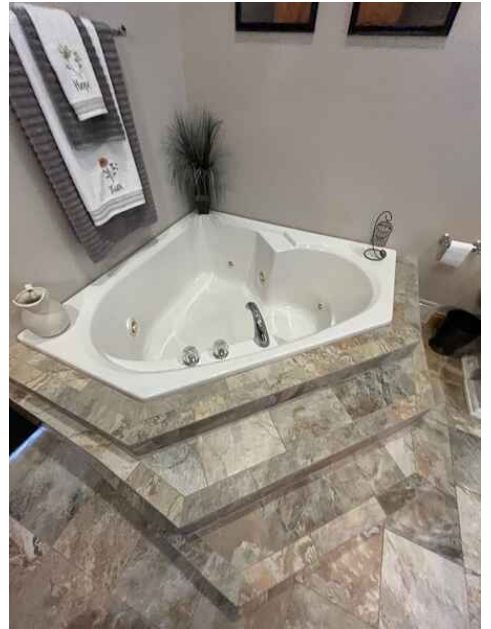
A jetted tub did not have an access panel installed. In order to maintain or service the jetted tubs components, I recommend having an access panel installed by a qualified contractor.

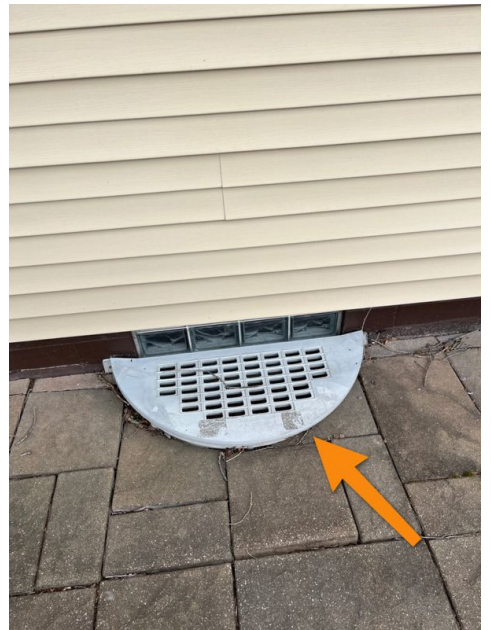
A window well(s) did not have a water resistant, weight bearing cover present. In addition, debris was observed in the window well(s) at the time of the inspection. In order to prevent moisture and pest intrusion as well as debris buildup, I recommend having proper window well covers installed.

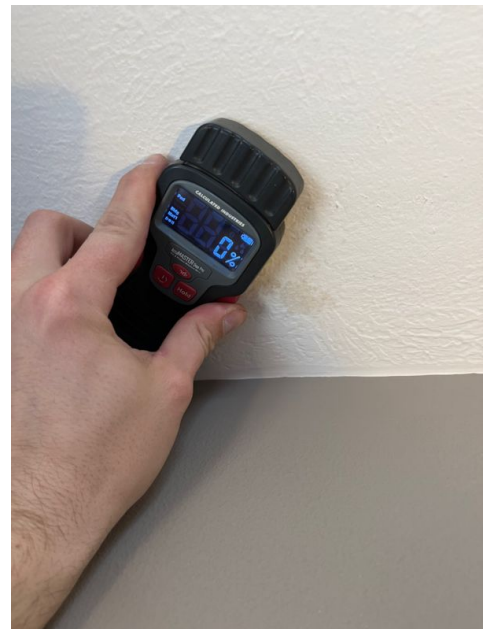
Moisture stains were observed on areas of the ceilings/walls. These areas were tested with a moisture detector which indicated elevated levels of moisture were not present. Continue to monitor.

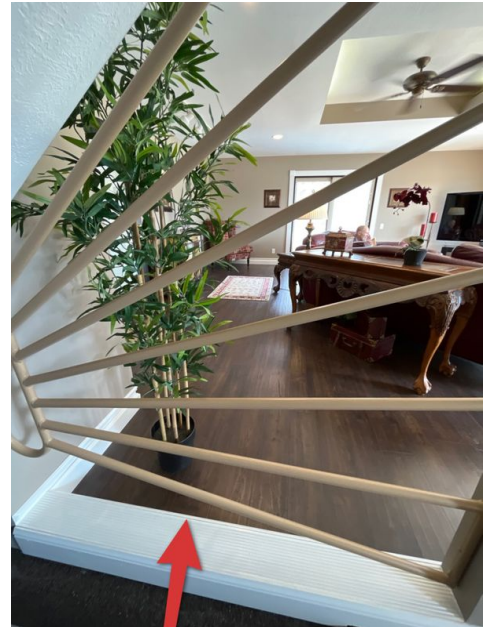
The baluster spacing is too wide in areas on the guard rails. In order to prevent children from fitting through/falling or becoming stuck, it is recommended that the spacing between the balusters is a maximum of 4 inches. This is a fall hazard. I recommend a qualified contractor.

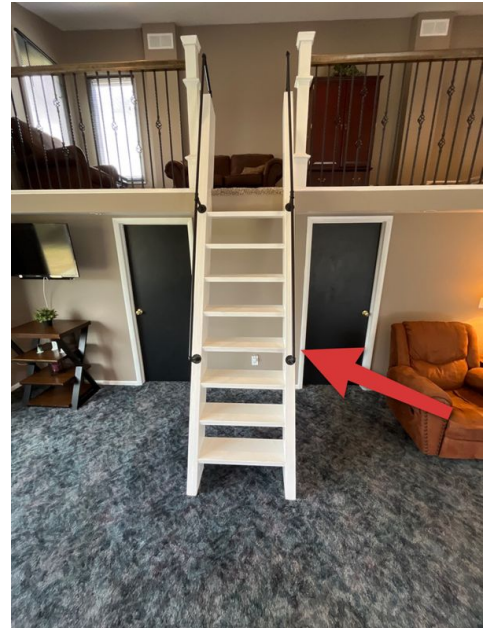
A staircase was observed to present a safety hazard. This is a fall hazard. I recommend a qualified contractor.

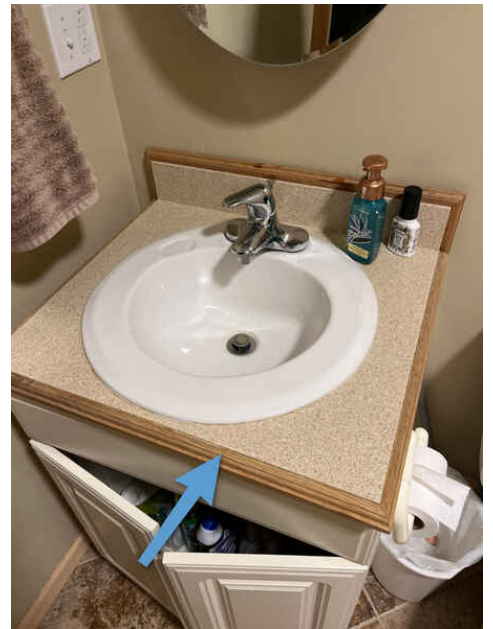
A countertop was not fully secured. In order to provide adequate support as well as prevent injury, I recommend a qualified contractor.

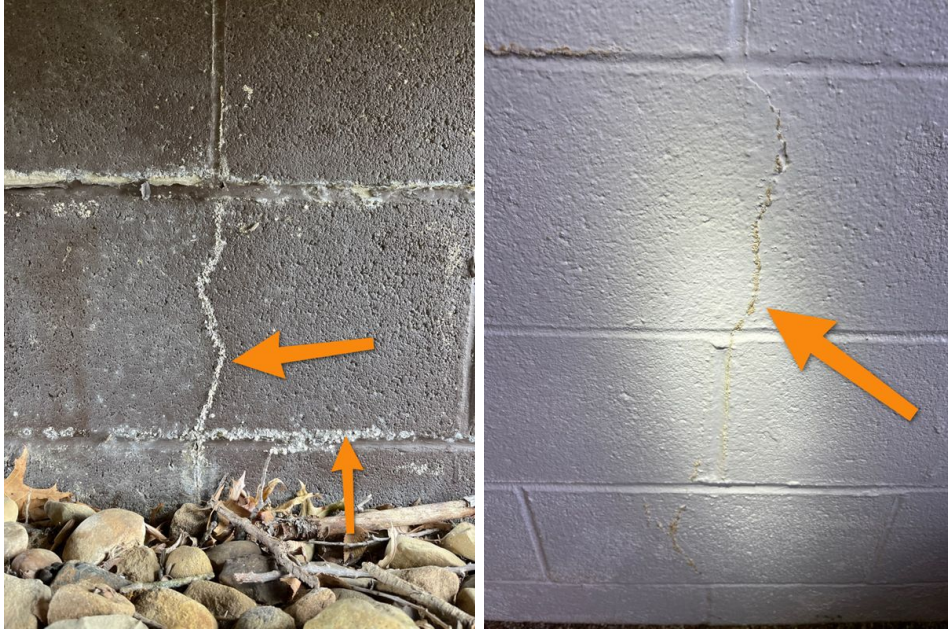
Efflorescence (mineral salts) was observed on various areas throughout the basement. Efflorescence is the chalky residue left on concrete, stone, and block when moisture passes through it. I recommend a qualified contractor. Continue to monitor.

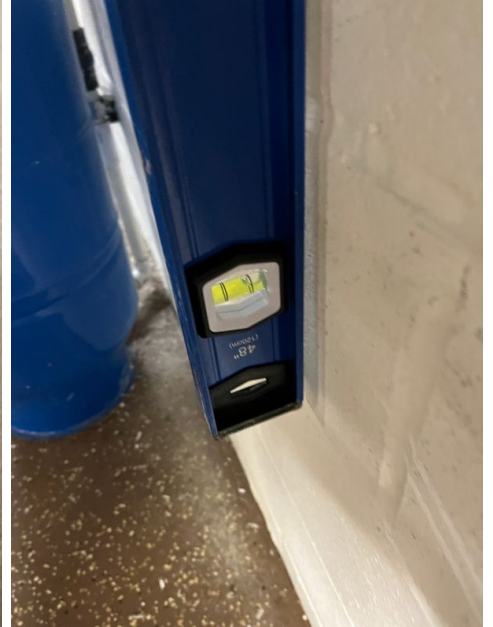
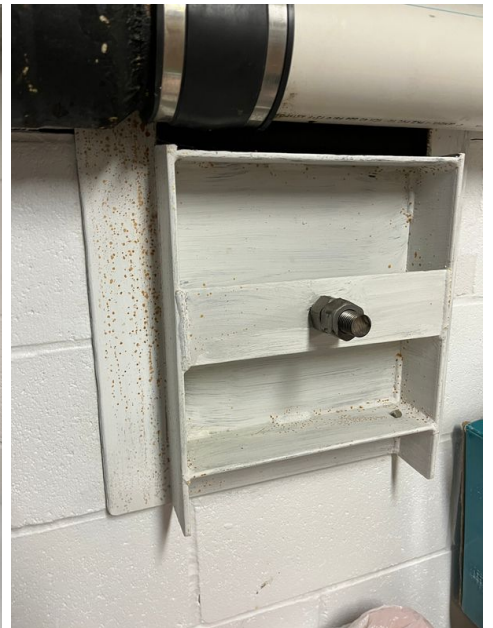
Evidence of past structural repairs was observed. I recommend consulting with the seller(s) to ensure that these repairs were made by licensed and/or qualified structural professionals and to obtain any warranties or other documents related to the repairs. Continue to monitor.

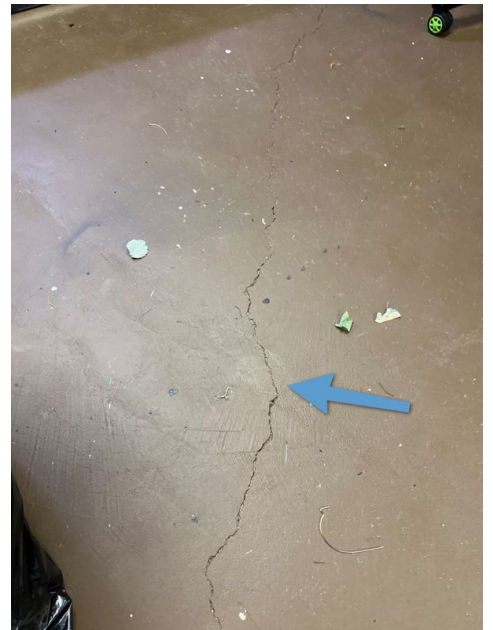
Cracking was observed on the basement slab. This will allow for moisture and pest intrusion. I recommend having the crack(s) properly sealed with concrete caulking. Continue to monitor.

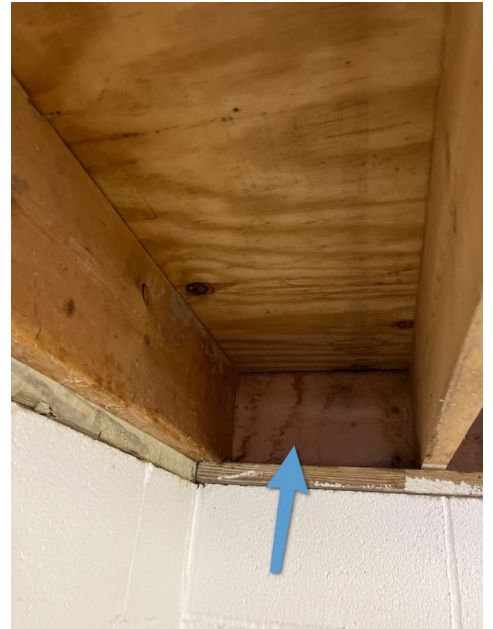
The foundation wall insulation was observed to be missing in areas. This will allow for energy loss. I recommend installing insulation in the rim joists.
