STARBOARD PROPERTY INSPECTIONS LLC

PROPERTY INSPECTION REPORT

1234 Main Street
Stow, OH 44224

05/18/2023 9:00AM

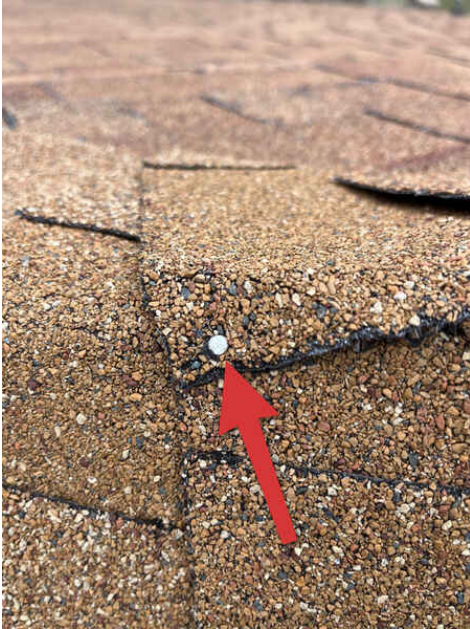
The roof was observed to have multiple deficiencies in area(s) on the exterior. This will allow for moisture and pest intrusion. In addition, this will shorten the lifespan of the shingles. I recommend a qualified contractor. Refer to the pictures below for specific deficiencies.

Exposed fasteners

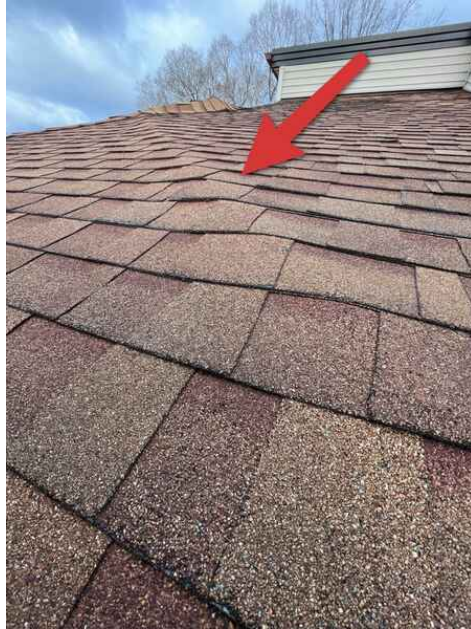
Shingles not laying flat

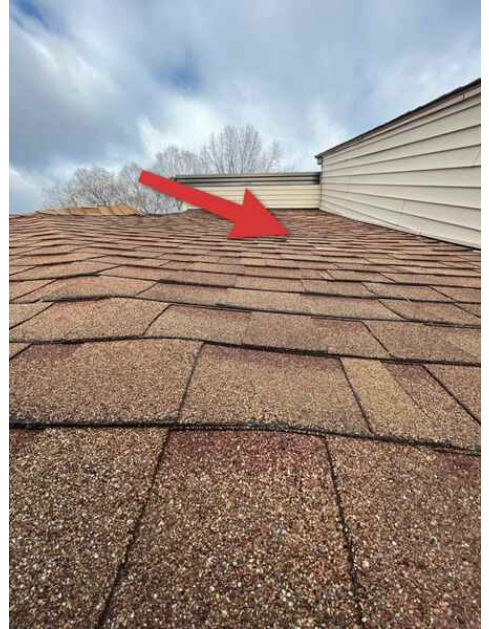
Roof sloping towards home

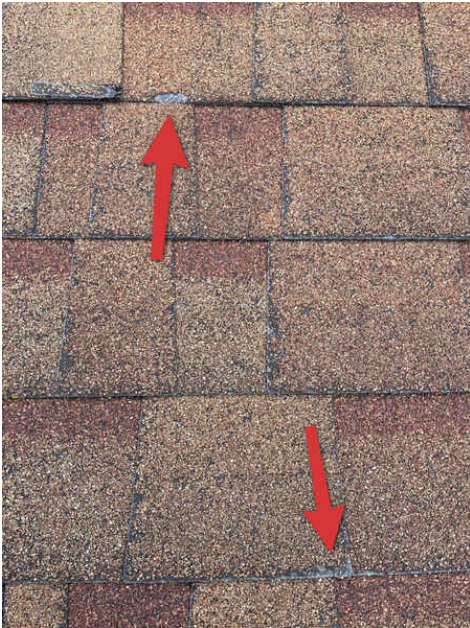
Damaged/torn shingles

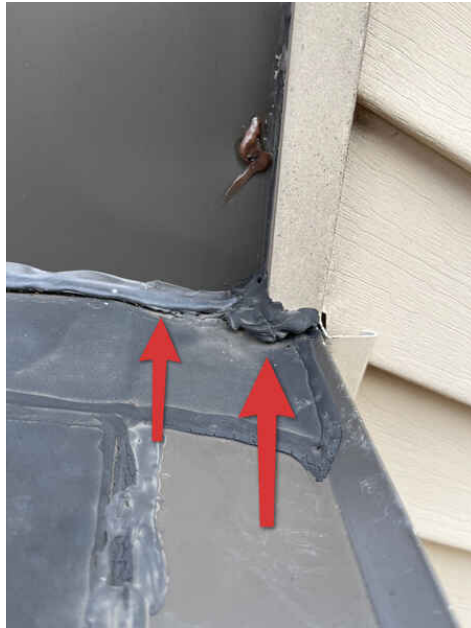
Failing sealant

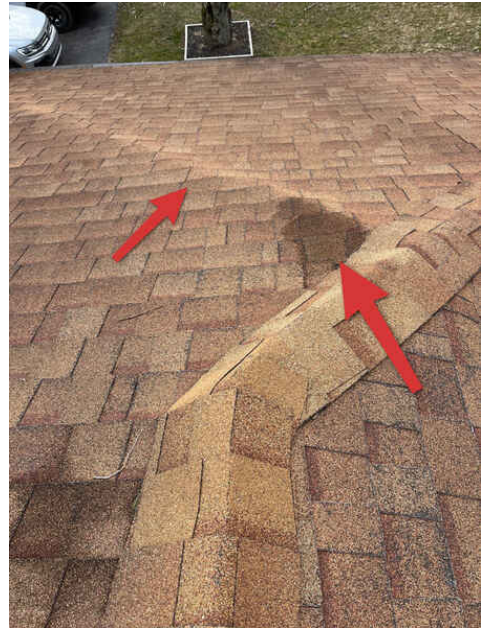
Shingles not laying flat

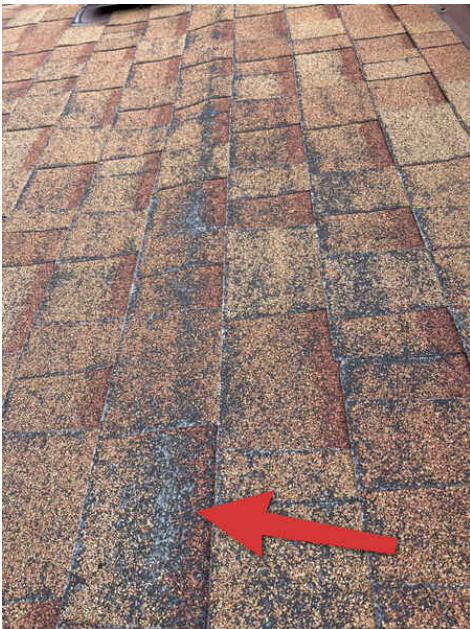
Shingles end of life condition

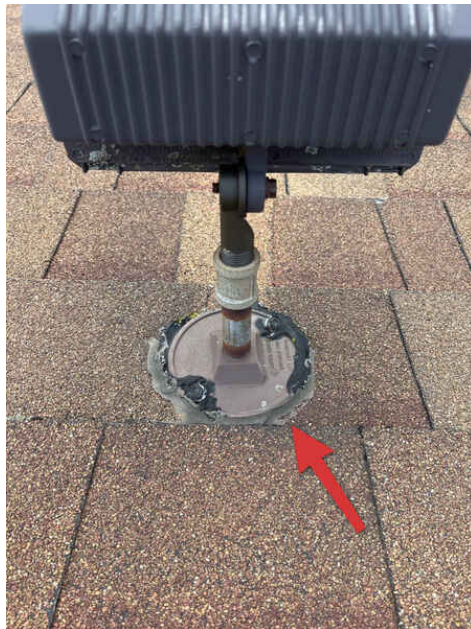
Failing sealant

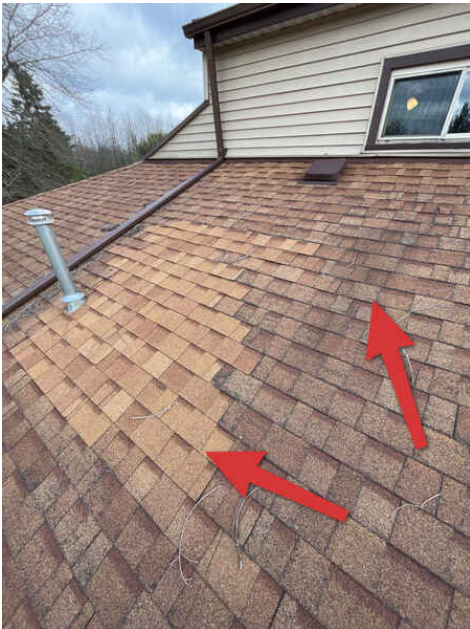
Patching present and major granule loss

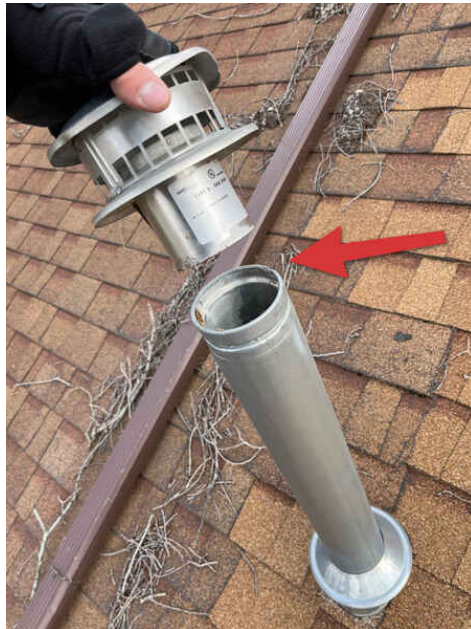
Flue vent not secured

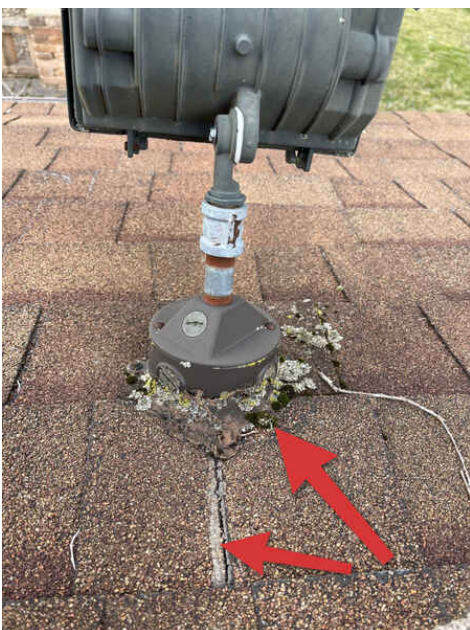
Failing sealant and moss growth

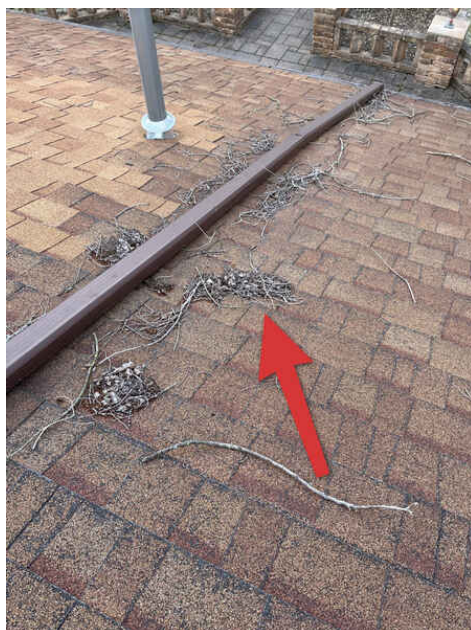
Debris on roof

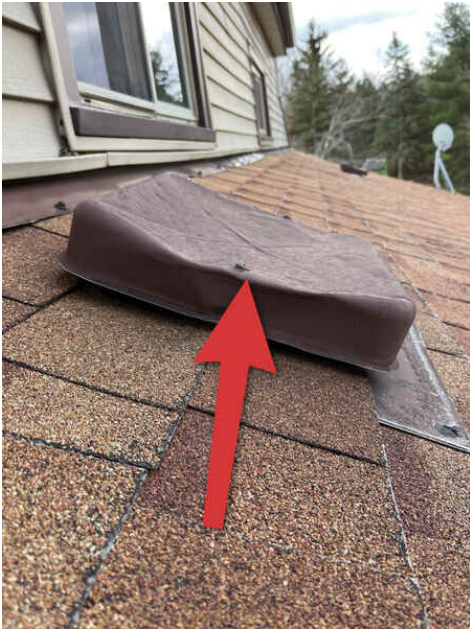
Damaged box vents

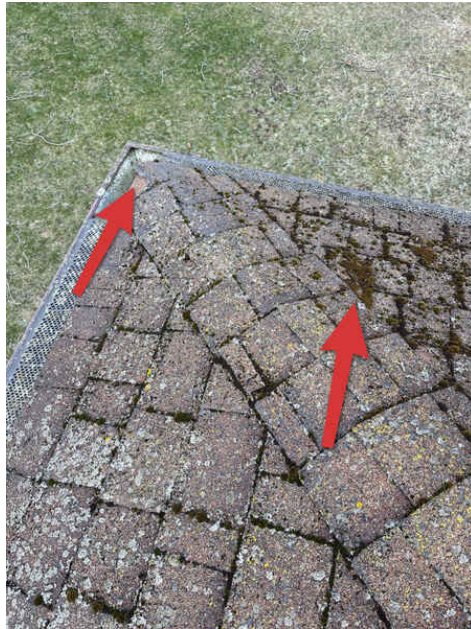
Damaged shingles and moss growth

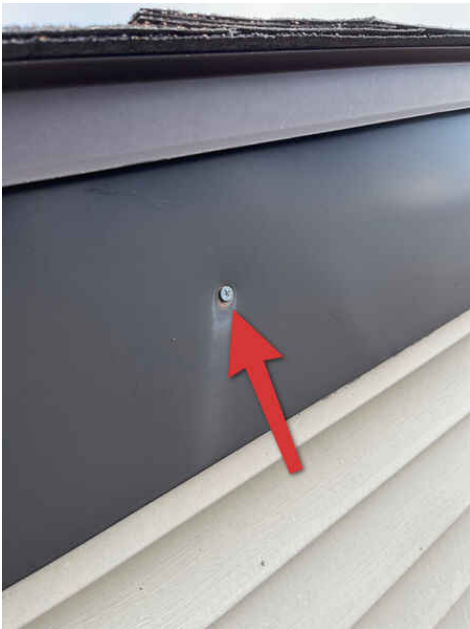
Exposed fasteners

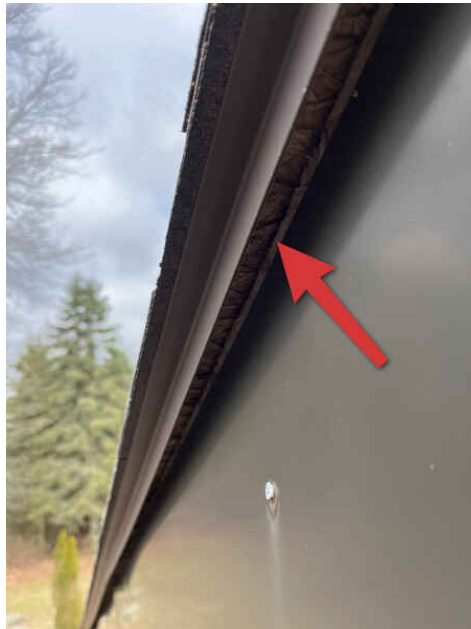
Missing flashing

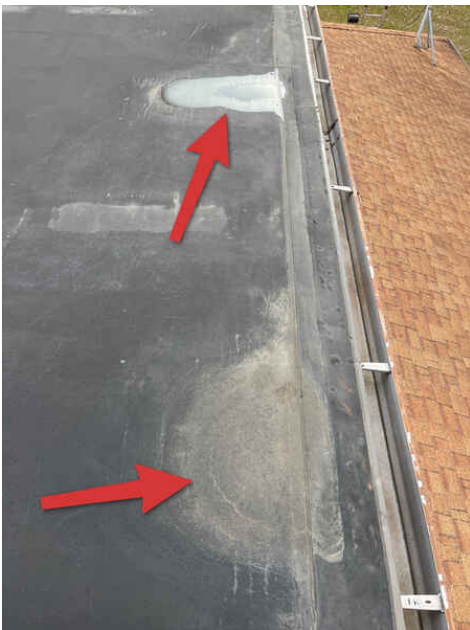
Ponding on flat roof

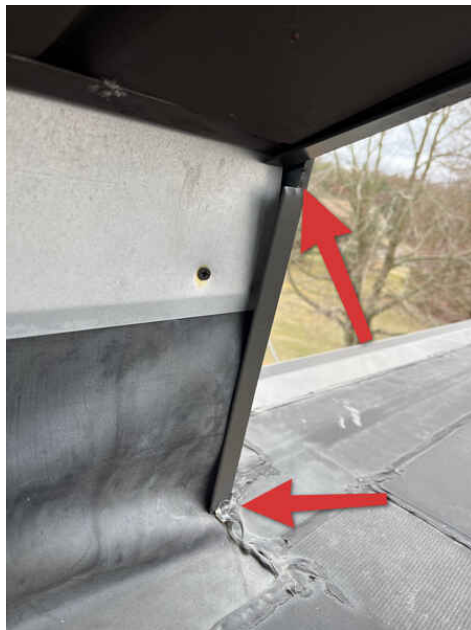
Failing sealant

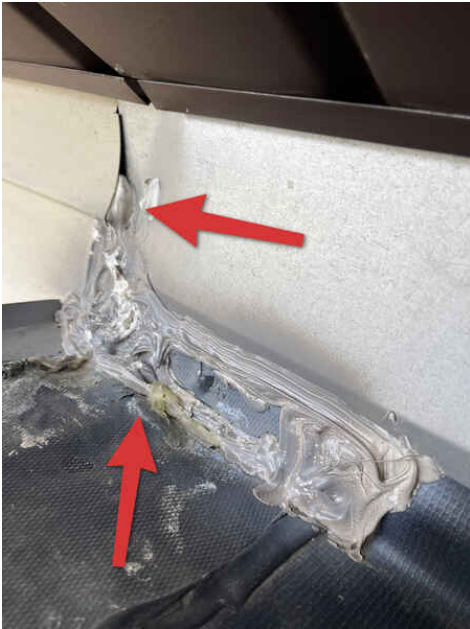
Poorly installed/failing sealant

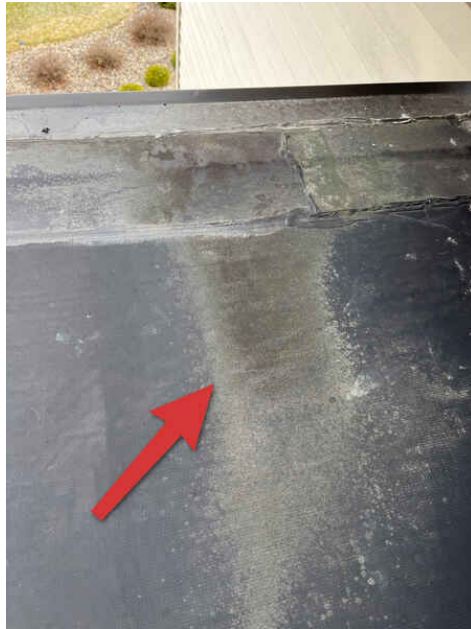
Evidence of ponding on flat roof

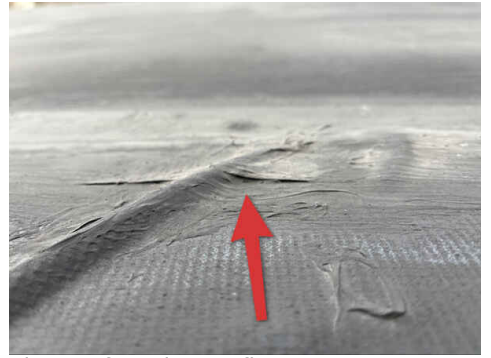
Flat roof not laying flat

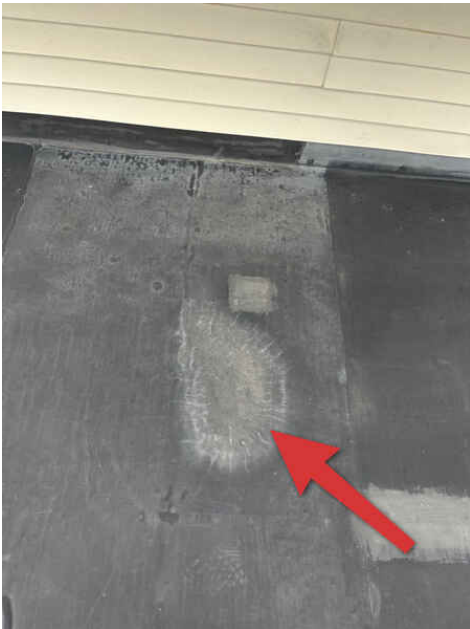
Evidence of ponding on flat roof

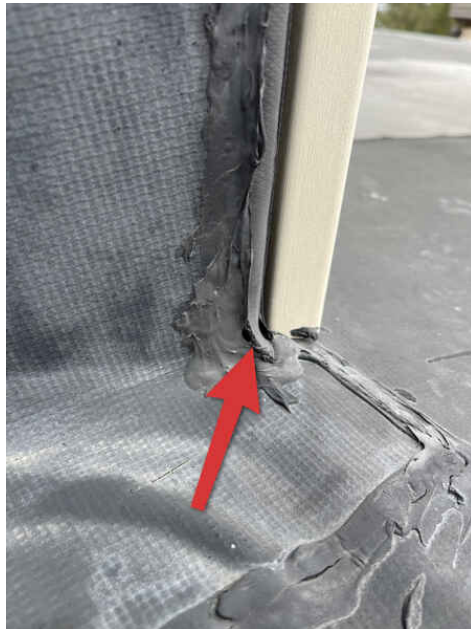
Failing sealant

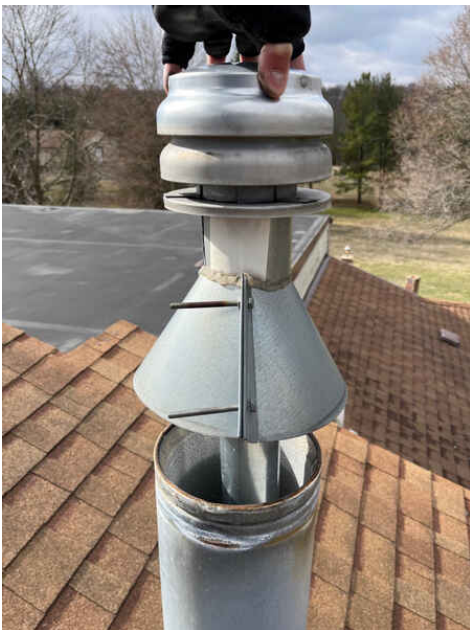
Flue vent loose

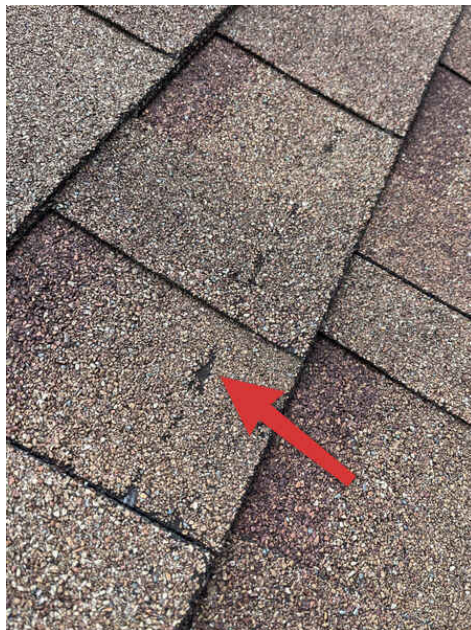
Damaged shingles

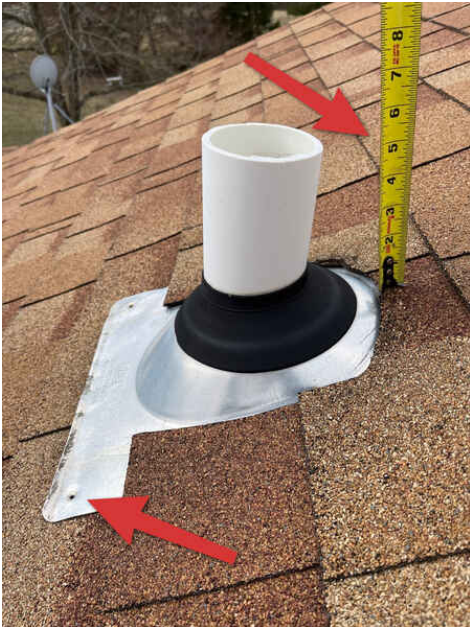
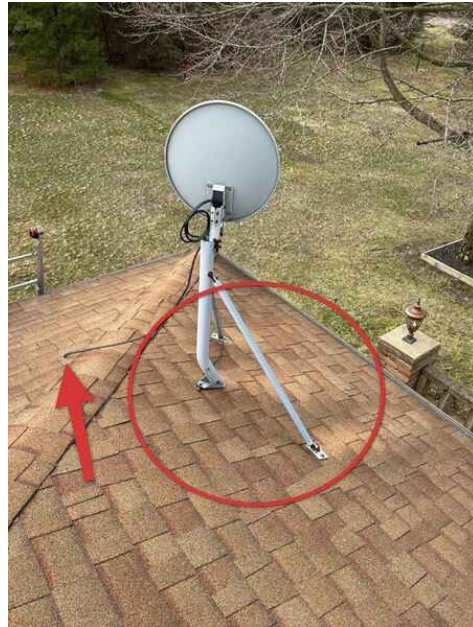
Missing fasteners and plumbing vent improper height

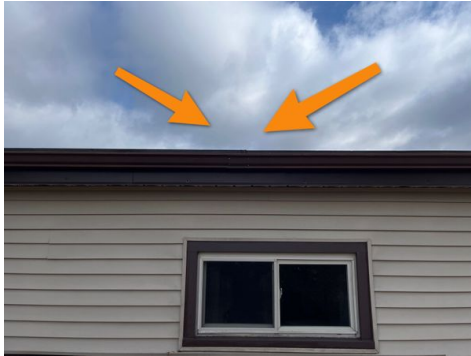
Back

A gutter was observed to be improperly sloped. Gutters should be sloped toward the downspouts in order to allow proper draining. This will allow for moisture intrusion. I recommend a qualified contractor.

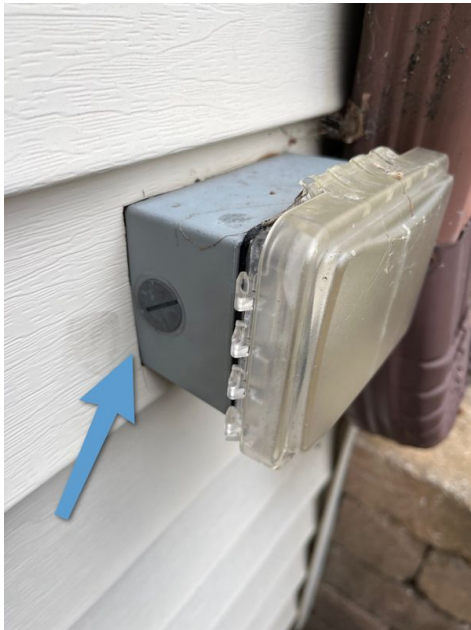
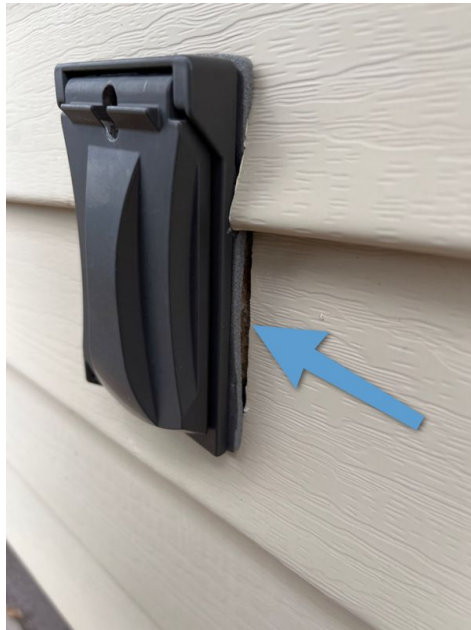
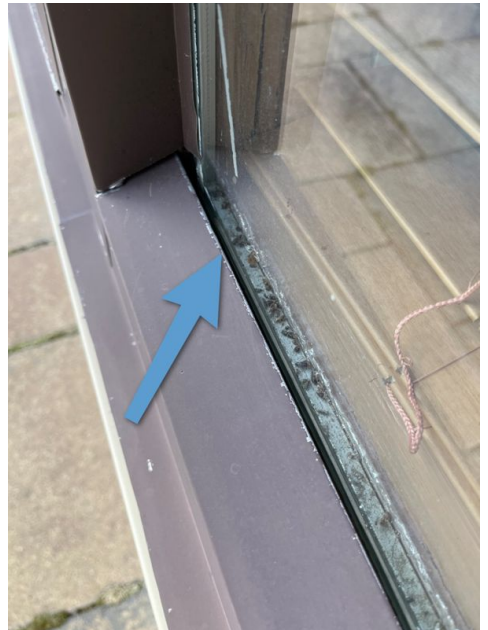
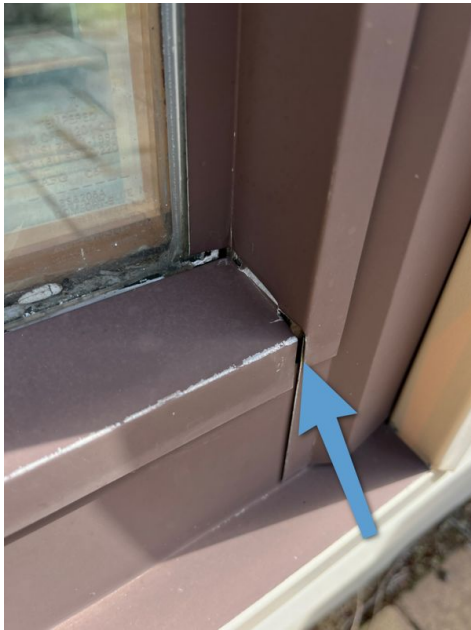
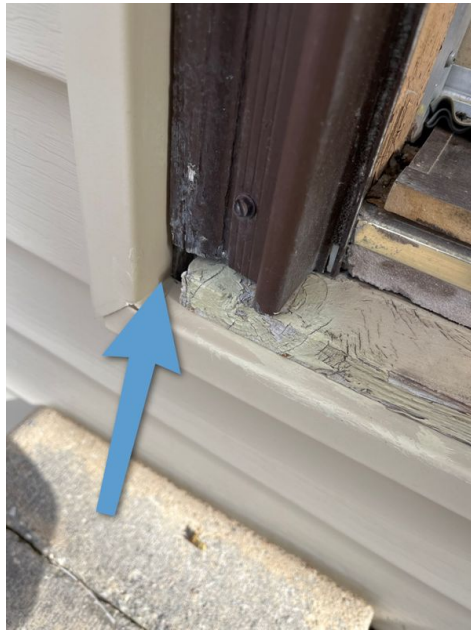
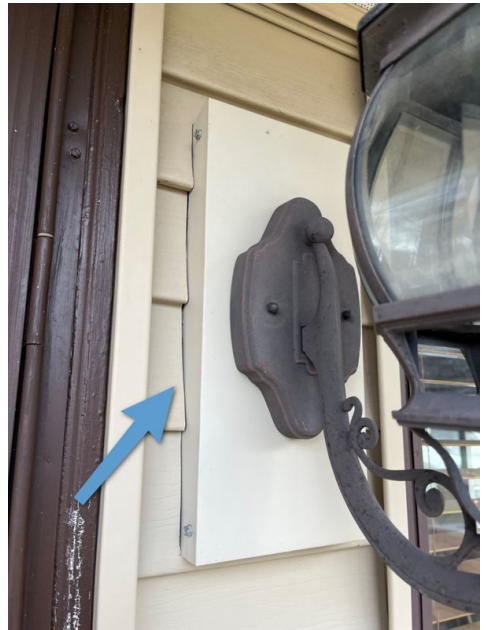
EXTERIOR CAULKING - DAMAGED/MISSING

Damaged/missing caulk was observed in area(s) on the exterior. This will allow for moisture and pest intrusion. I recommend a qualified contractor properly caulk all exterior gaps.

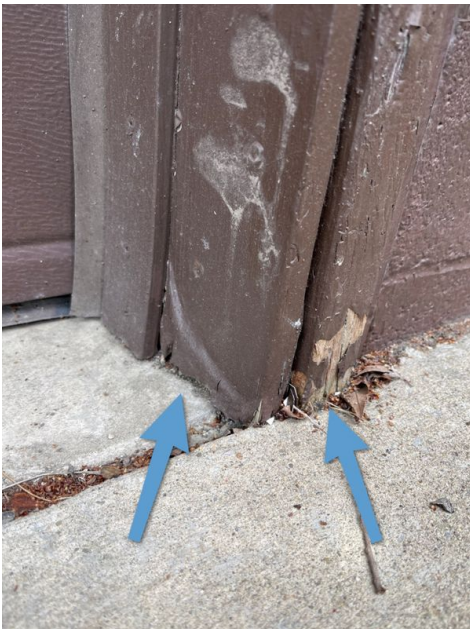
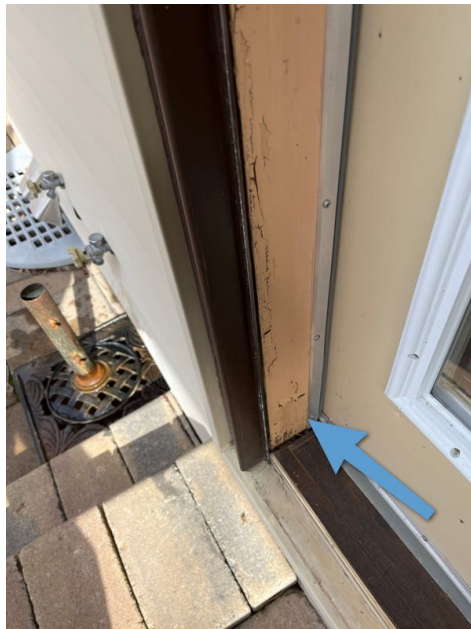
Back

EXTERIOR PAINT/SEAL - DAMAGED/MISSING

Damaged/missing paint was observed in area(s) on the exterior. This will allow for moisture and pest intrusion. I recommend properly painting/sealing all exposed areas.

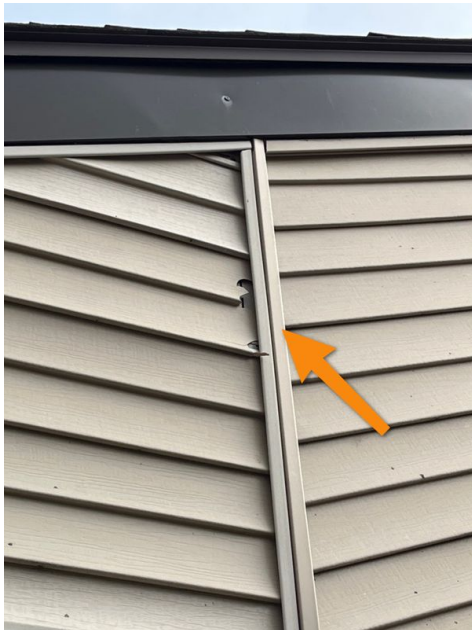
Right

SIDING - DAMAGED

The siding was observed to be damaged in area(s) on the exterior. This will allow for moisture and pest intrusion. I recommend a qualified contractor.

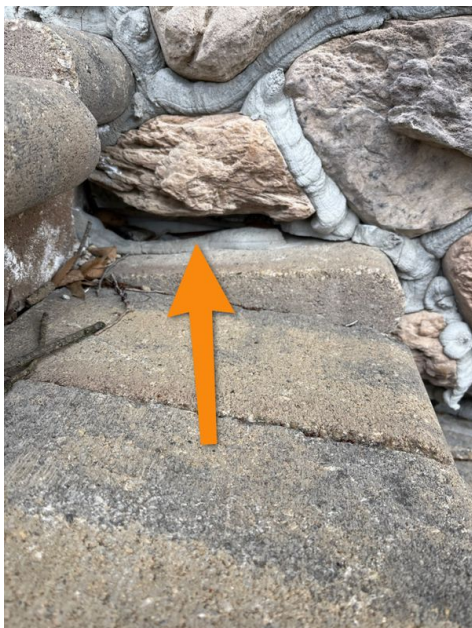
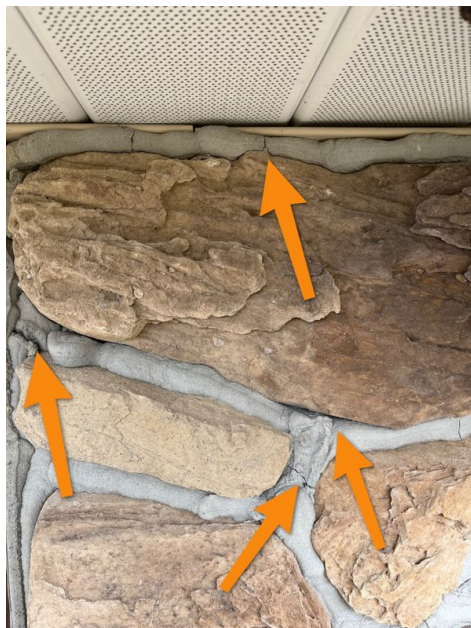
EXTERIOR MASONRY - CRACKING MORTAR

Cracking was observed on the mortar joints in area(s) on the exterior masonry. This will allow for moisture and pest intrusion. I recommend properly sealing the crack(s) with masonry caulking. If the cracks reappear after repairs have been made, I recommend a qualified contractor. Continue to monitor.

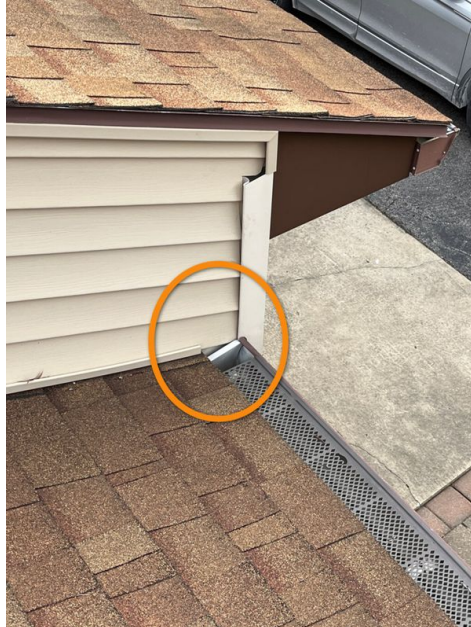
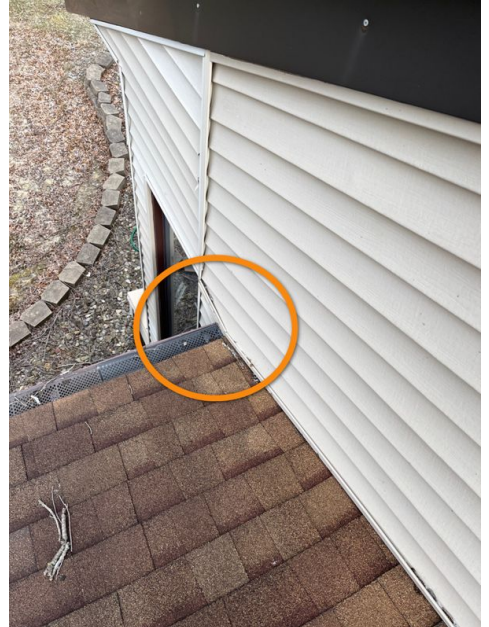
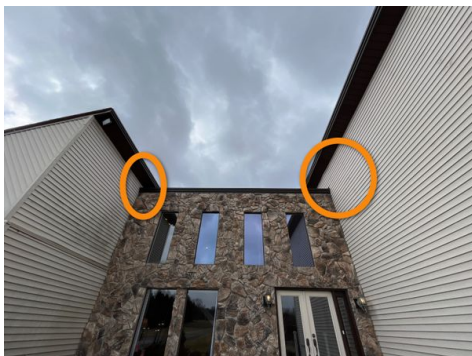
KICK-OUT FLASHING - MISSING

The kick-out flashing was observed to be missing in areas on the exterior. Kick-out flashing prevents moisture intrusion by directing rain water into the gutter and preventing it from getting behind the siding. This will allow for moisture intrusion. I recommend a qualified contractor.

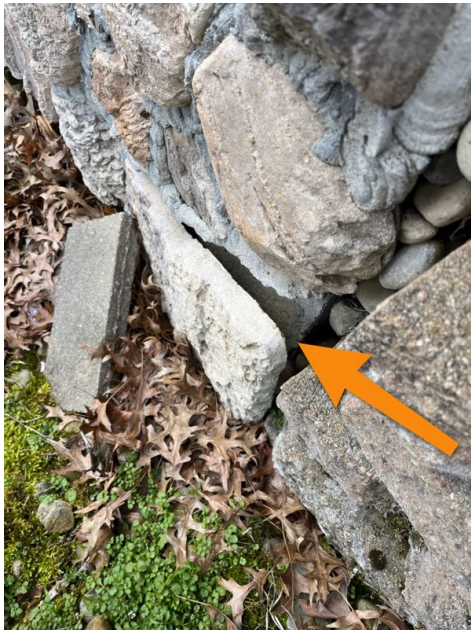
Front Right

EXTERIOR MASONRY - DAMAGED/LOOSE

Damage/loose stone was observed in area(s) on the exterior masonry. This will allow for moisture and pest intrusion as well as wood rot. I recommend a qualified contractor.

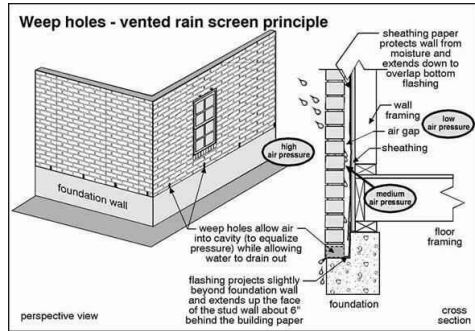
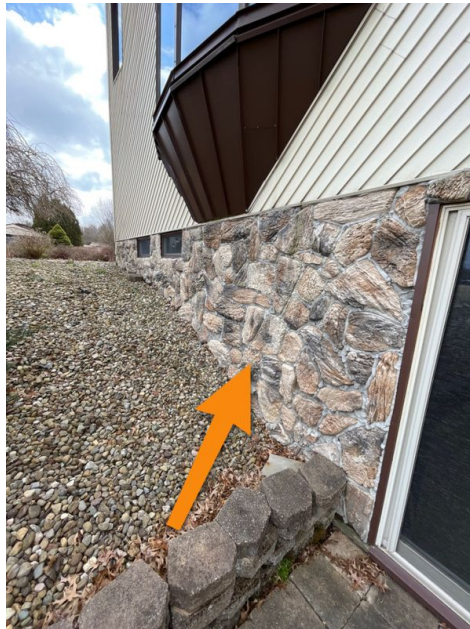
EXTERIOR MASONRY VENEER - WEEP HOLES MISSING

The exterior masonry veneer was observed to have the weep holes missing. The masonry veneer system is designed to allow any moisture that gets behind the surface to exit the inside of the wall through the weep holes, which are located at the bottom of the veneer. This will allow for moisture and pest intrusion. I recommend a qualified contractor.

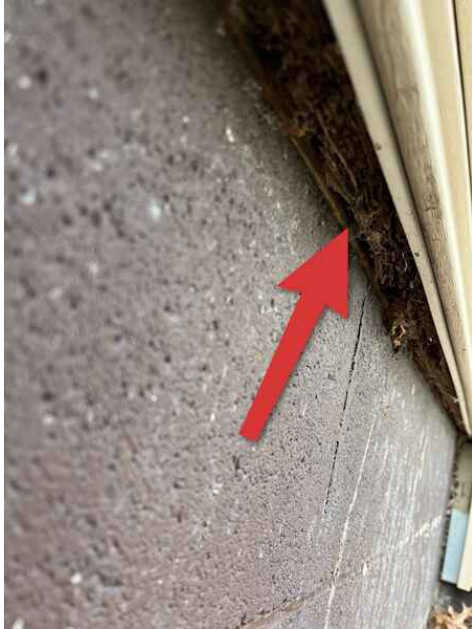
Right

EXTERIOR - WOOD ROT

Wood rot was observed in area(s) on the exterior including behind the siding, below windows and behind the stone veneer. This may be due to poor/improper installation of the siding/flushing and stone veneer. This will allow for moisture and pest intrusion. I recommend a qualified contractor.

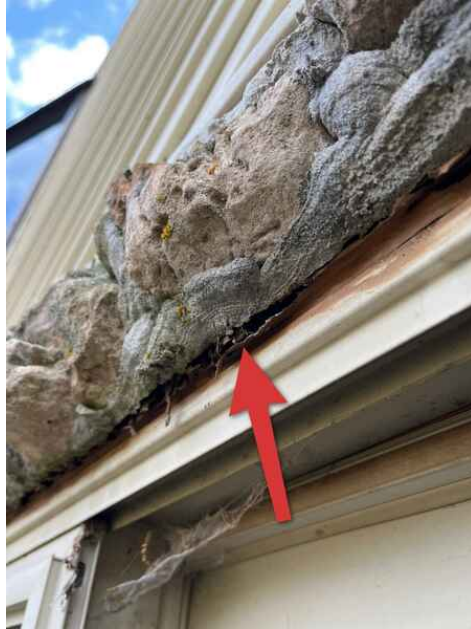
Behind stone veneer - missing moisture barrier

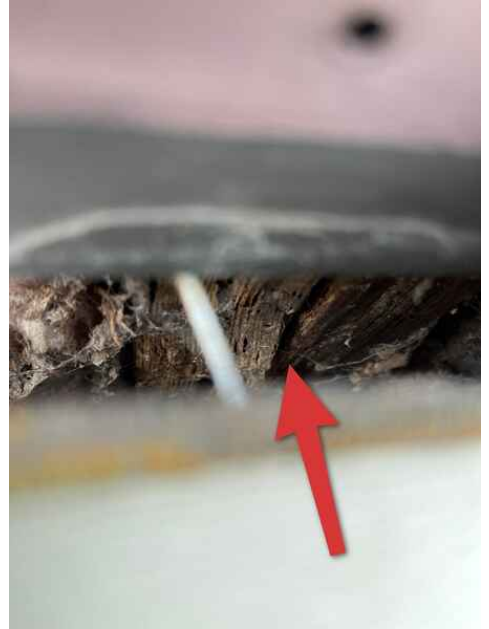
Behind siding below windows

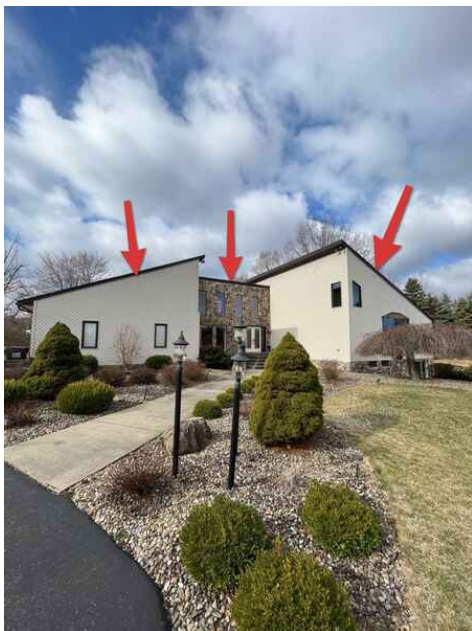
Siding installed diagonally and stone veneer missing weep holes/moisture barrier

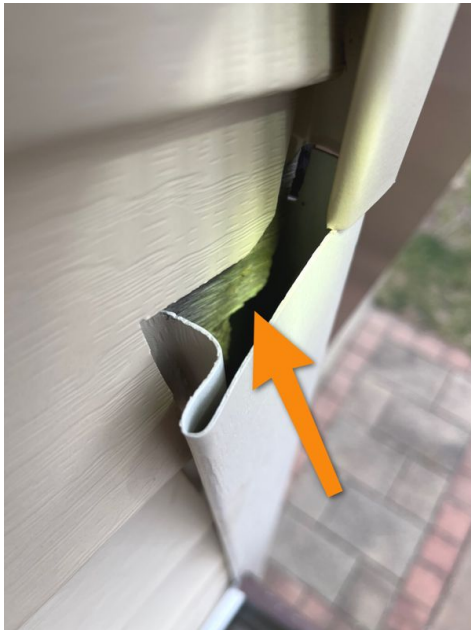
Left

FLASHING - MISSING

The flashing was observed to be missing in area(s) on the exterior. This will allow for moisture and pest intrusion as well as wood rot. I recommend a qualified contractor.

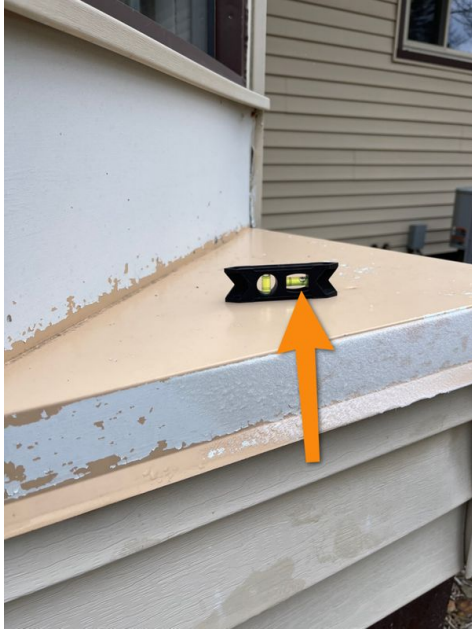
Right

FLASHING - IMPROPER SLOPE

The flashing was observed to be improperly sloped in area(s) on the exterior. Flashing should be sloped so that water is directed away from the structure. This will allow for moisture intrusion. I recommend a qualified contractor.

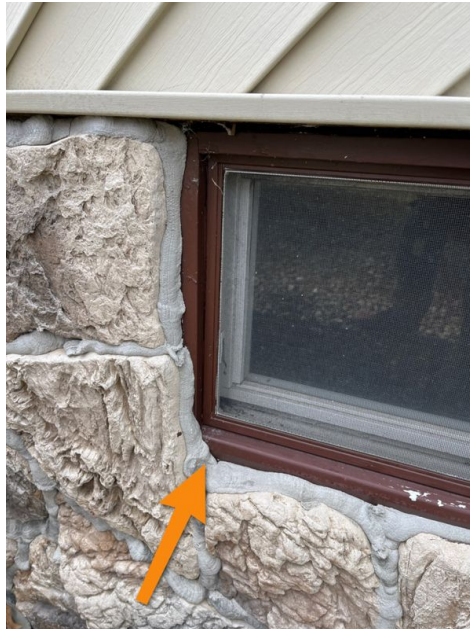
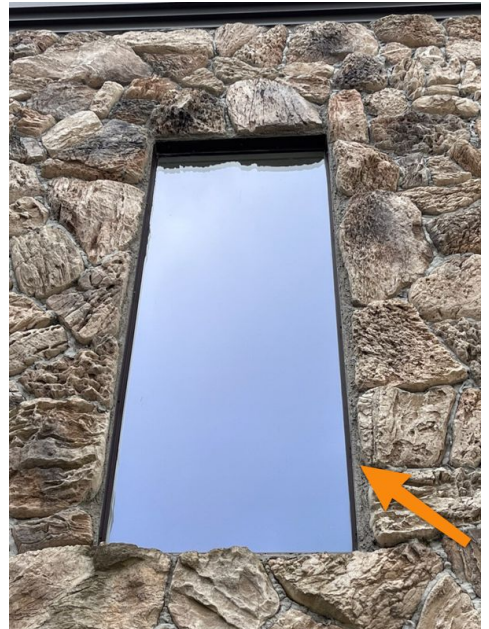
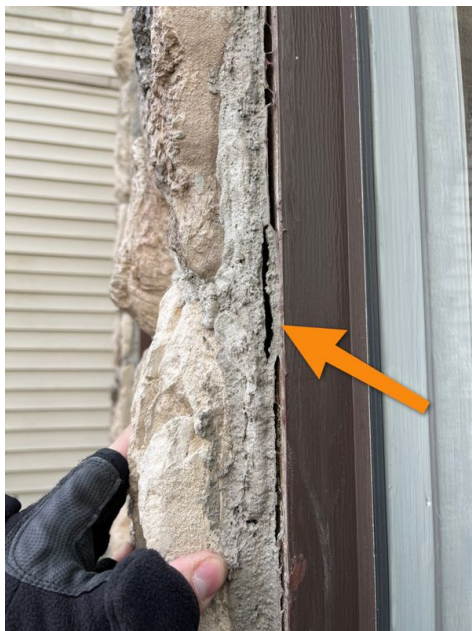
The masonry was observed to have mortar around the window(s), which can make replacement of the window(s) in the future difficult. It is recommended to have a 3/8 inch gap with backer rod and sealant around the windows. This will allow for moisture and pest intrusion. I recommend a qualified contractor.

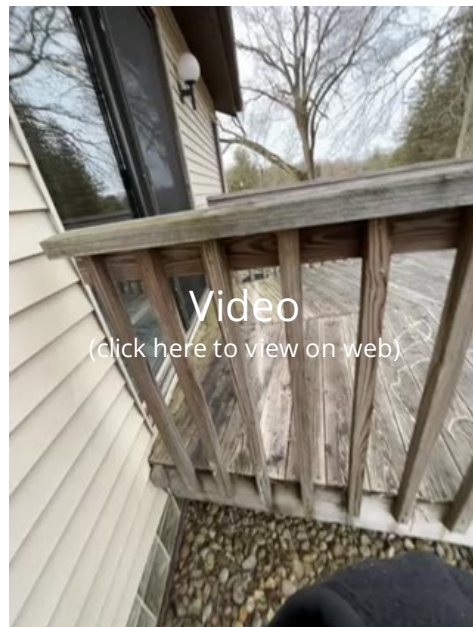
RIGHT

A guardrail(s) was observed to be loose in area(s) on the exterior. This is a fall hazard. I recommend a qualified contractor.

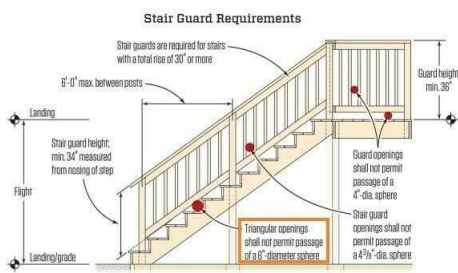
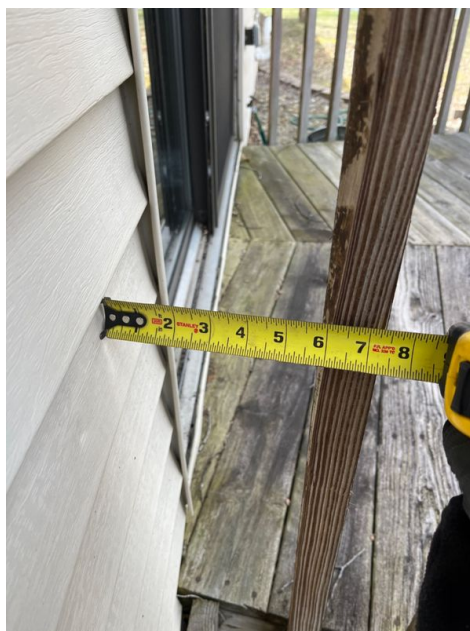
RIGHT

GUARDRAIL(S) - IMPROPER BALUSTER SPACING

A guardrail(s) was observed to have improper baluster spacing in area(s) on the exterior. The spacing in between balusters should be no greater than 4" wide. This is a fall hazard. I recommend a qualified contractor.

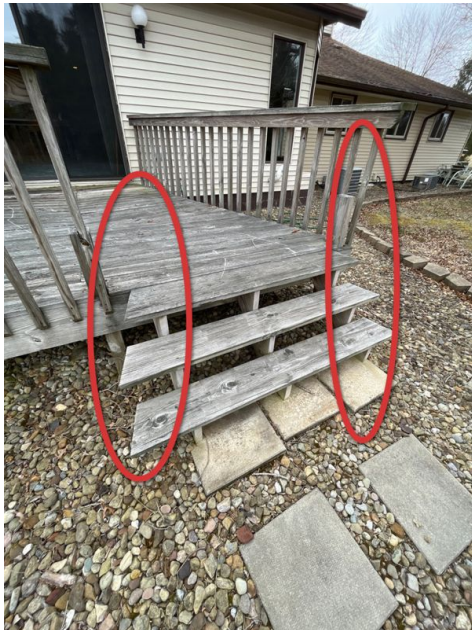
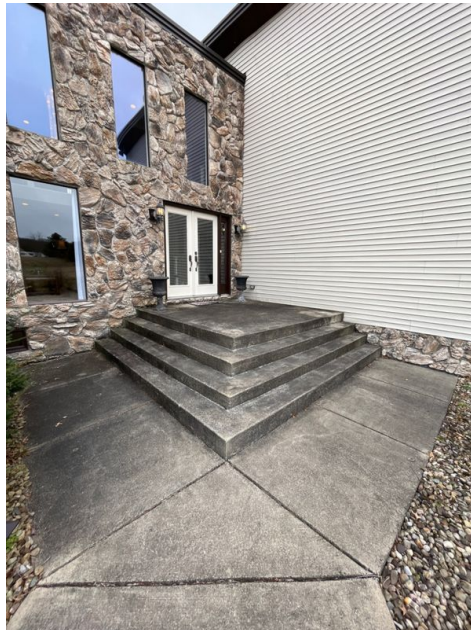
VARIOUS

GUARDRAIL(S) - MISSING

A missing guardrail(s) was observed in area(s) on the exterior. This is a fall hazard. I recommend a qualified contractor.

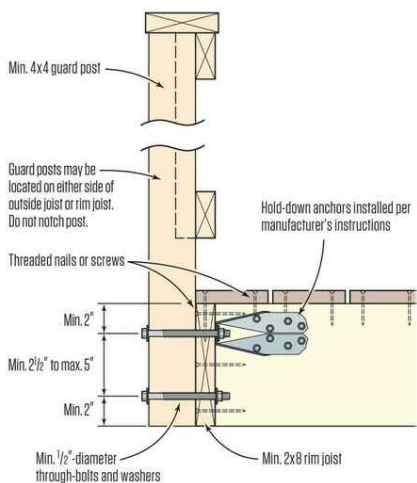
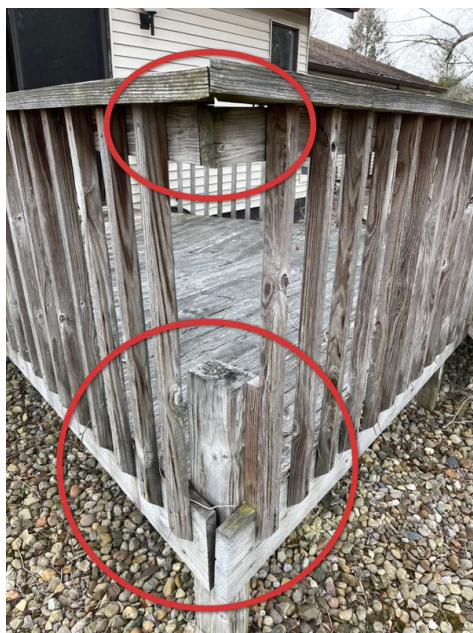
GUARDRAIL(S) - IMPROPER POST CONNECTION

A guardrail(s) was observed to be connected improperly to a post(s) in area(s) on the exterior. This is a fall hazard. I recommend a qualified contractor.

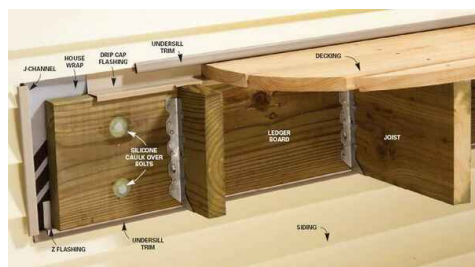
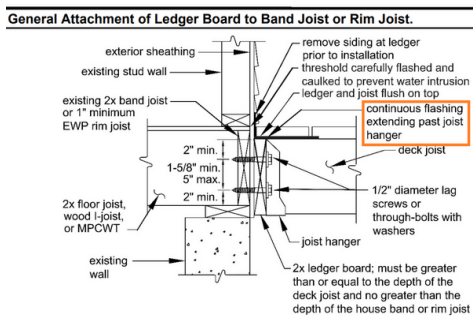
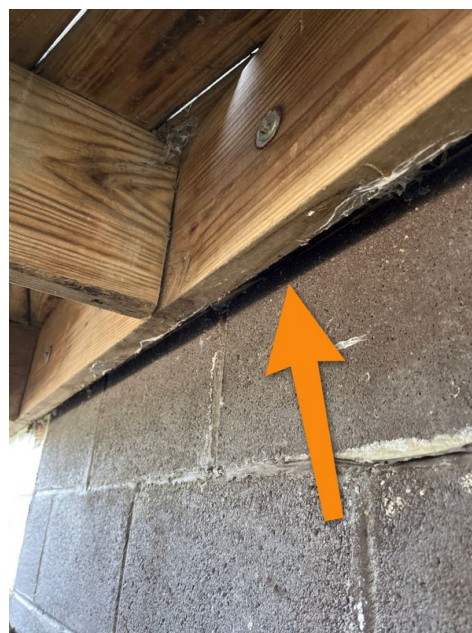
RIGHT

LEDGER BOARD - FLASHING MISSING

A ledger board on a deck/porch was observed to have missing flashing in area(s) on the exterior. This will allow for moisture intrusion and wood rot. I recommend a qualified contractor.

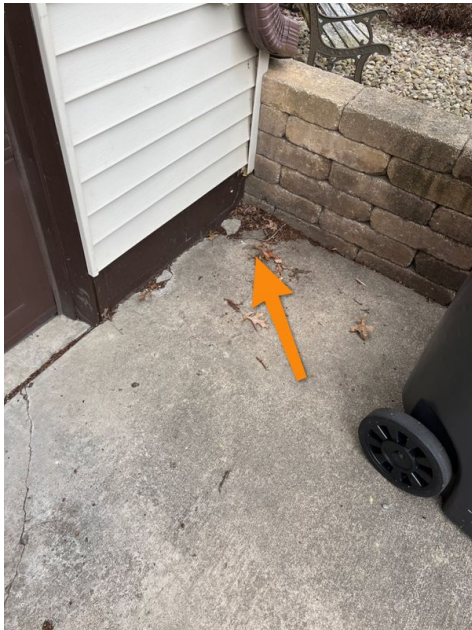
Front Left

HARDSCAPE - IMPROPERLY SLOPED

Areas of hardscape are not properly sloped throughout the exterior. This will allow for moisture intrusion into the foundation. I recommend a qualified contractor.

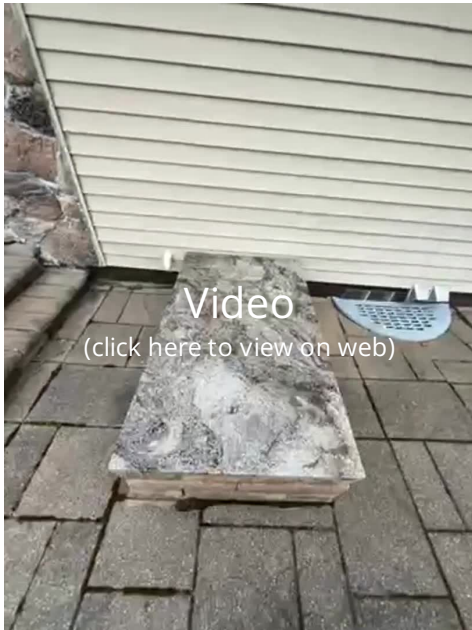
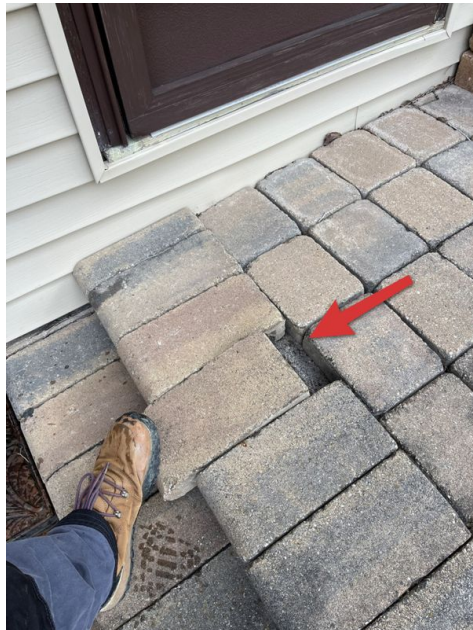
Back

Various pavers were observed to be loose/improperly secured. This is a safety hazard. I recommend a qualified contractor.

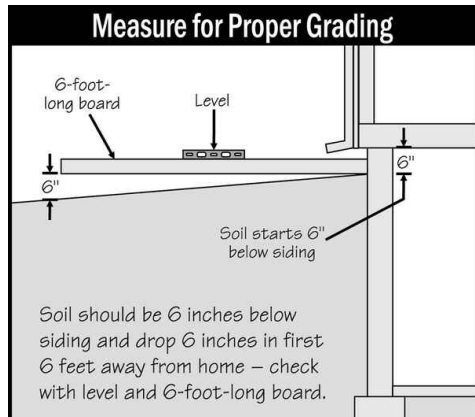
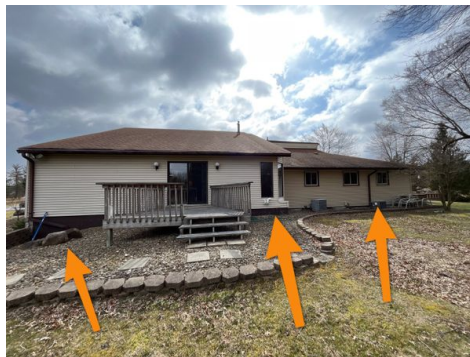
Right

Areas of the grading were observed to be sloping towards the home. In order to promote good drainage of rainwater away from the foundation and prevent moisture intrusion/damage to the foundation, I recommend regrading.

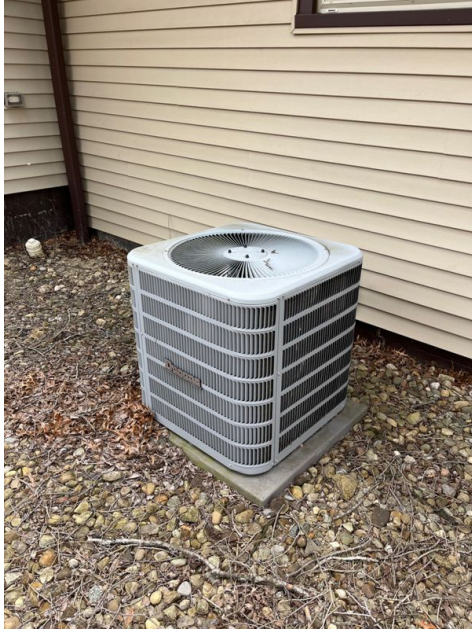
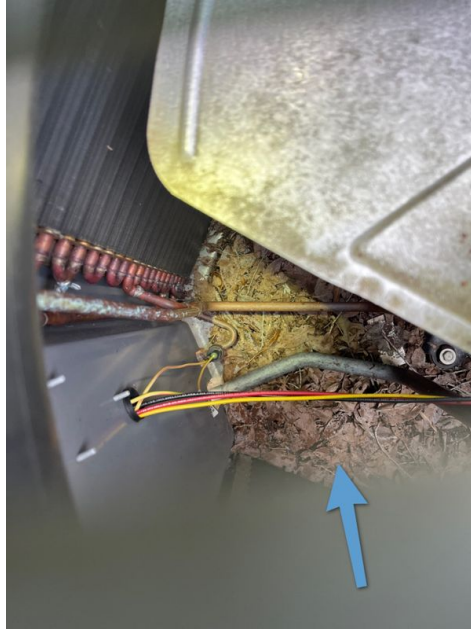
BOTH UNITS

Debris was present on and around the AC units. In order to extend the life of the air conditioner, I recommend having the air conditioner cleaned and serviced by a licensed HVAC contractor, followed by annually.

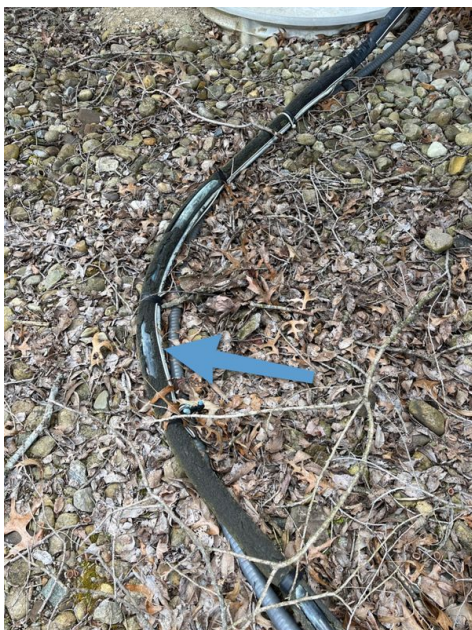
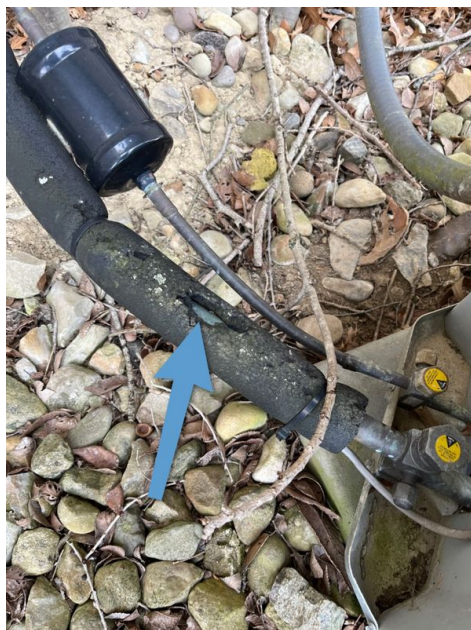
BOTH UNITS

INSULATION - DAMAGED/MISSING

The insulation on the suction lines for the air conditioners were observed to be damaged. In order to prevent any condensation leaks as well as energy loss, I recommend having the insulation replaced.

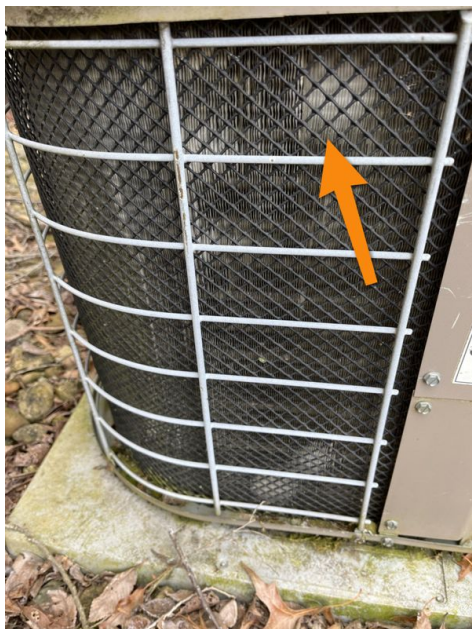
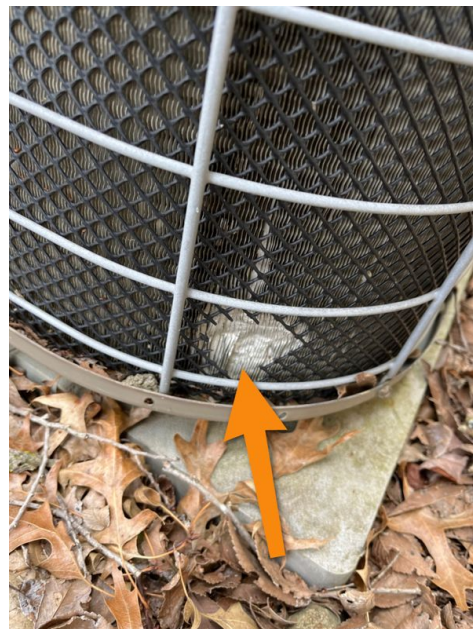
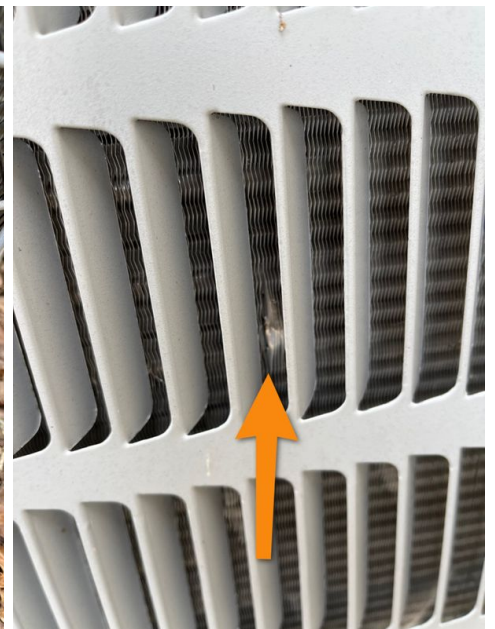
COIL/FIN DAMAGE

The air conditioner condensers were observed to have minor damage to the fins. Damage to the fins can restrict airflow to the unit. Minor damage can often be combed out. I recommend a licensed HVAC contractor.
