STARBOARD PROPERTY INSPECTIONS LLC

PROPERTY INSPECTION REPORT

1234 Main Street
Stow, OH 44224

05/18/2023 9:00AM

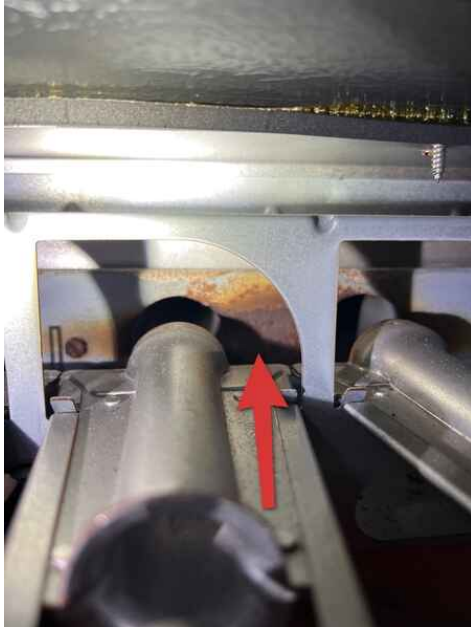
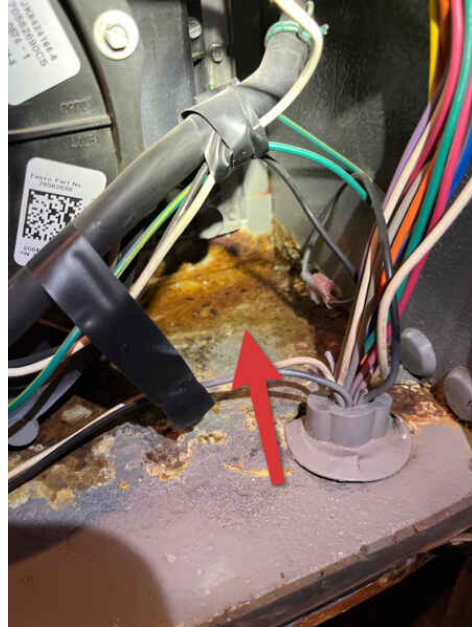
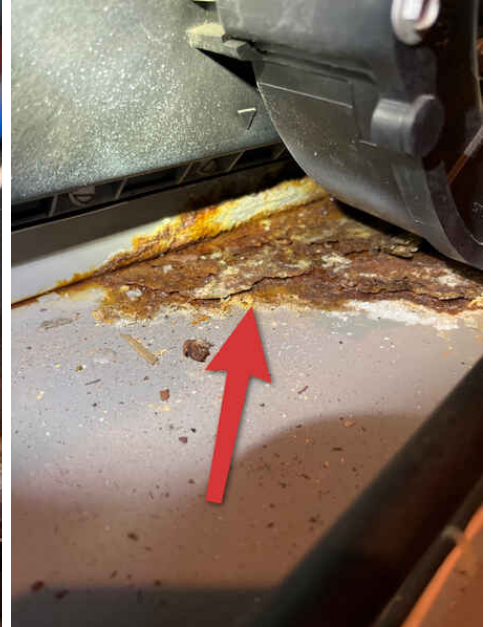
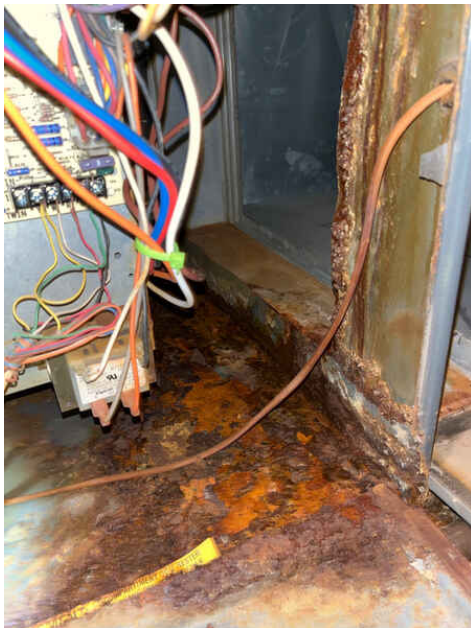
GOODMAN

FURNACE - CORROSION/RUST

Major corrosion/rust was observed on the Goodman furnace including on the heat exchanger. In addition, minor rust was present on the Luxaire furnace. In order to maintain the furnaces, I recommend a licensed HVAC contractor.

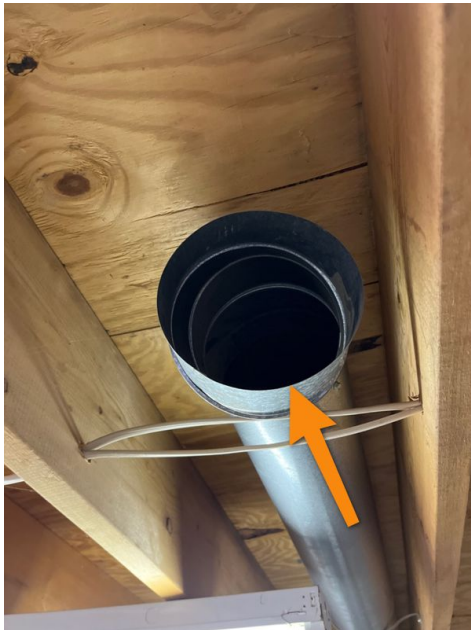
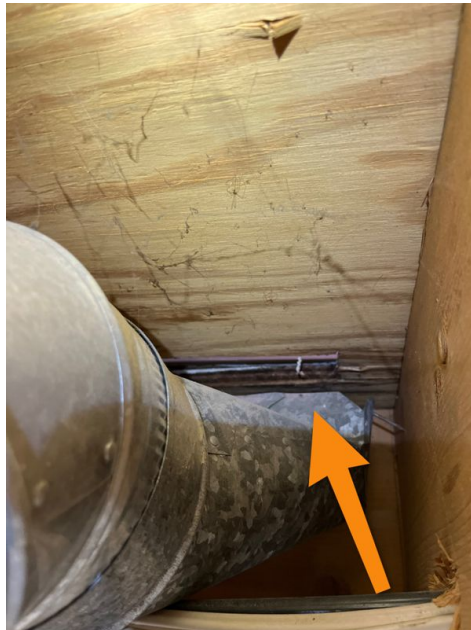
The ductwork was observed to be sealed poorly in area(s). In order to promote efficient air distribution as well as minimize dust/debris from entering the ductwork, I recommend a licensed HVAC contractor.

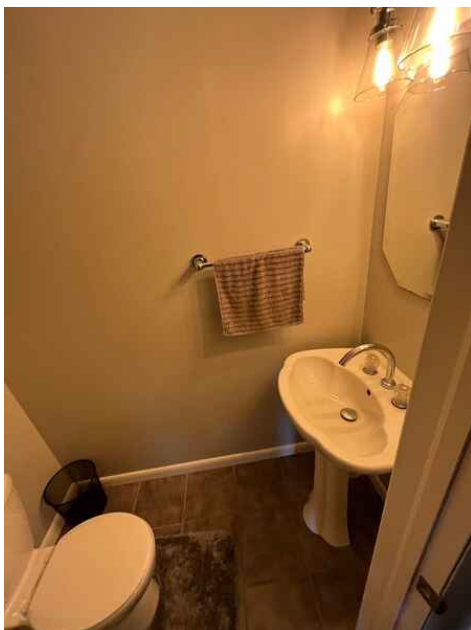
Bathroom near garage

A room(s) did not have a visible heat source. In order to provide adequate heat to the habitable space, I recommend having a heat source added by a qualified contractor.

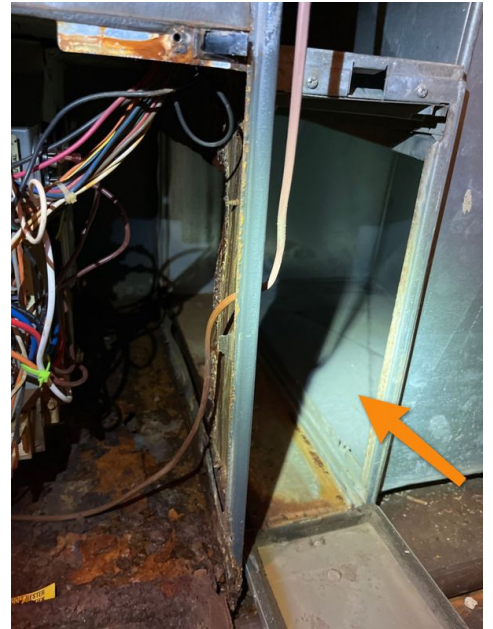
A furnace did not have a filter installed during the inspection. In order to extend the life of the furnace and prevent debris from circulating throughout the home, I recommend having a proper filter installed.

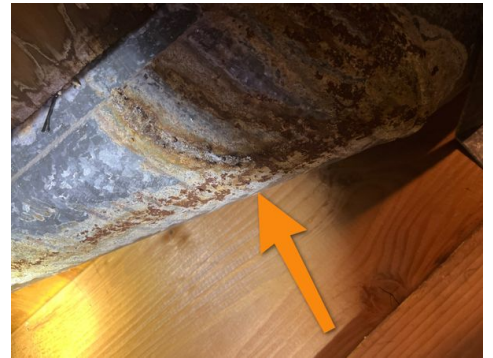
Basement

DUCTWORK - RUST/CORROSION

Rust/corrosion was present on the duct work. I recommend a licensed HVAC contractor.

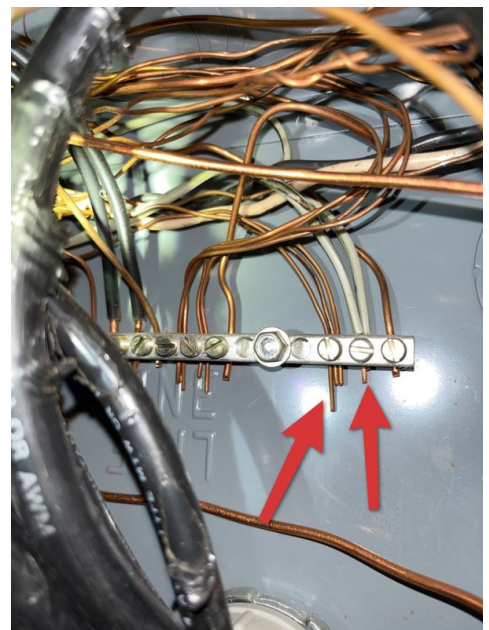
BASEMENT

A sub panel had neutral and ground wires that were not isolated from each other (on the same bus bar). This is a shock hazard. I recommend a licensed electrical contractor.

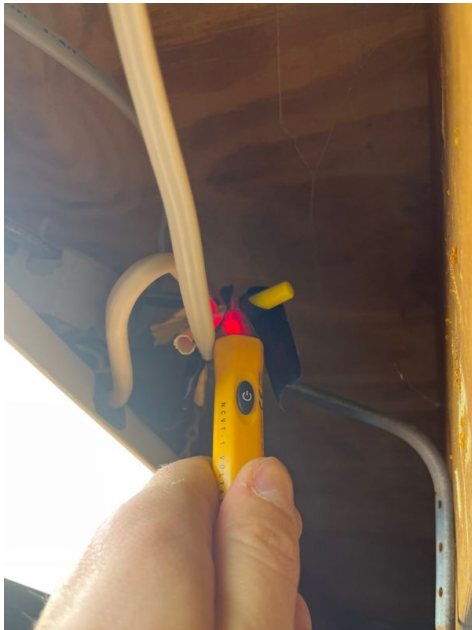
Basement

Open spliced wiring was observed at the time of the inspection. This is a fire hazard and shock hazard. I recommend a licensed electrical contractor.

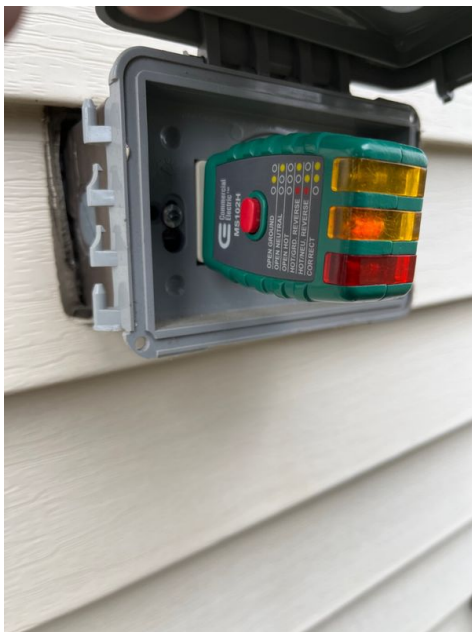
Right

A receptacle(s) had an open ground. The ground is an important safety feature that minimizes the risk of electric shock, and allows surge protectors to protect your electrical equipment. I recommend a licensed electrical contractor.

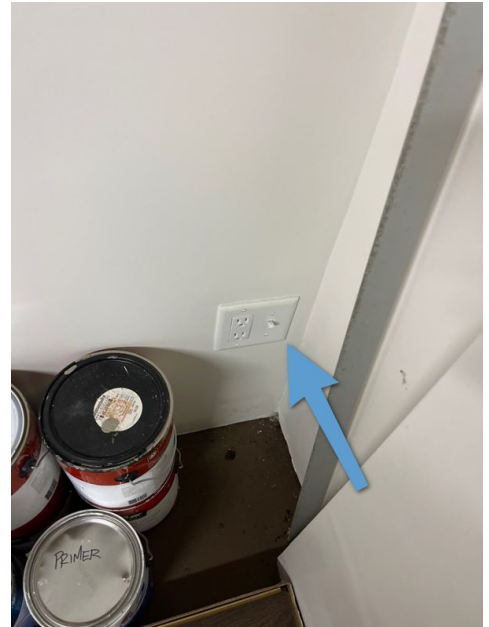
Basement

Various light switches were not functioning properly at the time of the inspection. I recommend having the light bulb replaced and then having the circuit addressed if necessary by a licensed electrical contractor.

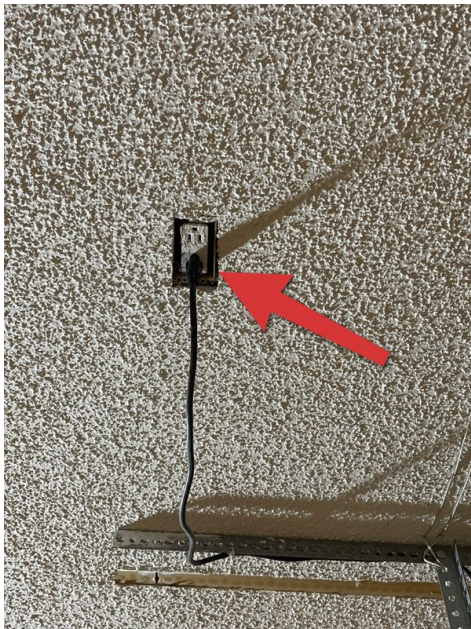
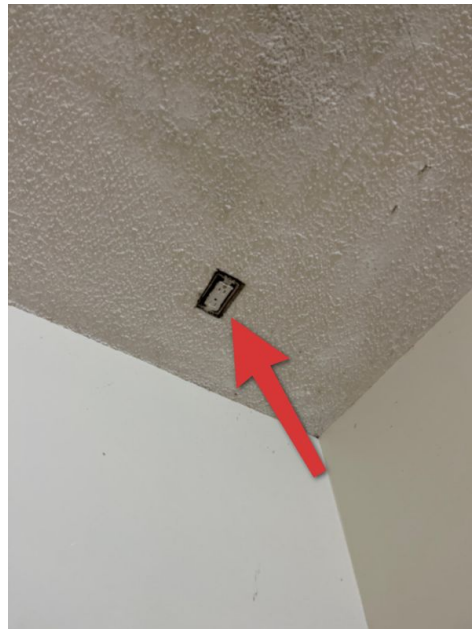
Garage

COVER PLATE MISSING

A cover plate(s) was observed to be missing. This is a fire hazard and shock hazard. I recommend a qualified contractor.

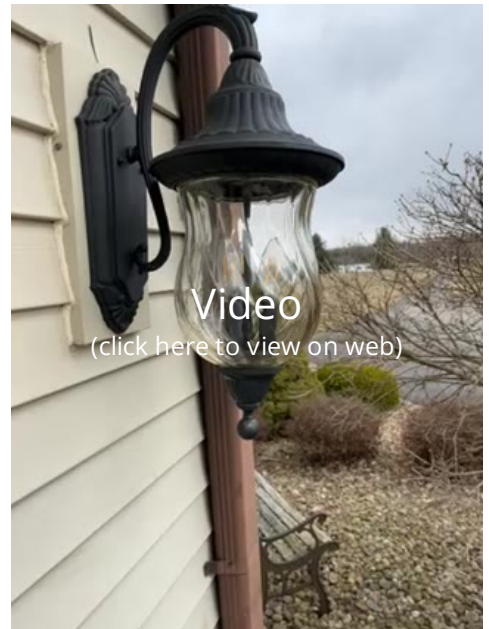
Various exterior light fixtures were not properly secured/sealed to the box. This will allow for moisture and pest intrusion. I recommend having all exterior light fixtures properly secured and sealed.

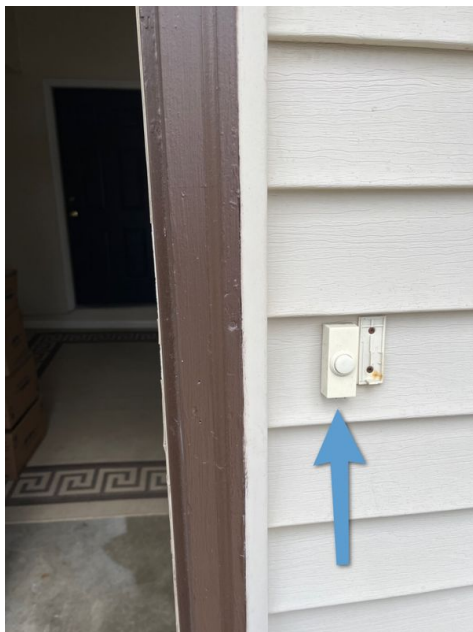
Left

A doorbell was not functioning during the inspection. I recommend a qualified contractor.

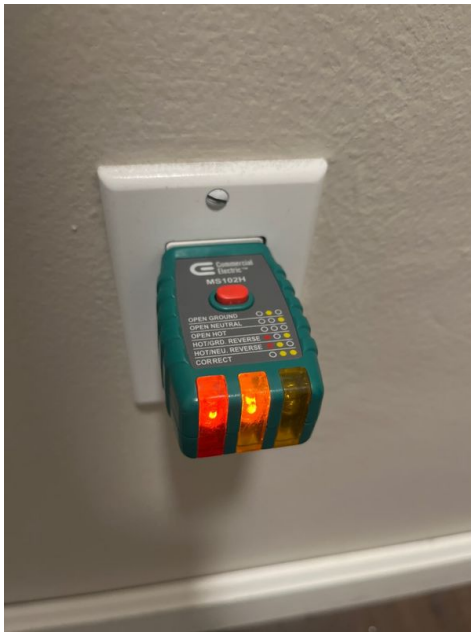
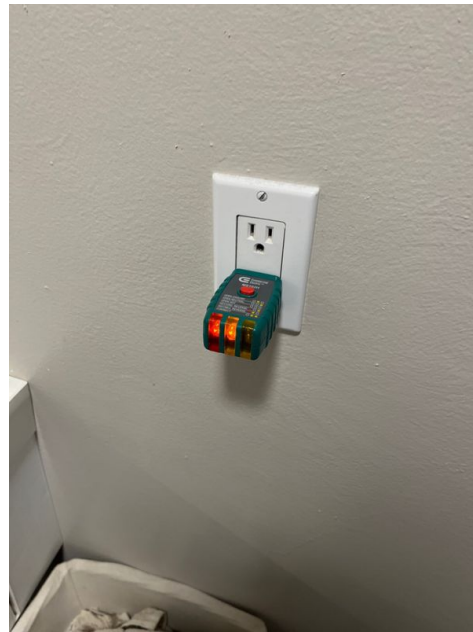
Laundry Room

A receptacle was observed to be wired with reverse polarity. This is a shock hazard. I recommend a licensed electrical contractor.

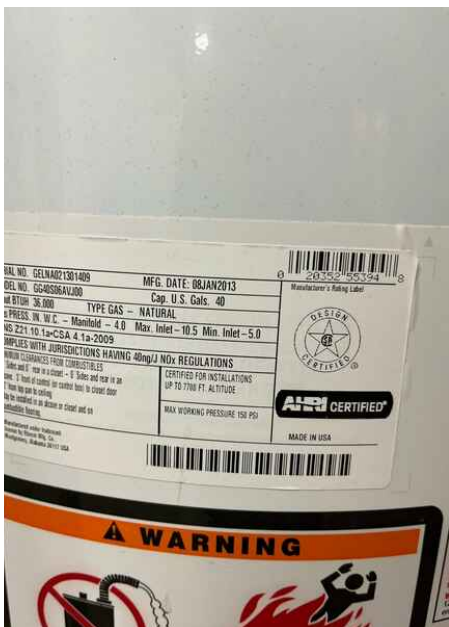
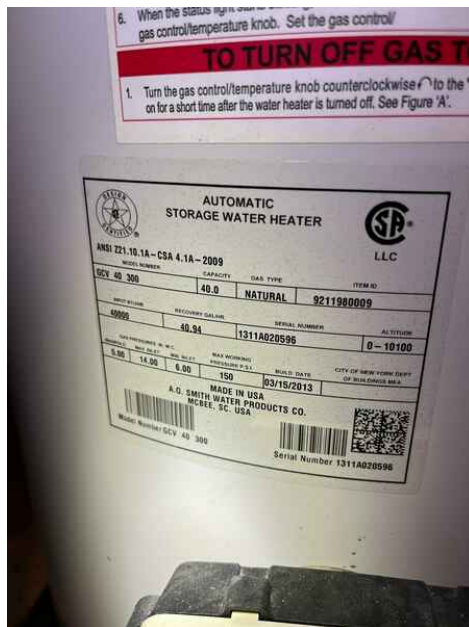
Atmospheric Water Heater: Approximate Manufacturing Age

10 Years Old

The typical life expectancy of a conventional water heater is 6-12 years. If the unit(s) was observed to be functioning at the time of the inspection but past its typical life expectancy, I recommend budgeting for future replacement.

GE - 2013

AO Smith - 2013

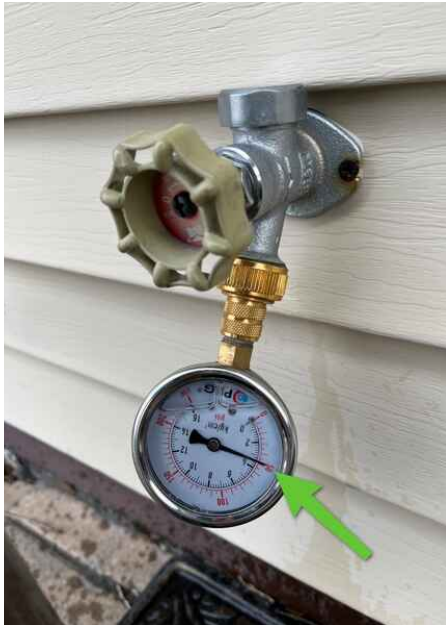
~49 psi

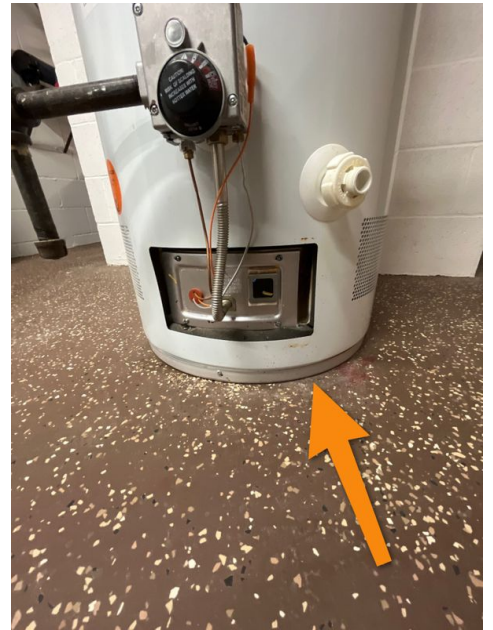
9.1.2 Atmospheric Water Heater

WATER HEATER - RUST

Rust was observed on the water heater. In order to maintain the water heater and minimize risk of moisture damage, I recommend a licensed plumbing contractor.

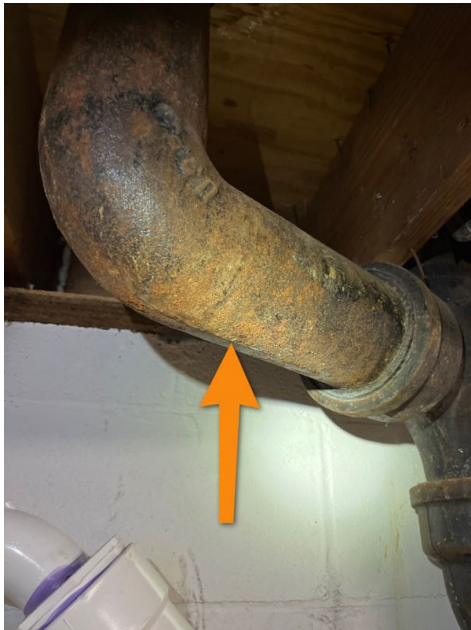
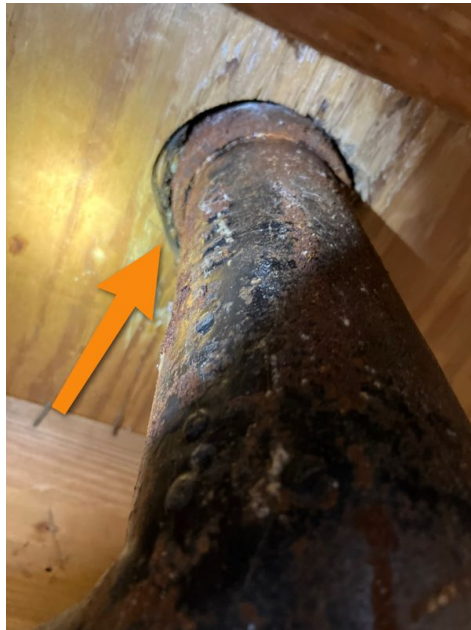
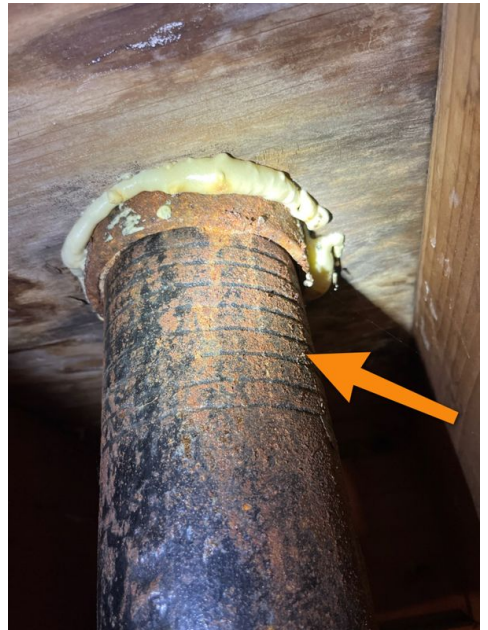
9.2.2 Drain, Waste, & Ventilation

DRAIN PIPE - LEAK

A drain pipe was leaking at the time of the inspection. This will allow for moisture damage. I recommend a licensed plumbing contractor.

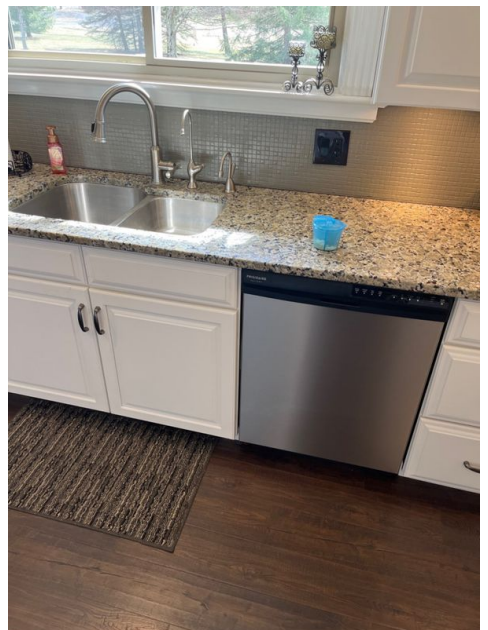
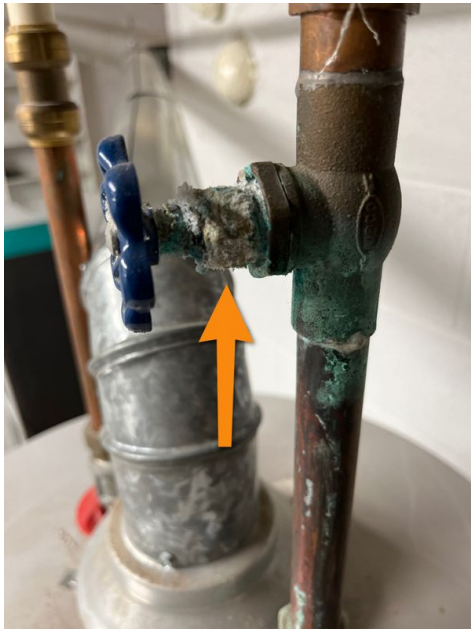
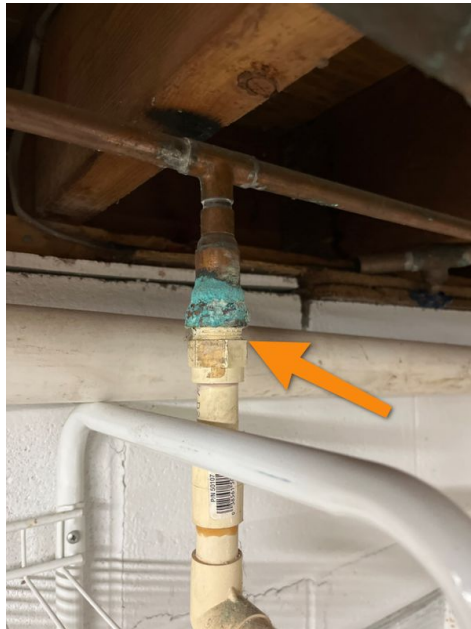
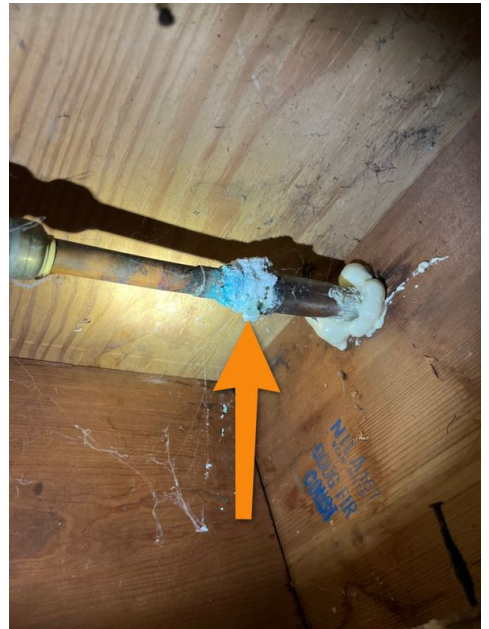
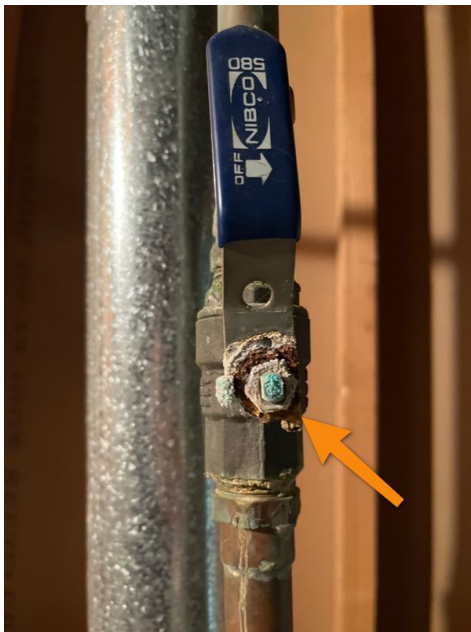
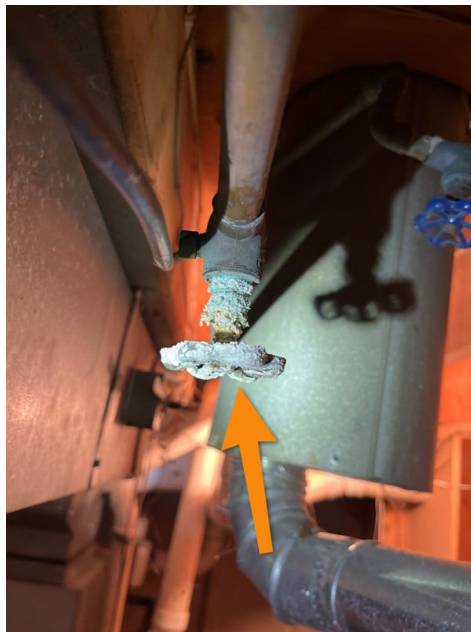
9.3.1 Water Supply

EFFLORESCENCE (MINERAL SALTS)/CORROSION

Efflorescence (mineral salts)/corrosion was observed on areas of the supply pipes. Efflorescence (mineral salts)/corrosion may be an indication that this area has been leaking, or may leak in the future. No live moisture was observed at the time of the inspection, however I recommend a licensed plumbing contractor.

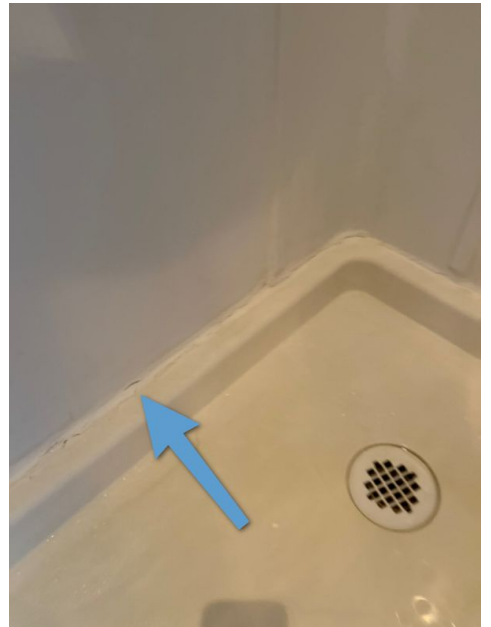
Owners Suit Bathroom

Maintenance and/or Minor Recommendations**TUB/SHOWER -
MISSING/DAMAGED CAULKING**

Areas of a tub/shower were observed to have missing/damaged caulking. In order to prevent moisture damage to the surrounding area, I recommend caulking all gaps.

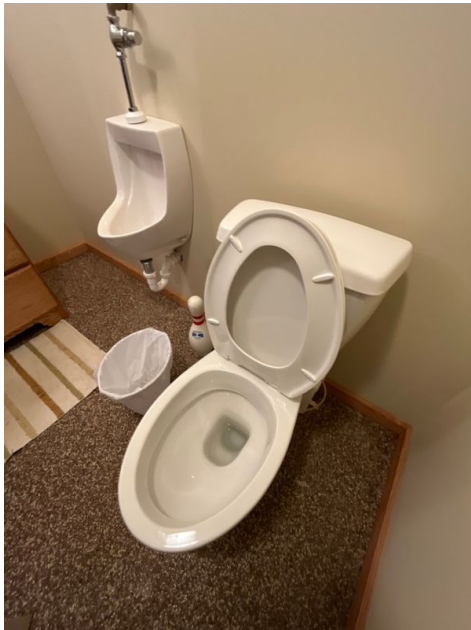
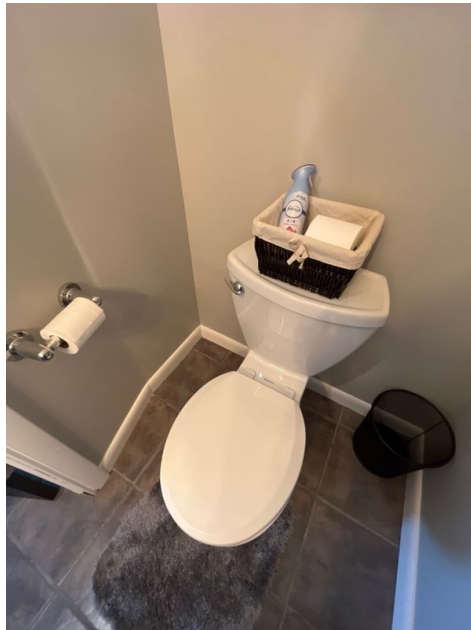
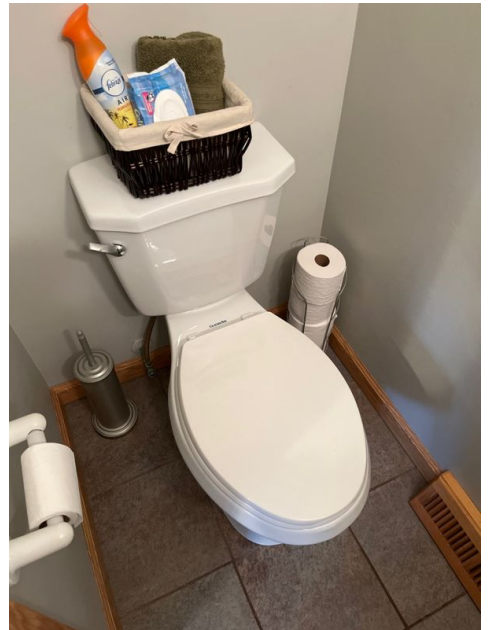
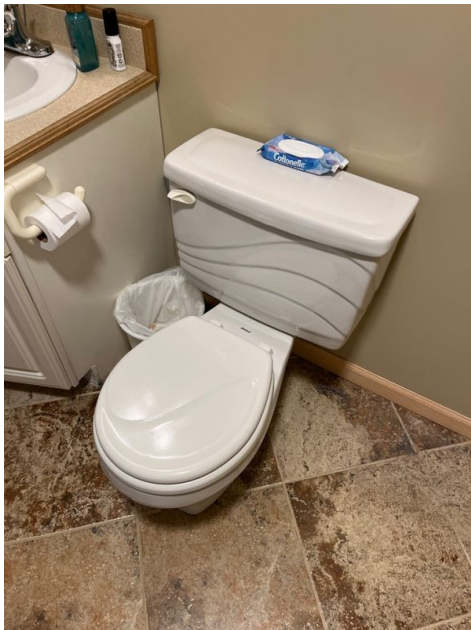
9.5.2 Fixtures

TOILET - LOOSE

A toilet(s) was not tightly secured to the floor, which can result in leaks. This will allow for moisture damage to the surrounding areas. I recommend properly securing all toilets.

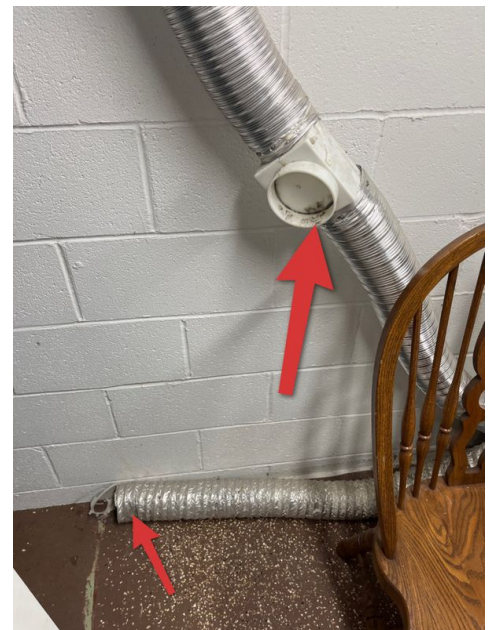
A dryer vent was disconnected. In order to prevent carbon monoxide from entering the home, I recommend a qualified contractor.

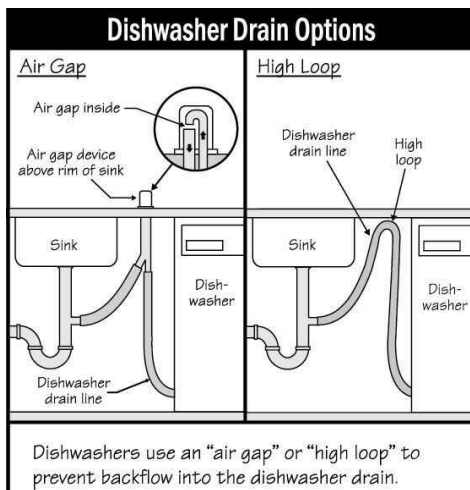
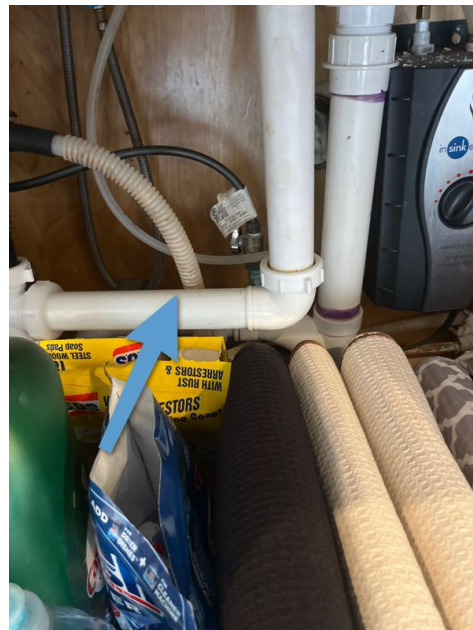
The dishwasher drain line was observed to be improperly installed. This will allow for poor drainage. I recommend a qualified contractor.

- Connect to the under sink dishwasher drain connection (25c).
- Connect to a disposer dishwasher drain connection (25d).

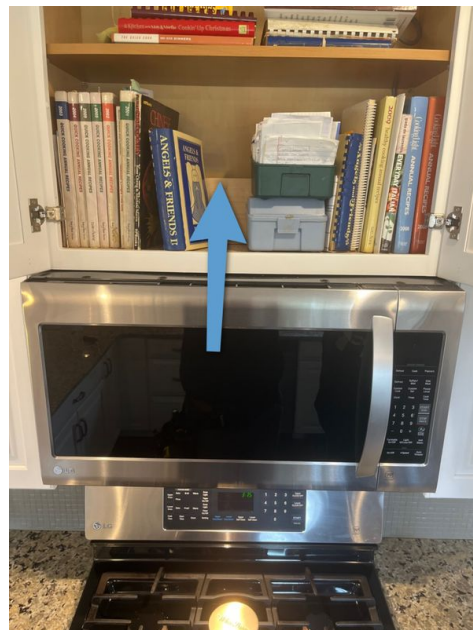
KITCHEN

EXHAUST FAN - DIRECTED IMPROPERLY

The recirculating exhaust fan was directed improperly. In order to provide adequate ventilation, I recommend a qualified contractor.

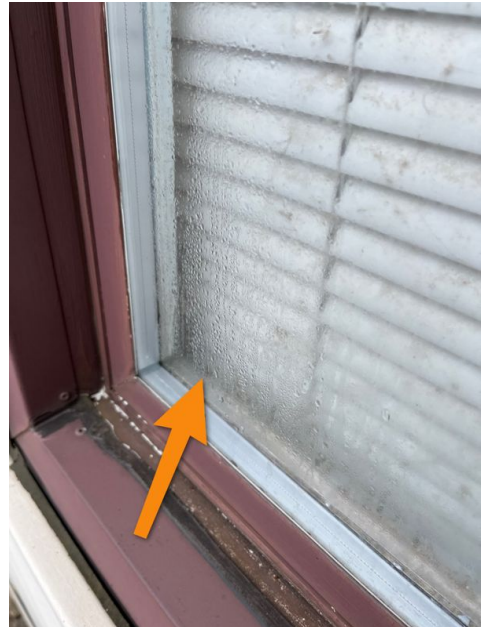
Front Left

A window(s) appeared to have a failed seal in the home. Some windows have two or more sheets of glass separated by a spacer and sealant system creating a sealed airspace. A break in this seal anywhere along the edge can allow moisture between the glass panes, which can then evaporate and leave a fog or haze. I recommend a qualified contractor.

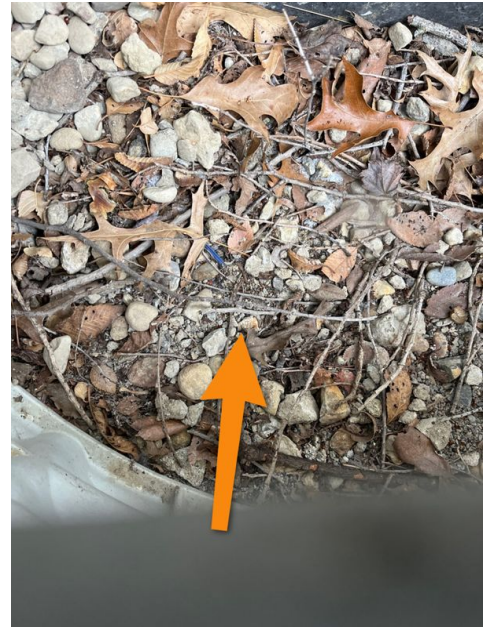
A window well(s) did not have a water resistant, weight bearing cover present. In addition, debris was observed in the window well(s) at the time of the inspection. In order to prevent moisture and pest intrusion as well as debris buildup, I recommend having proper window well covers installed.

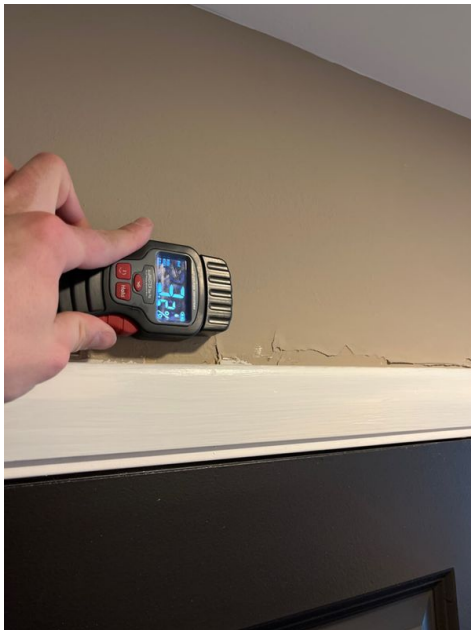
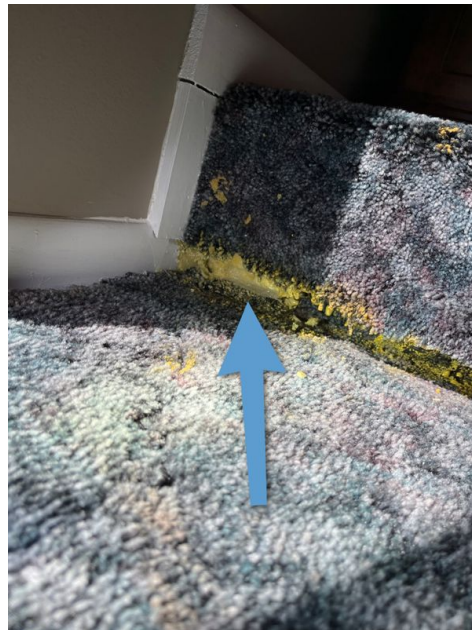
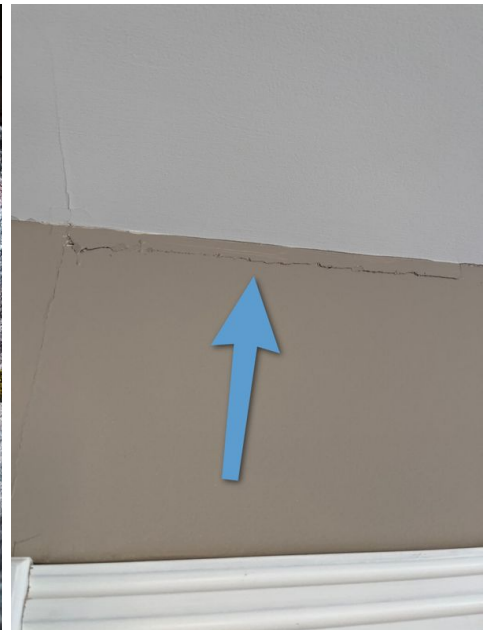
CEILING/WALL - GENERAL DAMAGE

Damage was observed on a ceiling(s)/wall(s). Although the cracking/damage appears to be cosmetic and high levels of moisture were not observed, I recommend a qualified contractor.

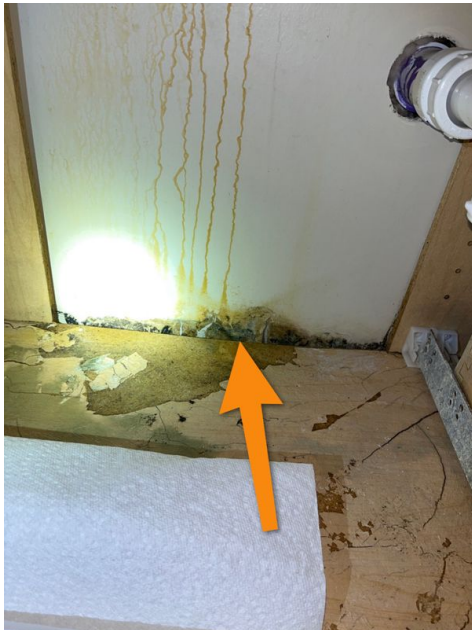
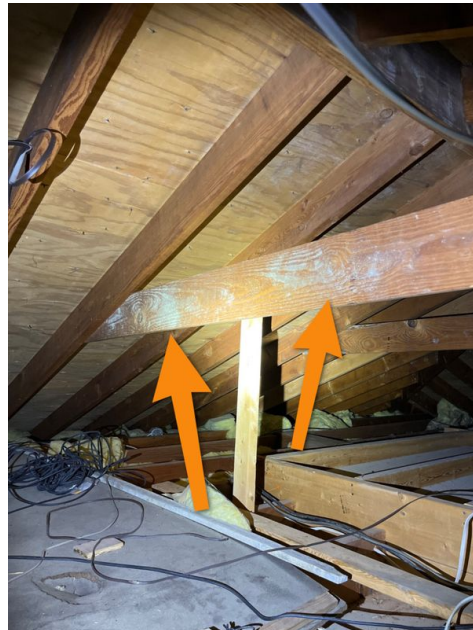
Probable mold was observed at the time of the inspection in various areas. I recommend a certified mold tester.

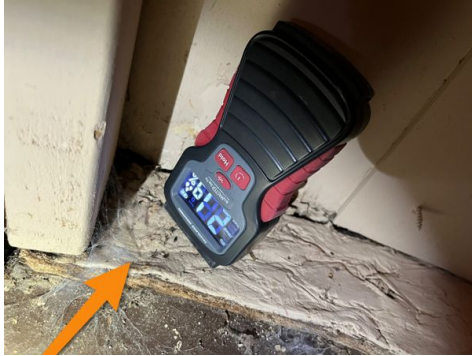
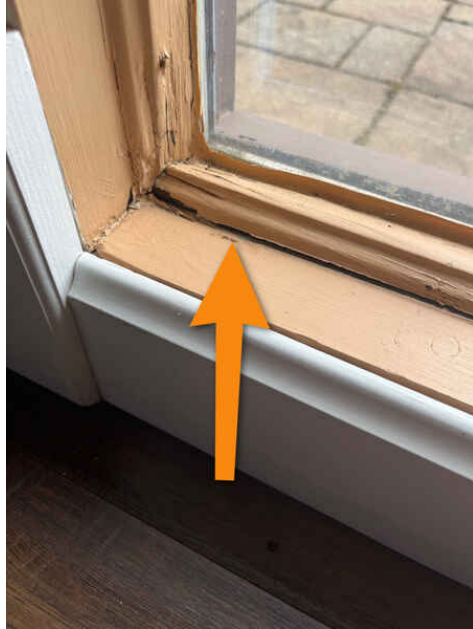
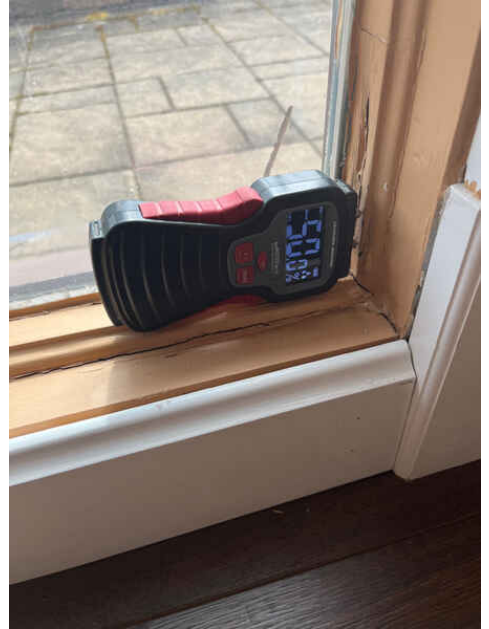
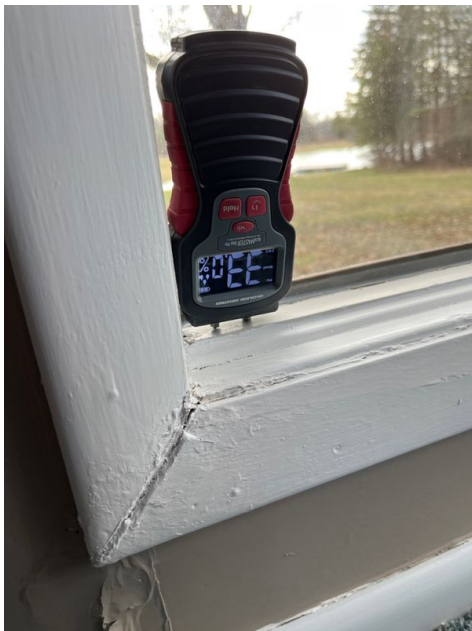
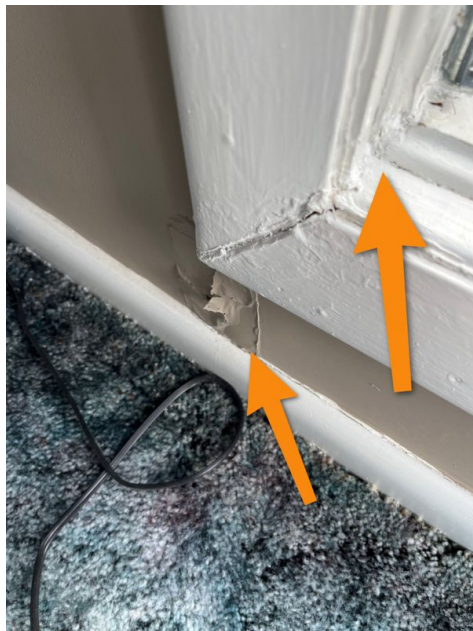
ACTIVE MOISTURE - CONFIRMED WITH A MOISTURE DETECTOR

Active moisture was observed at the time of the inspection. The area(s) was tested with a moisture detector, which indicated that there was elevated levels of moisture present. In order to determine whether mold, wood rot, etc. is present, I recommend a qualified contractor.

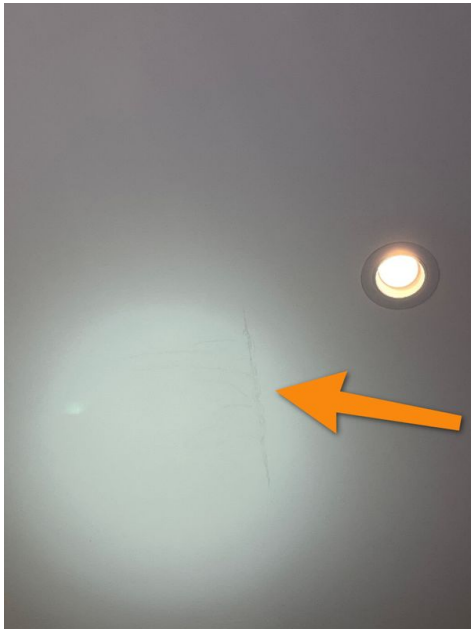
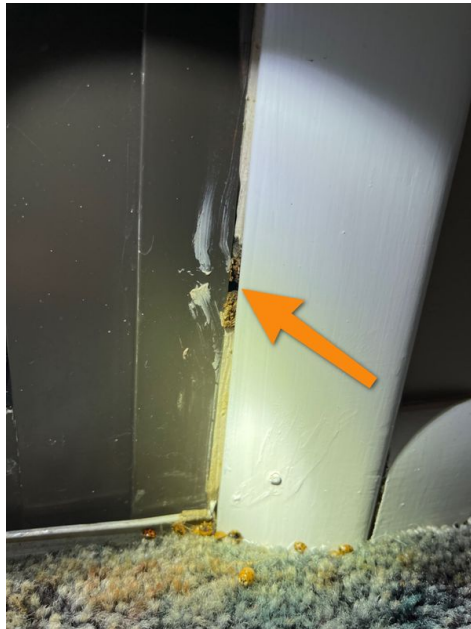
MOISTURE STAINS/DAMAGE

Moisture stains/damage was observed in various locations throughout the interior of the home. Although no active moisture was observed in these areas at the time of the inspection, this could be evidence of a past or present leak. In order to prevent further deterioration as well as pest intrusion, I recommend a qualified contractor.

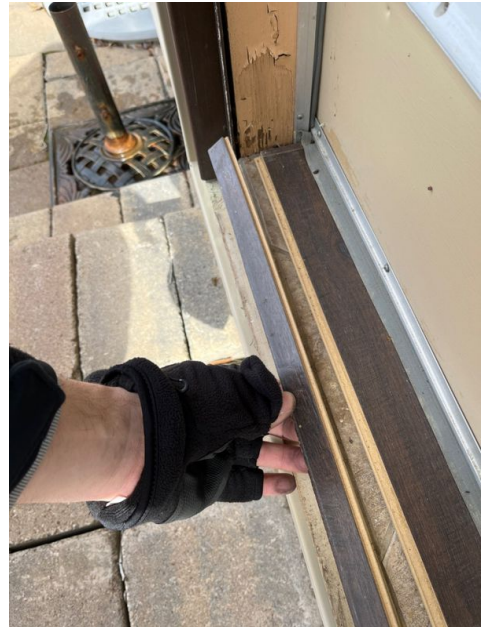
Back

FLOORING - DAMAGE

Areas of the flooring had damage/imperfections present. In order to prevent a trip hazard as well as further deterioration, I recommend a qualified contractor.

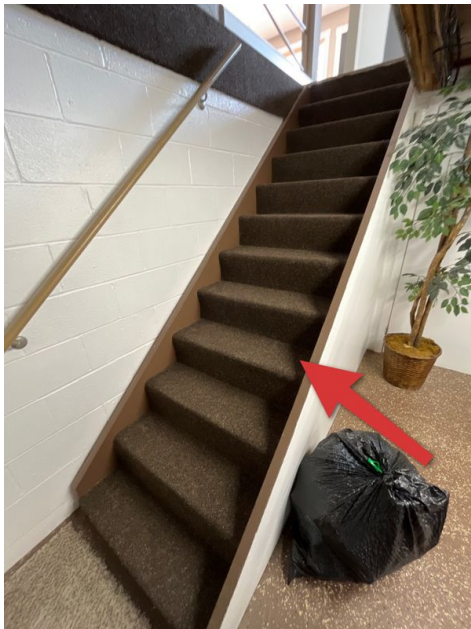
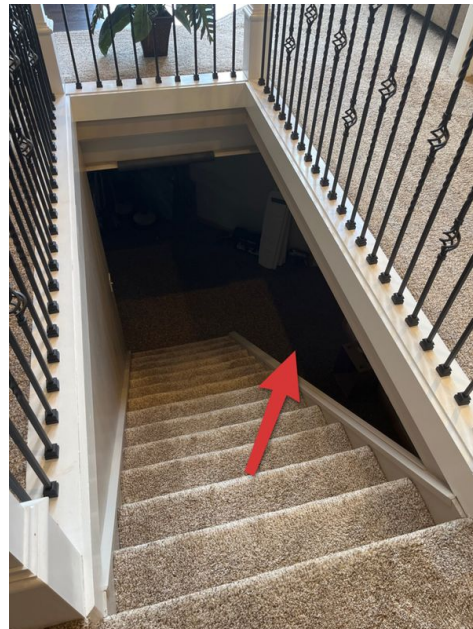
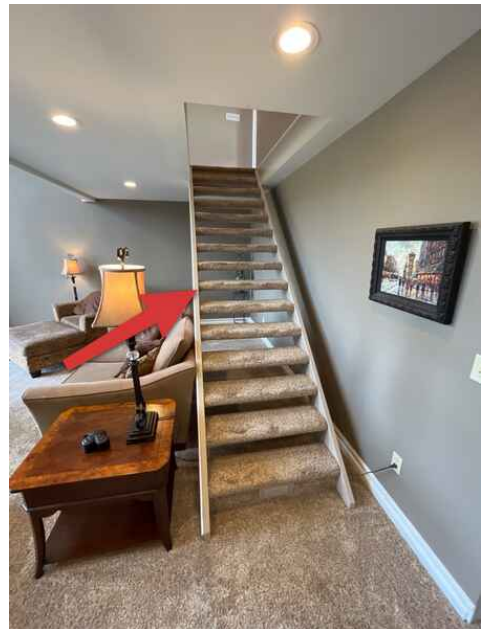
RAILINGS/BALUSTERS - MISSING

Missing railings/balusters were observed on a set of stairs. This is a fall hazard. I recommend a qualified contractor.

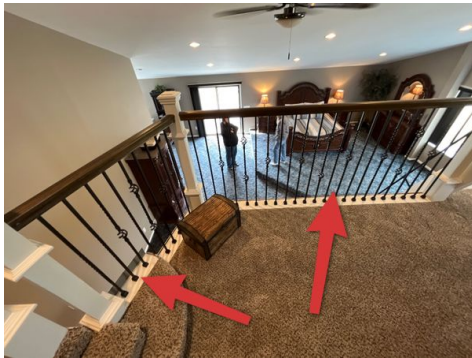
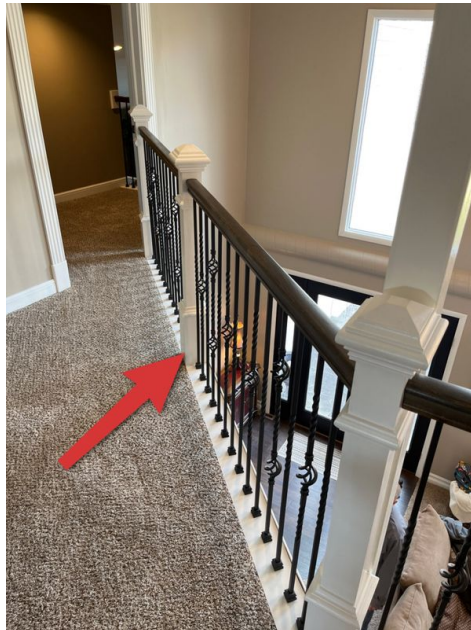
RAILING/BALUSTERS - LOOSE

Railing and balusters were observed to be loose in area(s). This is a fall hazard. I recommend a qualified contractor.

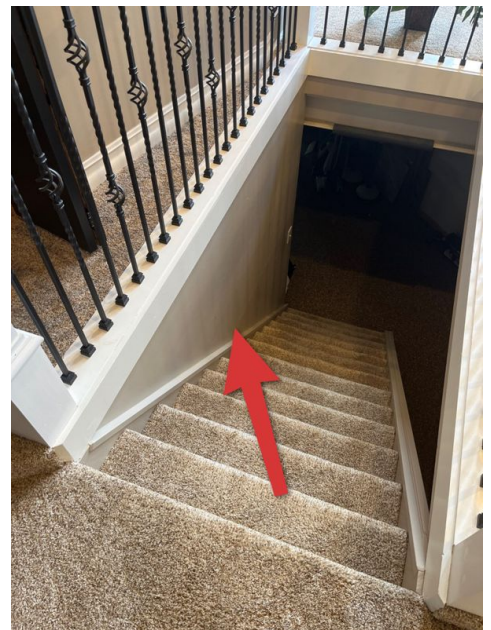
HANDRAIL - MISSING

A handrail was missing. This is a fall hazard. I recommend a qualified contractor.

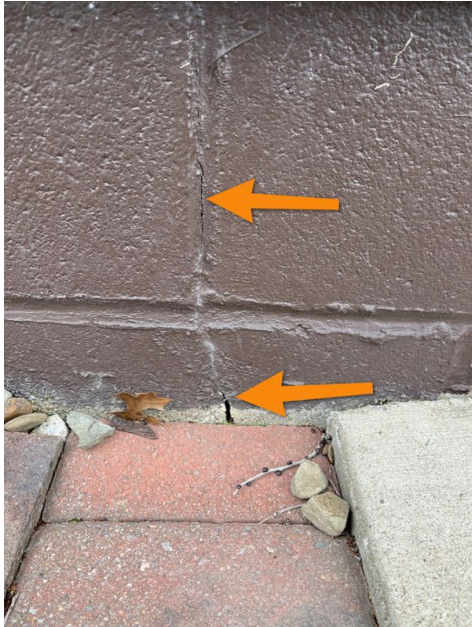
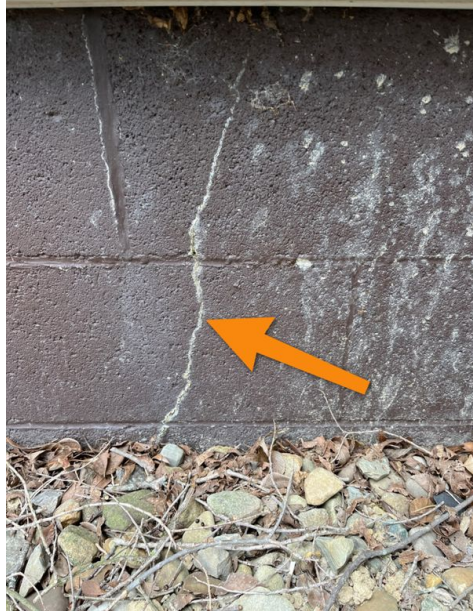
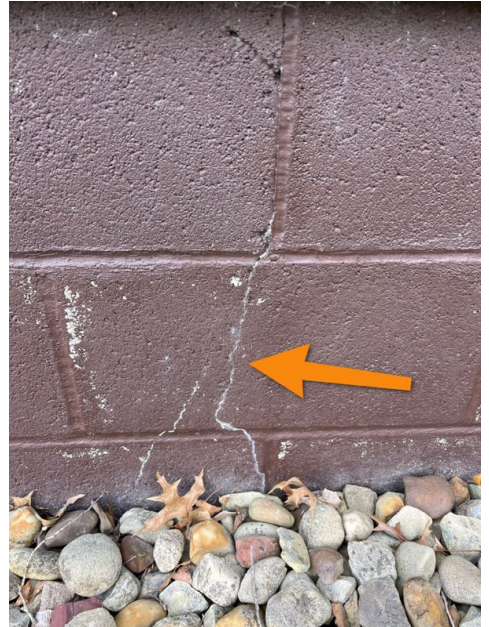
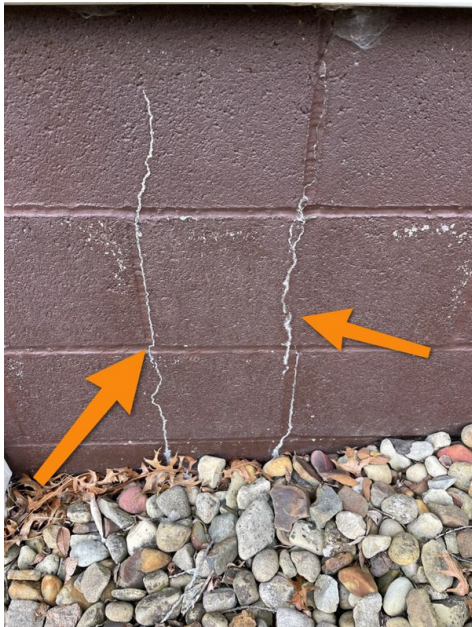
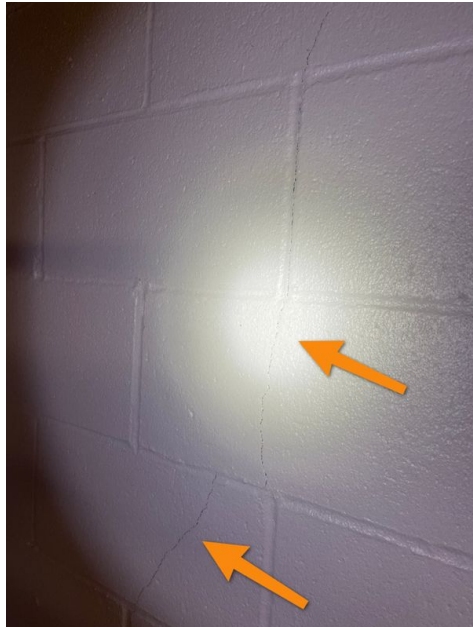
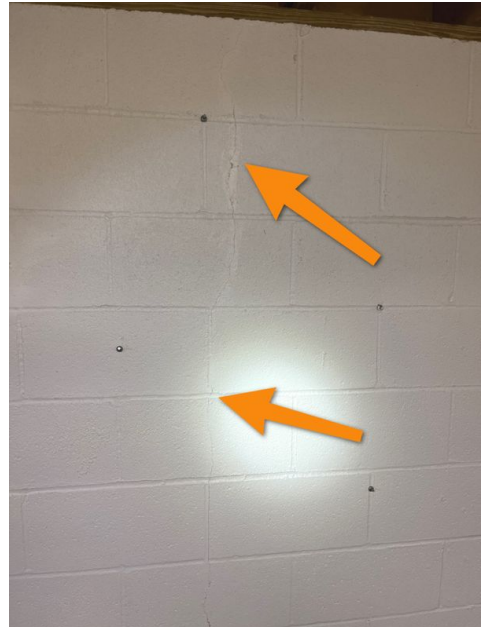
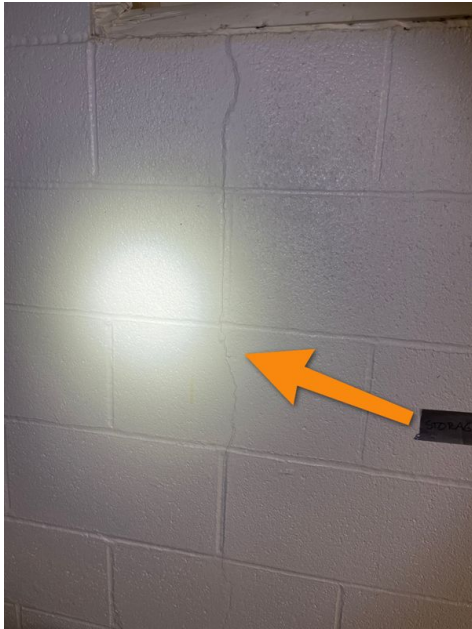
FOUNDATION - VERTICAL CRACK

Vertical cracking was observed on the foundation. This will allow for moisture and pest intrusion. In addition to verifying grounds are sloping away from the foundation and gutters/downspouts are functioning properly (diverting water away from the home), I recommend having the cracking properly filled in with concrete caulking. If the cracking reappears after repairs have been made, I recommend a qualified structural contractor. Continue to monitor.

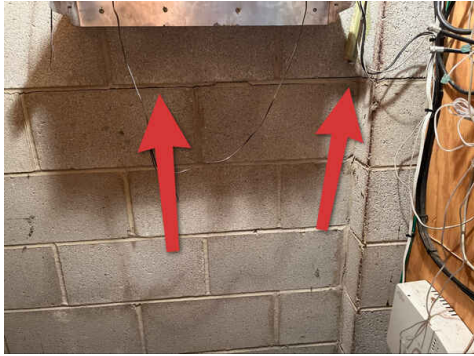
Various cracks on the right and left walls were observed at the time of the inspection. It is suspected that moisture intrusion from negative grading and downspouts terminating into the ground near the foundation are causing hydrostatic pressure. I recommend having the areas evaluated by a licensed structural engineer and repaired as necessary by a qualified contractor. Continue to monitor.

Left - horizontal crack

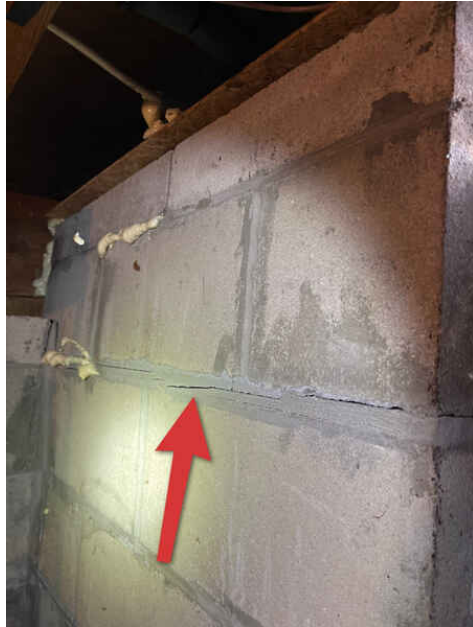
Right - horizontal crack
