STARBOARD PROPERTY INSPECTIONS LLC

PROPERTY INSPECTION REPORT

1234 Main Street
Stow, OH 44224

05/18/2023 9:00AM

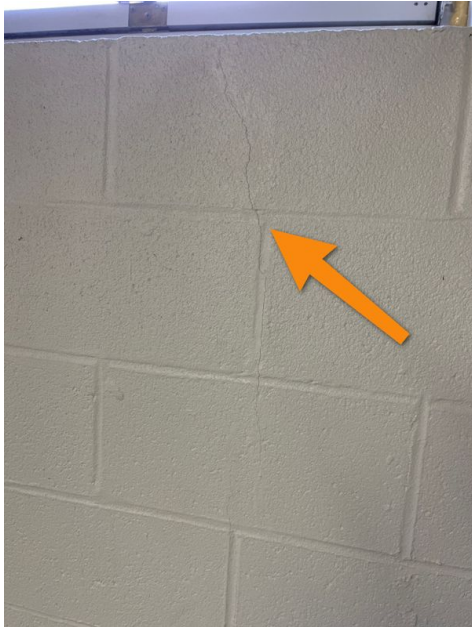
Front

General cracking was observed on the foundation which is considered typical for the age of the home. This will allow for moisture and pest intrusion. I recommend having the cracks properly filled in with concrete caulking. If the cracking reappears after repairs have been made, I recommend a qualified foundation contractor. Continue to monitor.

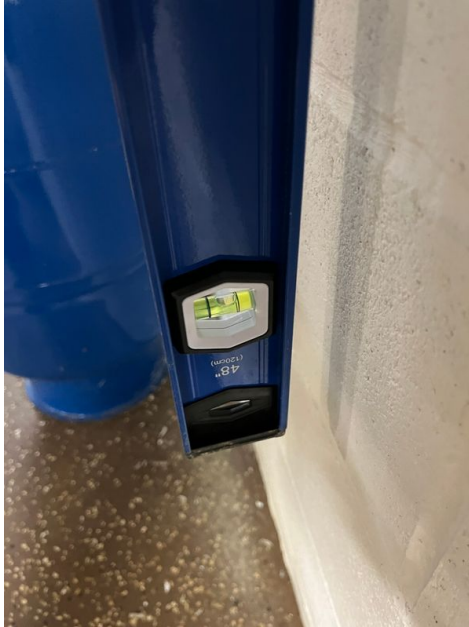
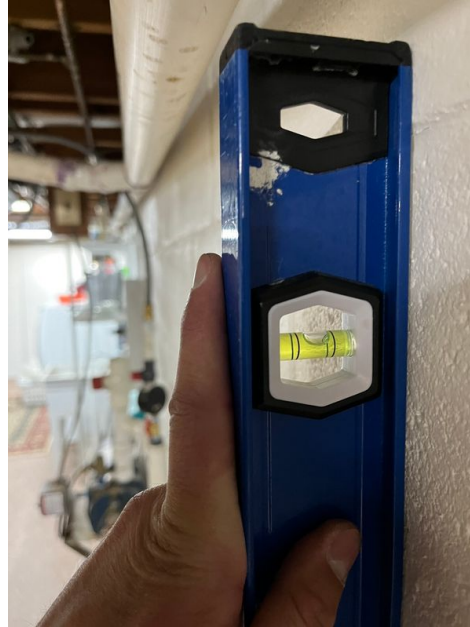
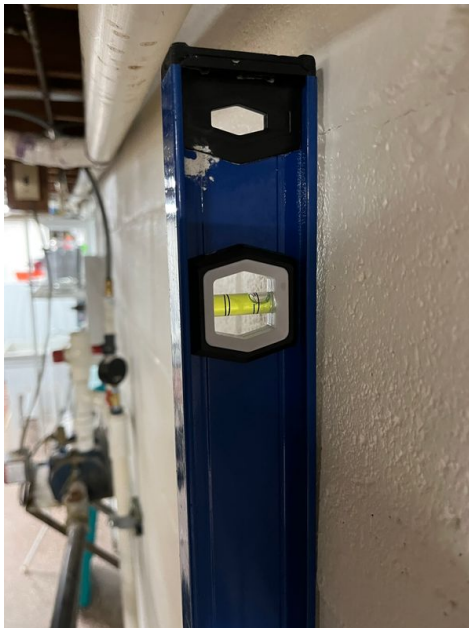
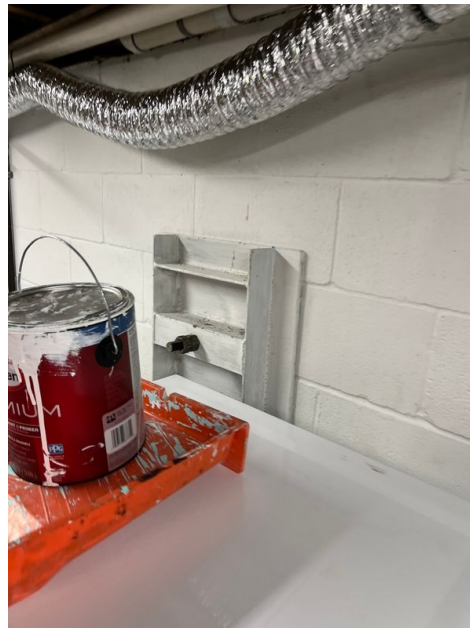
Evidence of past structural repairs was observed. I recommend consulting with the seller(s) to ensure that these repairs were made by licensed and/or qualified structural professionals and to obtain any warranties or other documents related to the repairs. Continue to monitor.

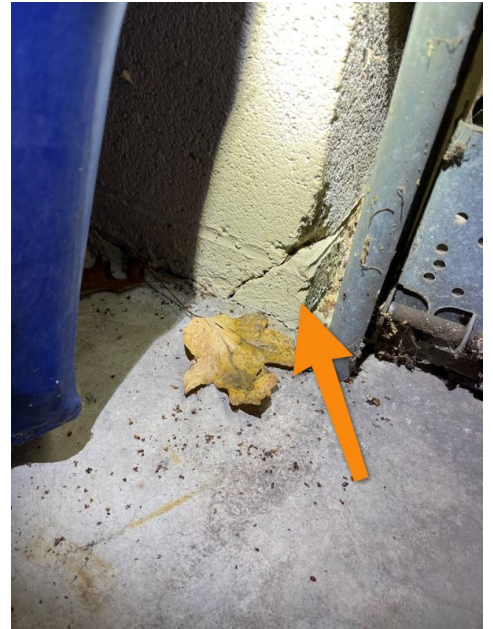
Garage

Cracked/damaged blocks were observed on the garage foundation. In order to prevent further deterioration, I recommend a qualified contractor. Continue to monitor.

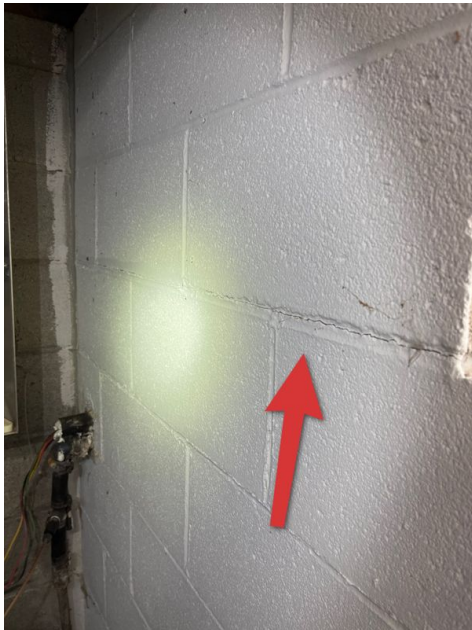
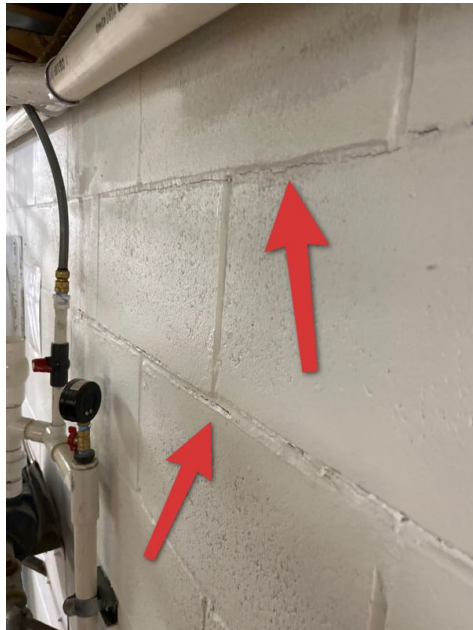
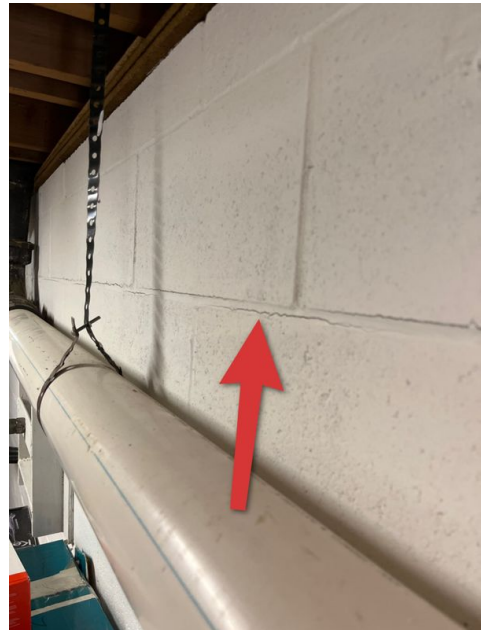
Back

Horizontal cracking was observed on the back and right foundation walls. This is typically caused by hydrostatic pressure pushing on the foundation walls. I recommend a qualified structural contractor.

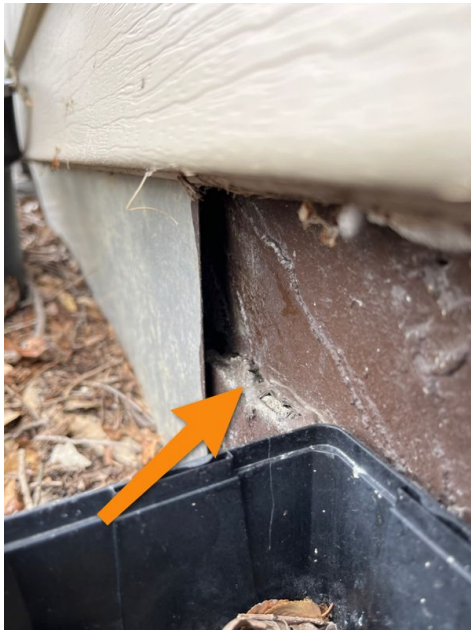
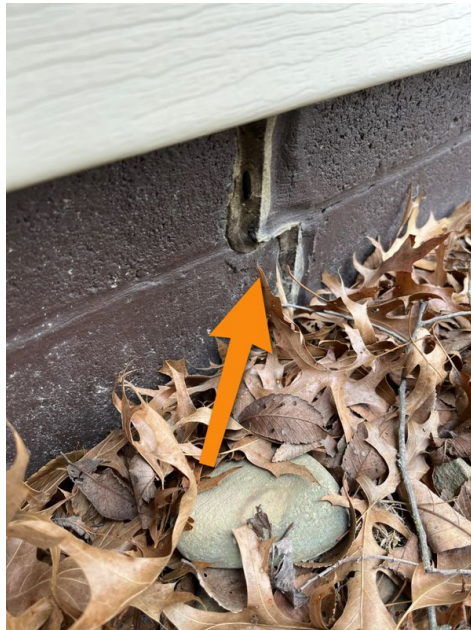
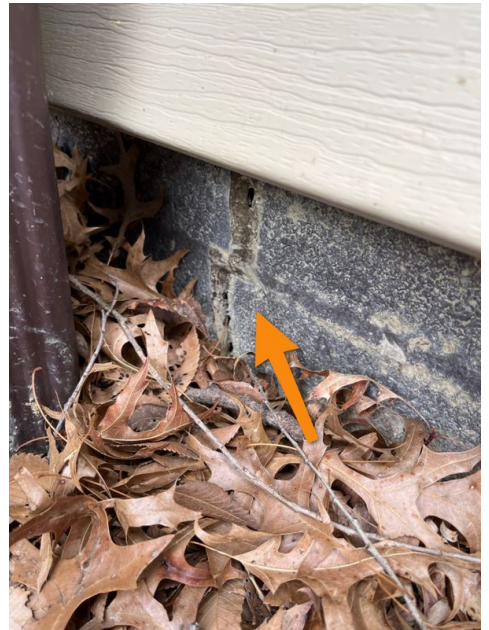
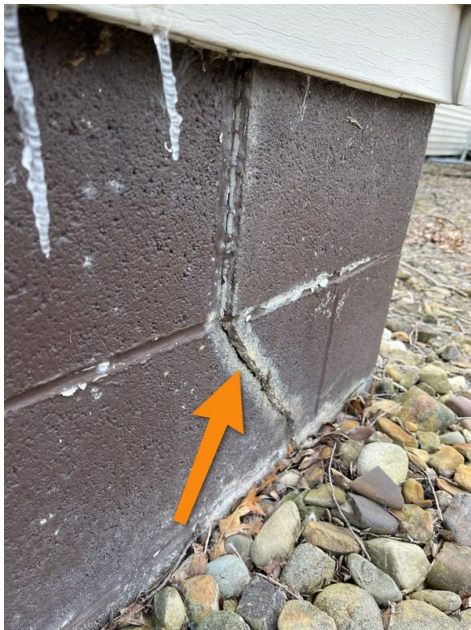
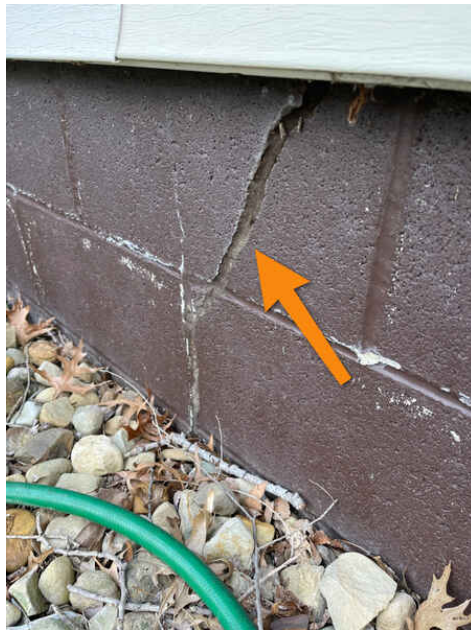
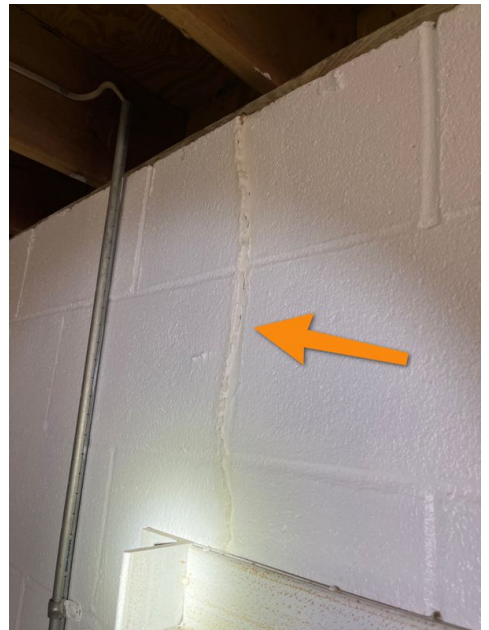
Foundation blocks were observed to be shifting. This will allow for moisture and pest intrusion. I recommend a qualified contractor. Continue to monitor.

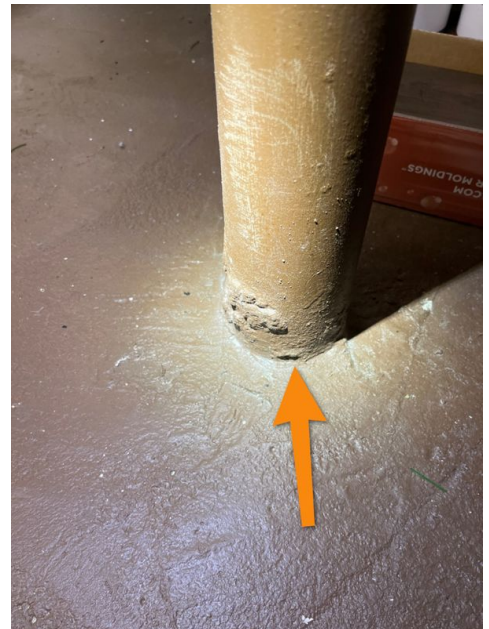
The bottom of a steel support post(s) had concrete poured around it. In addition, rust was present. There may be moisture below the concrete, therefore having the steel post(s) not sit on the concrete instead of going through the concrete may make it susceptible to rust/deterioration. I recommend a qualified contractor. Continue to monitor.

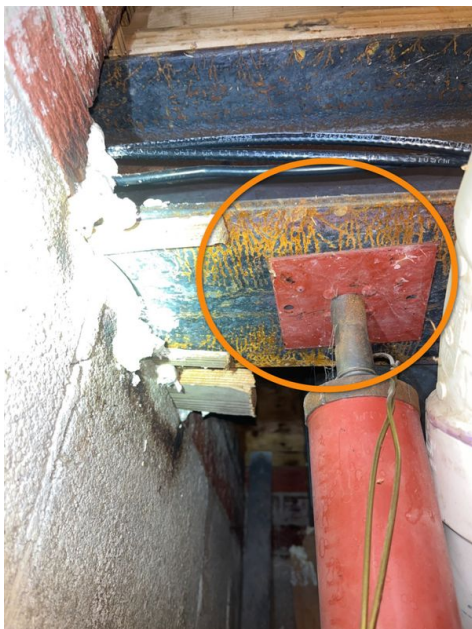
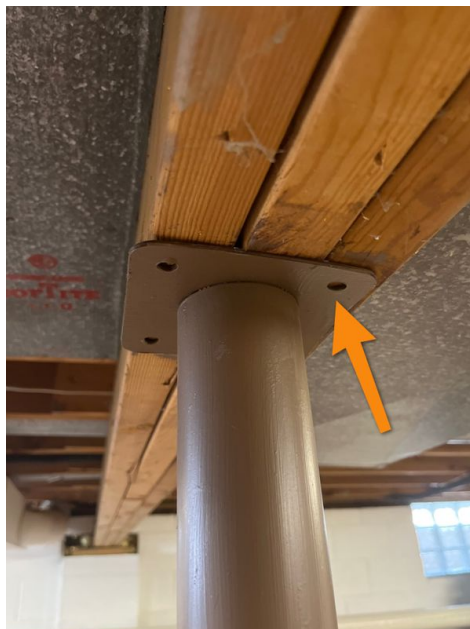
The top of a support post is not properly secured in place. The posts should be mechanically connected to the beam above to provide additional resistance against lateral displacement. I recommend a qualified contractor.

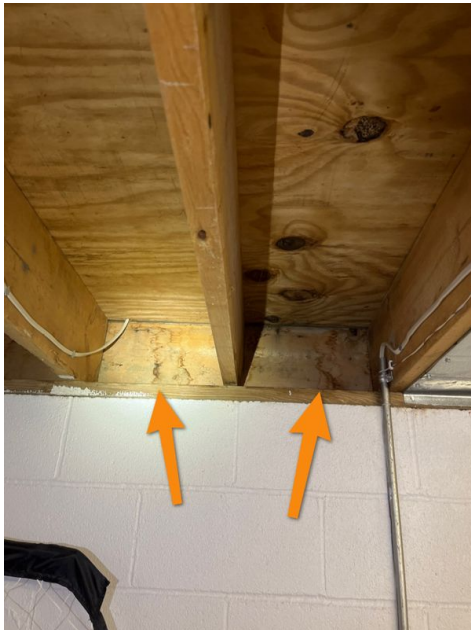
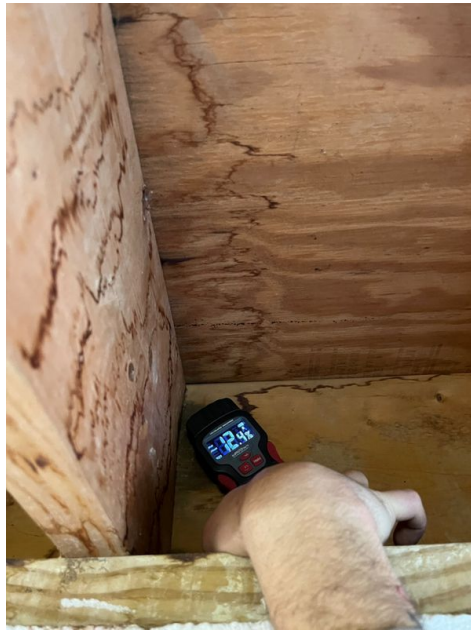
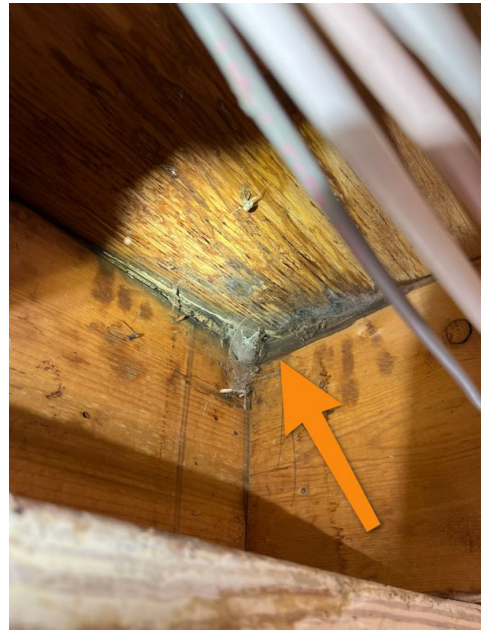
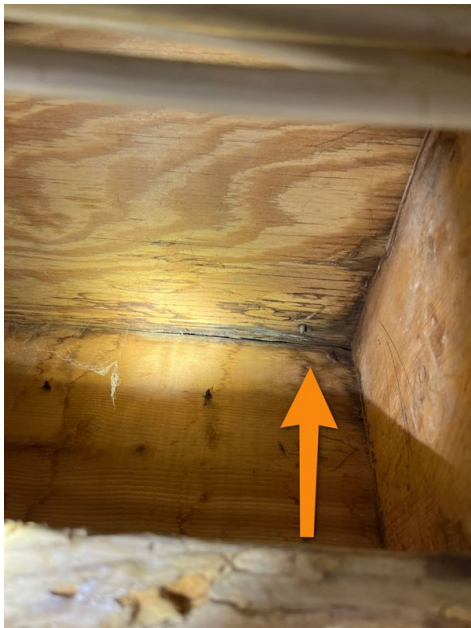
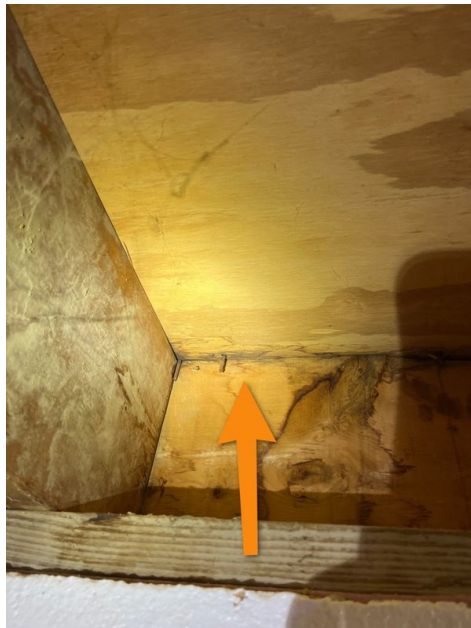
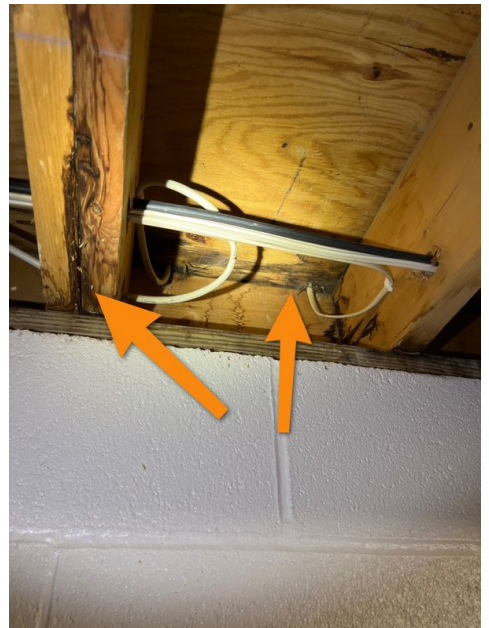
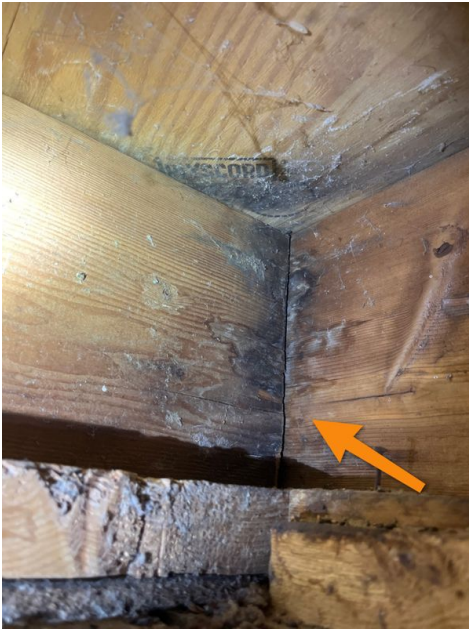
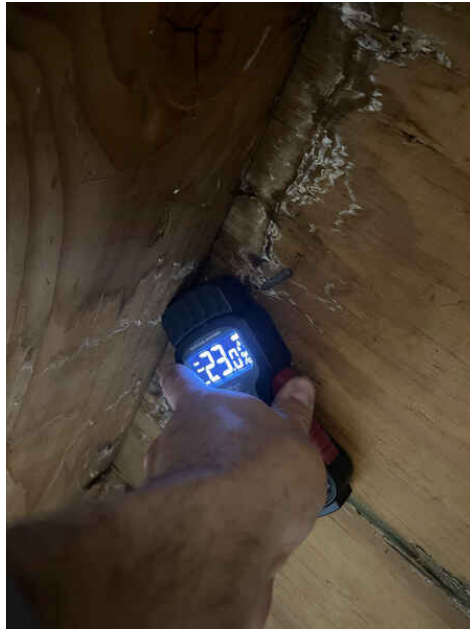
Moisture stains/damage was observed on areas of the subfloor and floor structure. In order to verify whether or not an active leak is present, I recommend a qualified contractor. Continue to monitor.

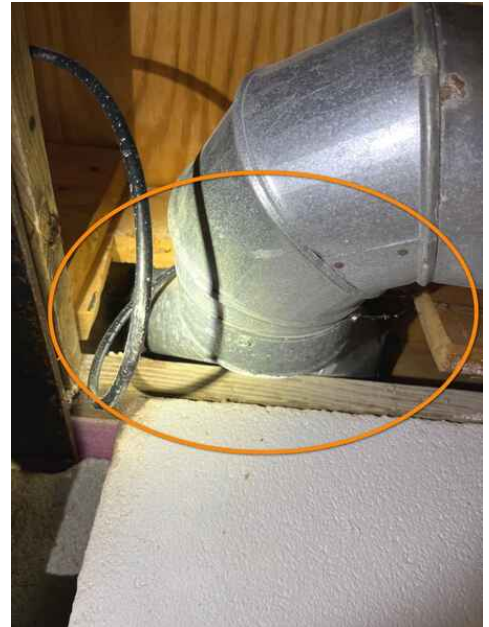
Basement Front

A floor joist(s) was observed to be improperly modified. Cuts, holes, and any other modifications to floor joists must be done to specific standards in order to maintain the structural integrity. I recommend a qualified contractor.

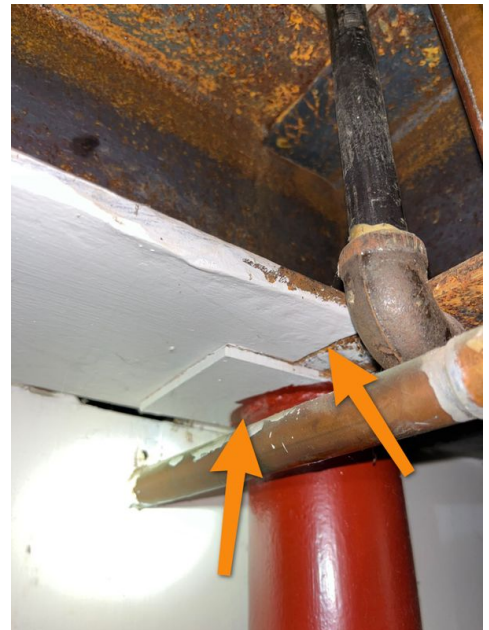
Near basement staircase

An I-beam did not appear to be properly positioned on a post. In order to properly support the floor structure, I recommend a qualified contractor.

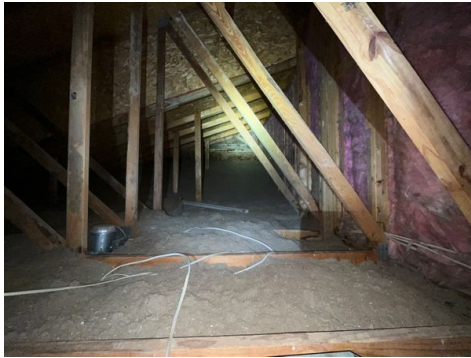
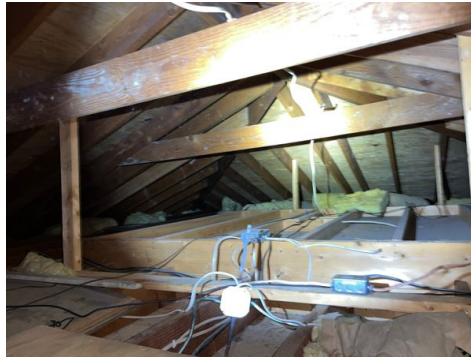
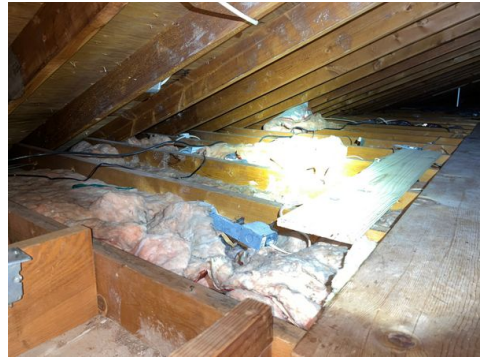
In order to prevent injury/damaging the property, the insulation/lack of a secure walkway limited access to fully inspect the attic and framework, therefore the attic was only inspected from safe/accessible areas.

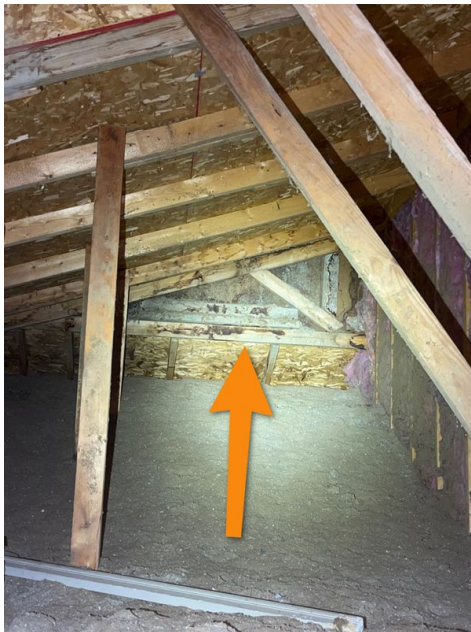
Garage Back

Moisture stains/damage was present in the attic. In order to verify whether or not an active leak is present, I recommend a qualified contractor. Continue to monitor.

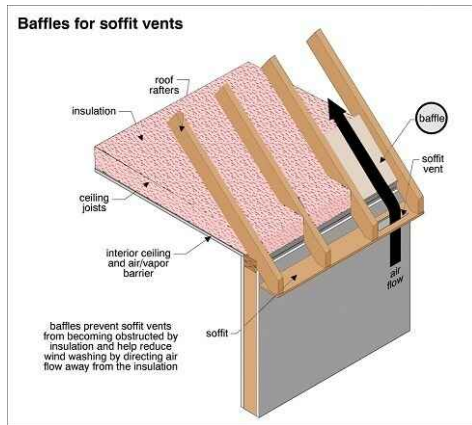
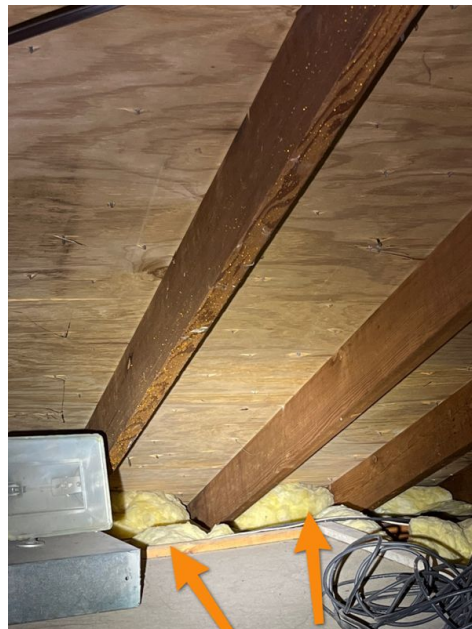
VARIOUS

SOFFIT VENTS - MISSING BAFFLES

The attic had missing baffles near the soffit vent(s). Baffles are intended to prevent the insulation from settling over the vents and blocking the airflow. This will allow for moisture and pest intrusion, wood rot and mold growth. In addition, this will shorten the lifespan of the roofing material. I recommend a qualified contractor.

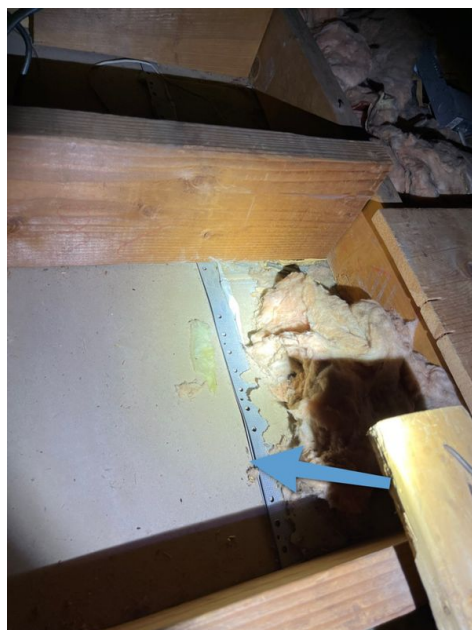
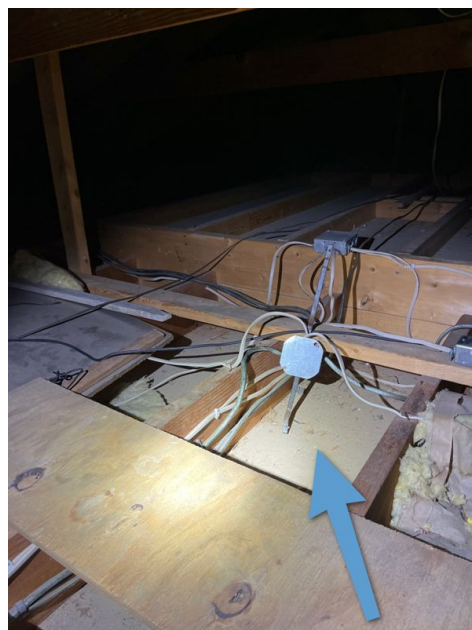
VARIOUS

The insulation was not sufficient in areas of the attic. In order to prevent energy loss, I recommend a qualified contractor.
