STARBOARD PROPERTY INSPECTIONS, LLC (330) 554-9498 starboardinspections@gmail.com https://www.starboardinspections.com

STARBOARD HOME INSPECTION

Updated: JULY 6, 2021

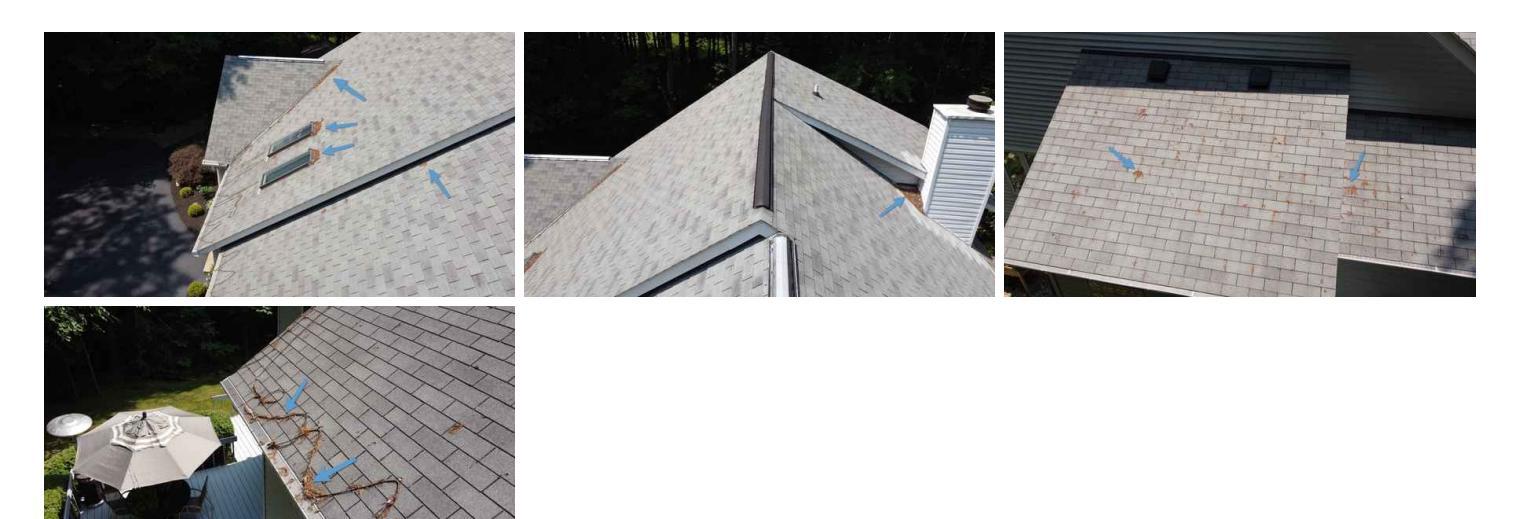
Debris was observed on the roof surface. I recommend a reputable contractor clear all debris as excessive debris and vegetation will lead to increased moisture and deterioration of the roof coverings.

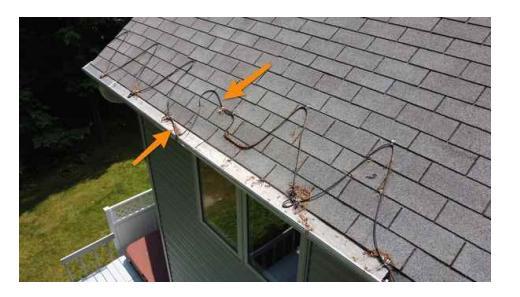
3.2.2 Coverings HEATING CABLE - DAMAGE

The roof was observed to have heating cables installed along the edges. Various cables were observed to be loose/damaged. I recommend a reputable contractor repair as needed.

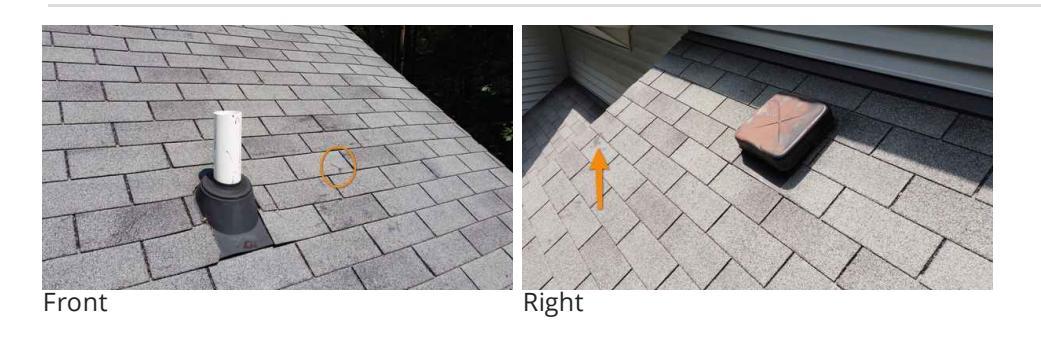
3.2.3 Coverings

Damaged shingles were observed on the roof. In order to prevent moisture intrusion, I recommend having the roof evaluated and repaired as necessary by a reputable contractor.

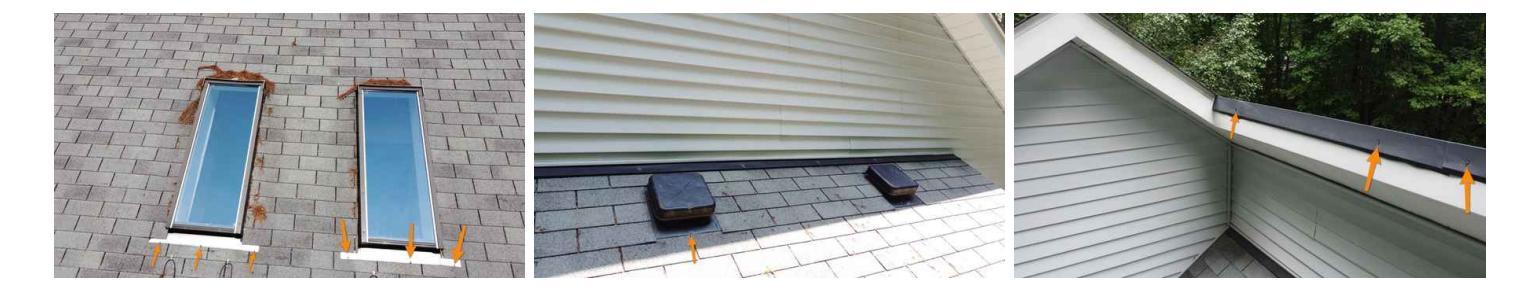
3.2.4 Coverings **EXPOSED NAILS**

Exposed nails were observed in areas of the roof. Exposed fasteners can corrode and/or leak. In order to prevent any moisture intrusion, I recommend having the areas evaluated and repaired as necessary by a reputable contractor

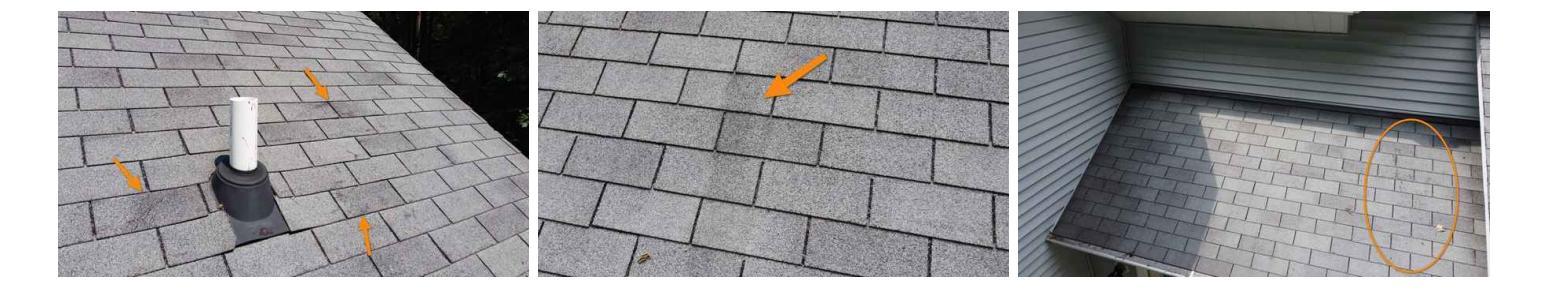
3.2.5 Coverings SHINGLES - GRANULE LOSS

The shingles have granule loss. Granule loss is to be expected on older roofs but could also have been caused by heavy rain/hail. This is an indication of a shortened lifespan of the roof, therefore I recommend having the roof evaluated and addressed as necessary by a reputable contractor.

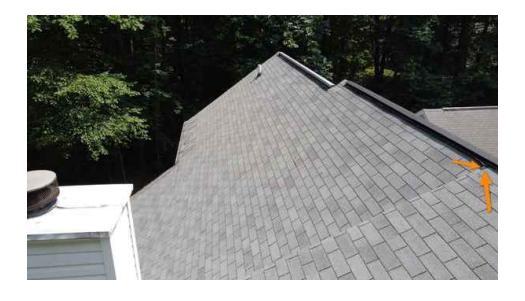
3.2.6 Coverings

A shingle was missing on the back ridge of the roof. I recommend having the roof evaluated and repaired as necessary by a reputable contractor.

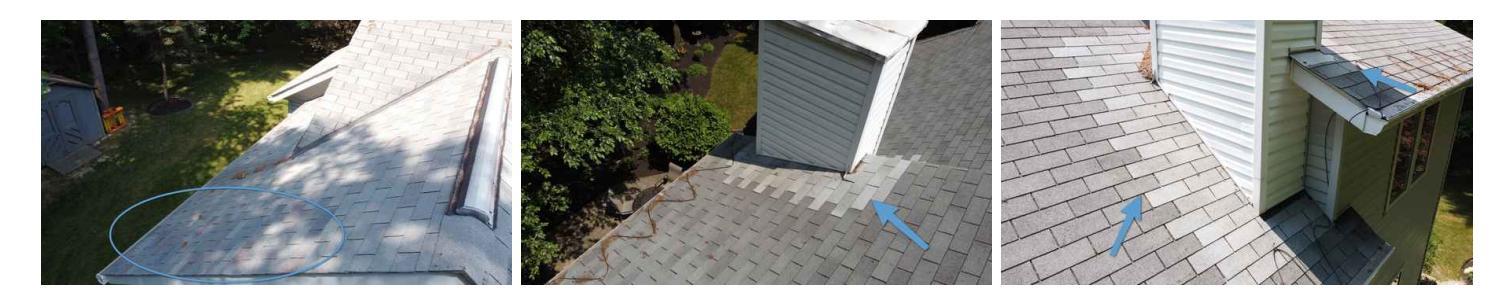
3.2.7 Coverings **SHINGLES - PATCHING**

Patching was observed on the shingles in various areas. The patching appears to be in good condition, however I recommend asking the seller about this and requesting any/all pertinent paperwork. Continue to monitor.

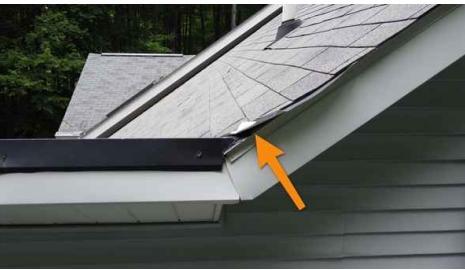
3.3.1 Flashings & Seals

The flashing was lifting up creating a gap in the back of the exterior. In order to prevent moisture intrusion, I recommend having this evaluated and repaired as necessary by a reputable contractor.

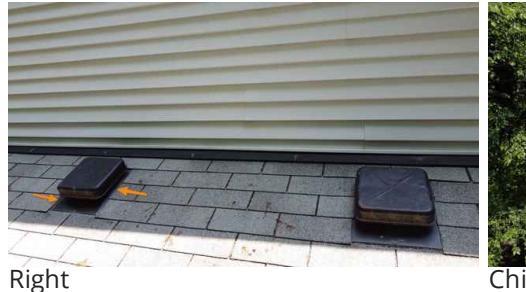
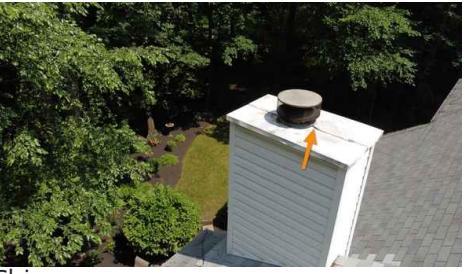
3.3.2 Flashings & Seals

Sealant was in poor condition throughout various areas. In order to prevent moisture intrusion, I recommend having these areas evaluated and repaired as necessary by a reputable contractor.

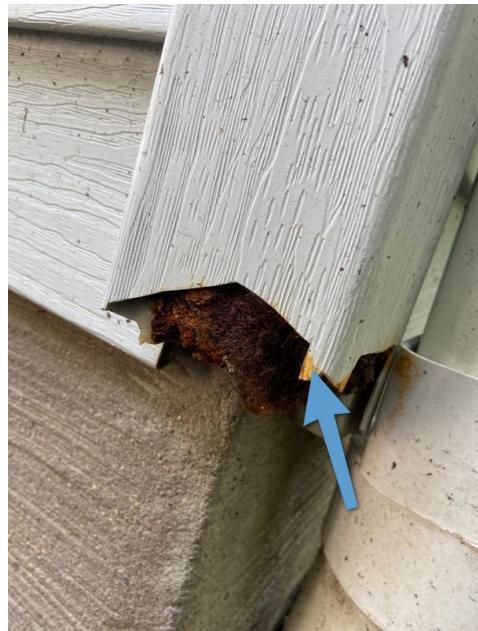
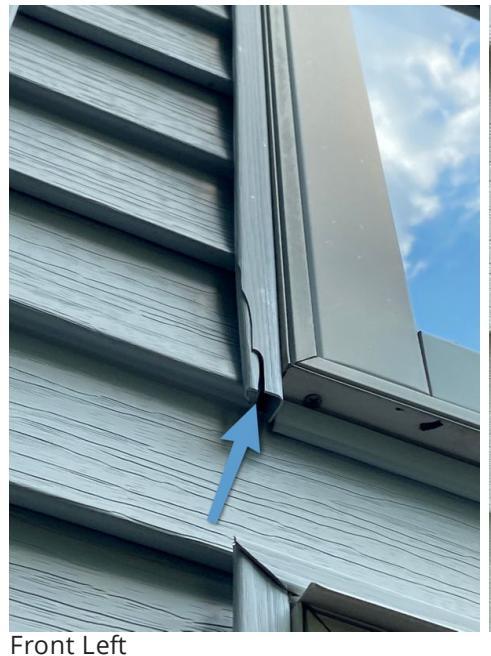
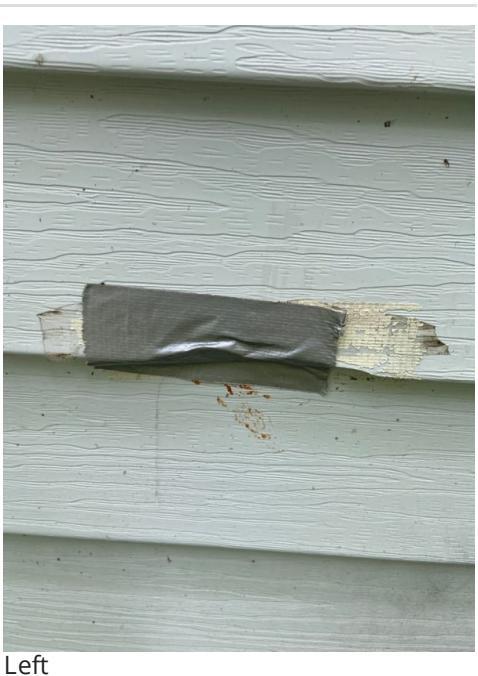
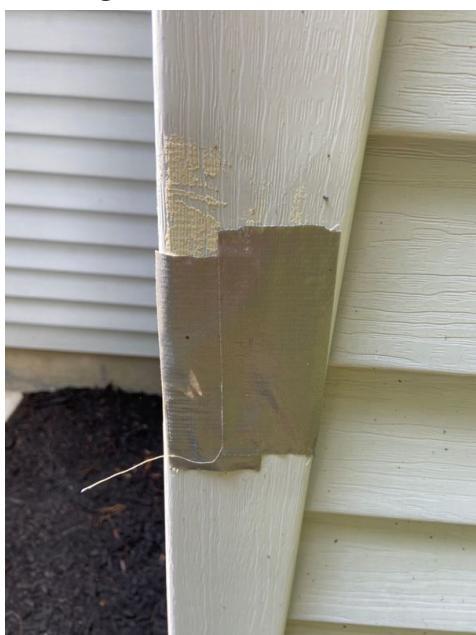
Areas of the siding have damage. In order to prevent moisture intrusion, I recommend having the siding evaluated and repaired as necessary by a reputable contractor.

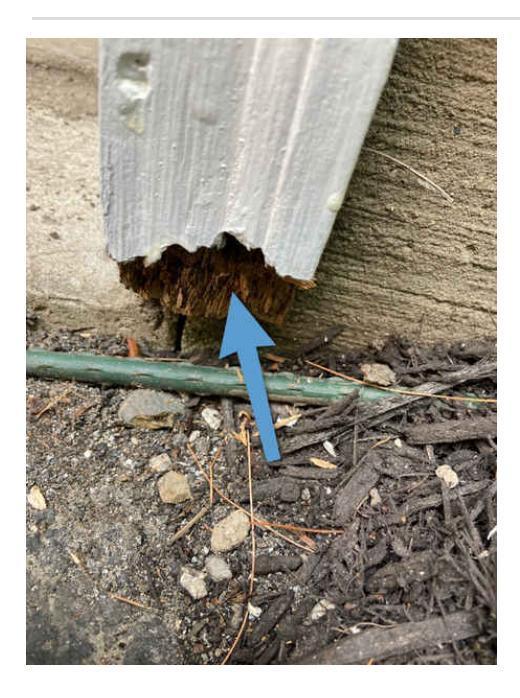
6.1.2 Siding, Flashing & Trim **TRIM - ROT** GARAGE TRIM

Trim was observed to have wood rot in areas. I recommend a reputable contractor evaluate and repair as necessary.

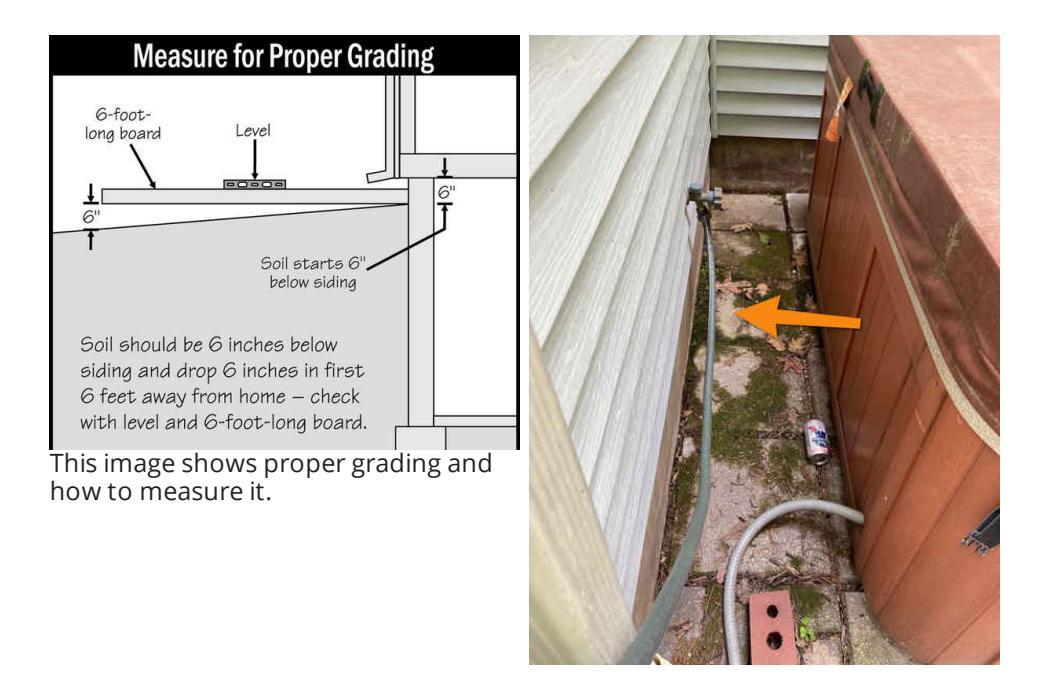
6.4.1 Vegetation, Grading, Drainage & Retaining Walls

Areas of the grading are not properly sloped away from the home. In order to promote good drainage of rainwater away from the foundation, I recommend having the grading improved by a reputable contractor.

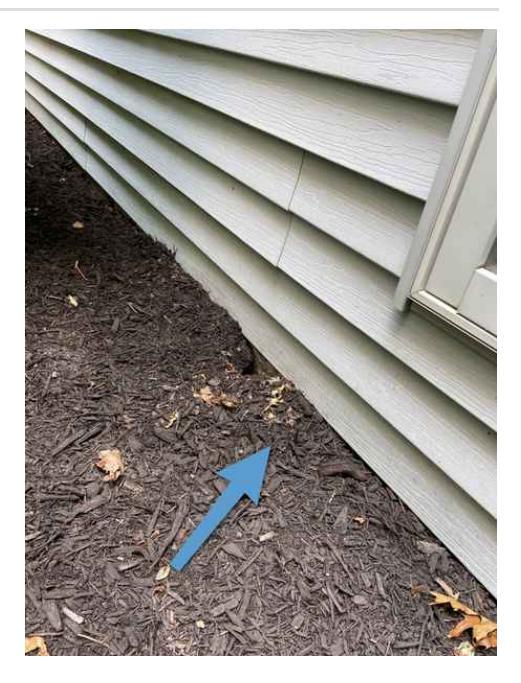
6.4.2 Vegetation, Grading, Drainage & Retaining Walls

Areas of the siding are in close contact with the ground. It's recommended to have a minimum of 6 inches from the bottom piece of the siding to the finished grade to prevent damage to the siding from rain/snow. I recommend having the grading and landscaping evaluated and addressed as necessary by a reputable contractor.

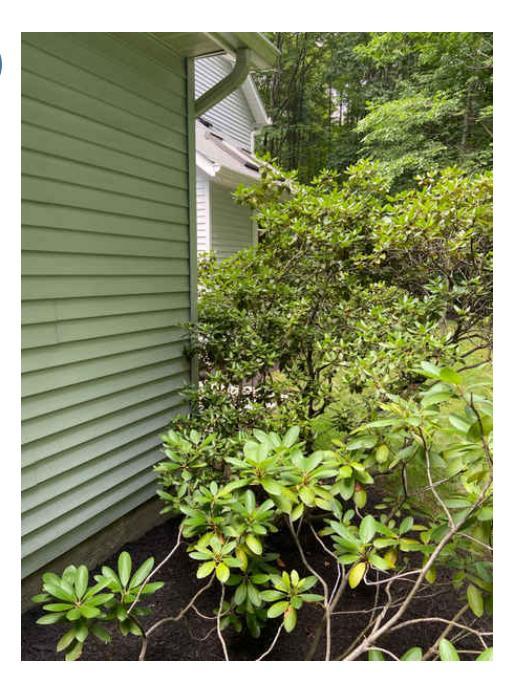
6.4.3 Vegetation, Grading, Drainage & Retaining Walls

Areas of vegetation are in close contact to the home. In order to prevent branches from chafing the siding or roof, leaves from clogging gutters, roots from damaging the foundation, critters from having a way to get onto the roof, etc., I recommend having the vegetation trimmed back at least 3 feet away from the home.

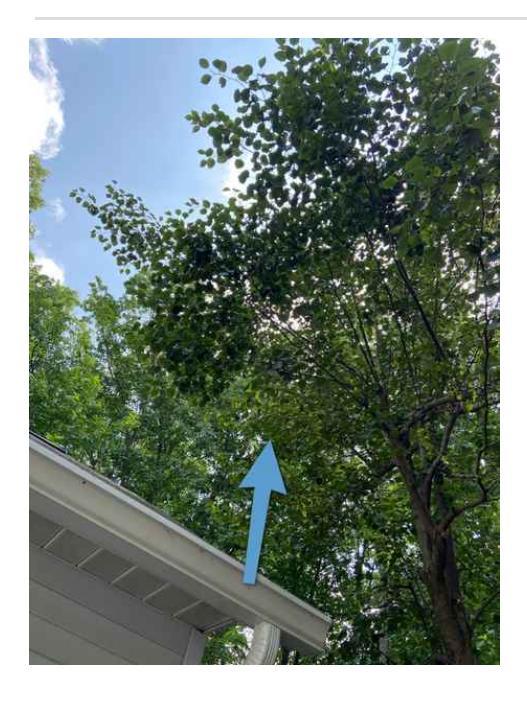
6.4.4 Vegetation, Grading, Drainage & Retaining Walls

Tree branches were overhanging the roof in various areas. Branches overhanging the roof can cause leaves to clog gutters, branches could fall and cause damage, and critters can use branches to get onto the home. I recommend having the overhanging trees evaluated and addressed as necessary by a reputable contractor.

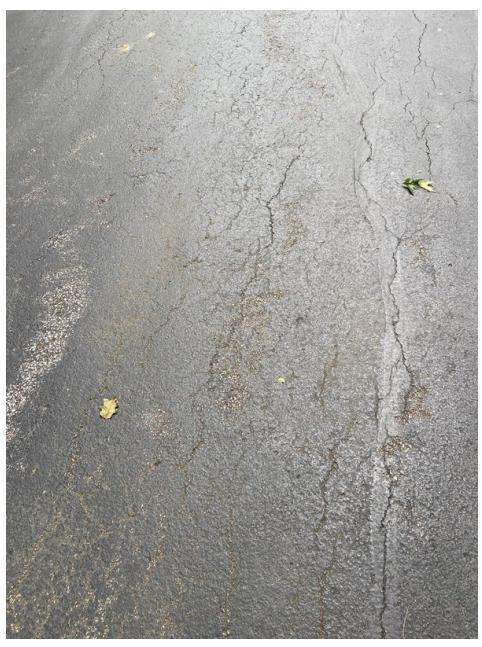
6.5.1 Sidewalks, Patios & Driveways

Cracking was observed in areas of the asphalt driveway. In order to prevent further deterioration of the driveway, I recommend having the driveway evaluated and repaired as necessary by a reputable contractor.

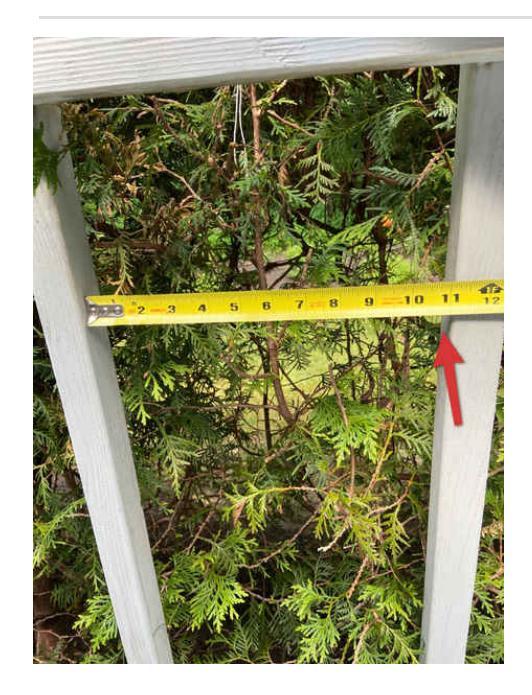
6.6.1 Decks/Porches

The spacing between the balusters is too wide in areas of the guardrails. In order to prevent children from fitting through or becoming stuck, it is recommended that the spacing between the balusters on guardrails should not allow a 4 inch sphere to pass through. I recommend having this evaluated and addressed by a reputable contractor.

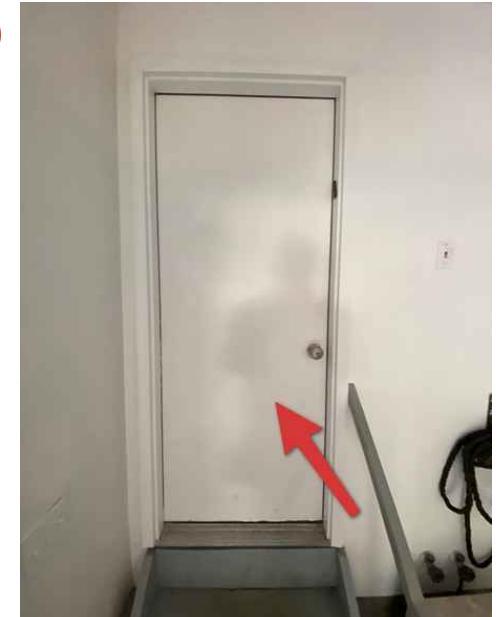
The garage man door is not self-closing. This is a safety hazard and could allow for carbon monoxide to escape into the home. I recommend a reputable contractor evaluate and repair as necessary.

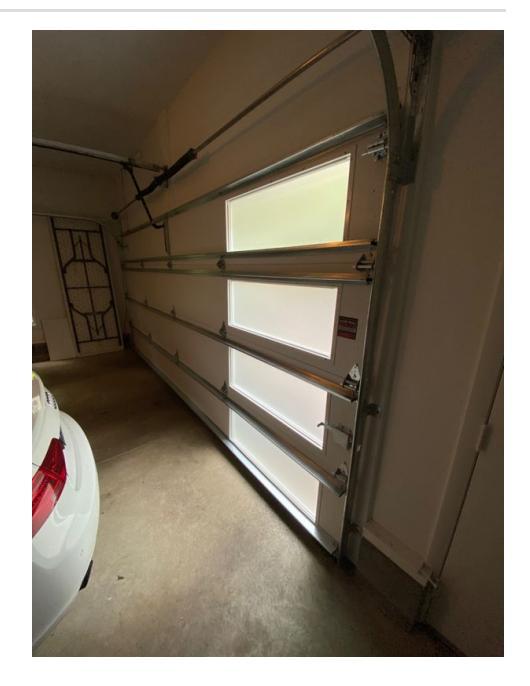
7.6.1 Garage Door Opener and Safety **AUTO REVERSE - NOT FUNCTIONING** GARAGE

The safety feature known as auto reverse was not functioning during the inspection. When resistance was placed on the bottom of the garage door while it was coming down, the door did not automatically start going back up. I recommend having the opener adjusted, repaired, or replaced with an opener that has the safety feature included by a reputable contractor.

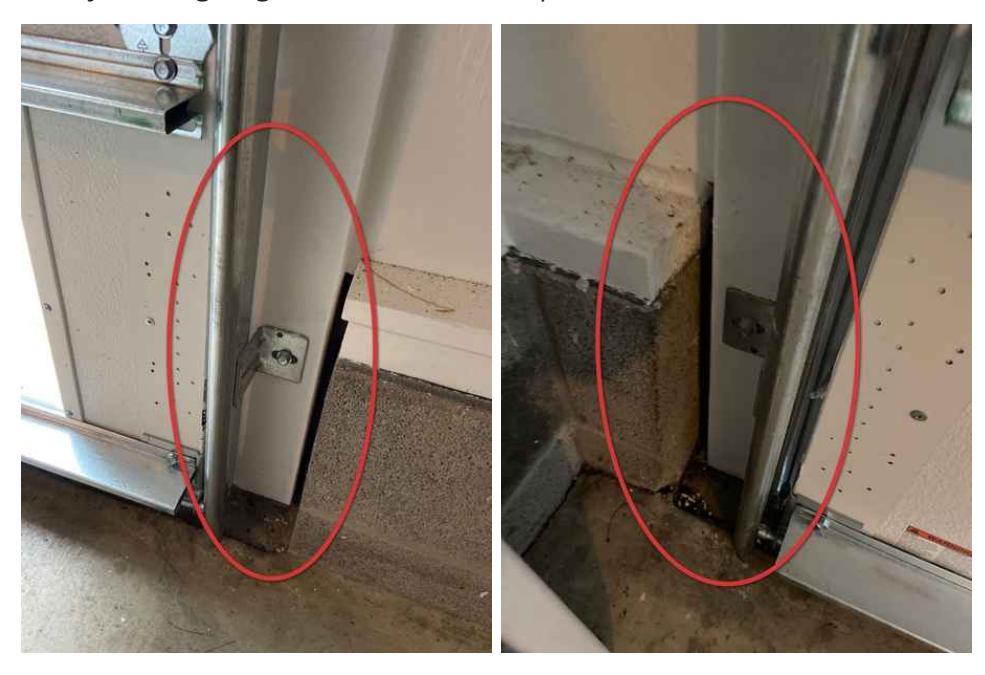
7.6.2 Garage Door Opener and Safety **NO PHOTO CELLS**

The automatic garage door opener(s) did not have the photo cell safety features. In order to increase the safety of the garage, I recommend a reputable contractor evaluate and repair as needed.

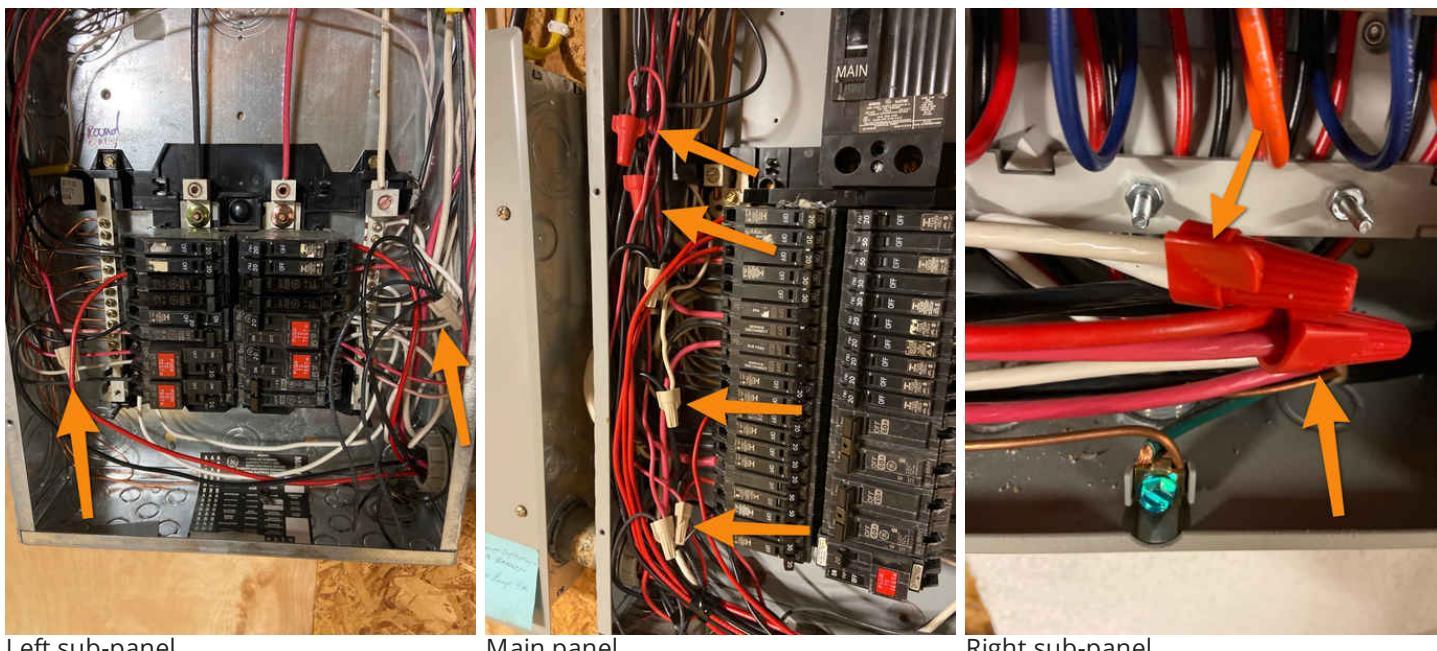
8.2.1 Service Panel WIRE NUT(S) PRESENT - Recommendation

Wire nuts were present in the main service panel and both sub-panels. This could be an indication of double tapped wiring, therefore I recommend a reputable licensed electrical contractor evaluate further and repair as necessary.

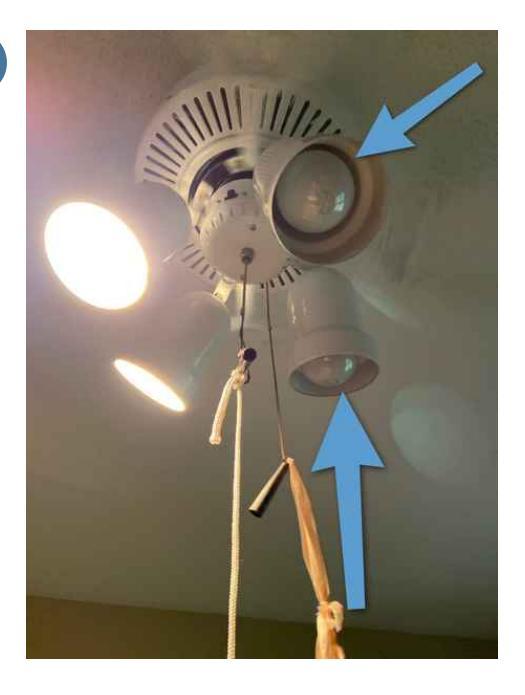
A light fixture was not functioning at the time of the inspection. I recommend having the light bulbs replaced and then having the circuit addressed if necessary by a reputable licensed electrical contractor.

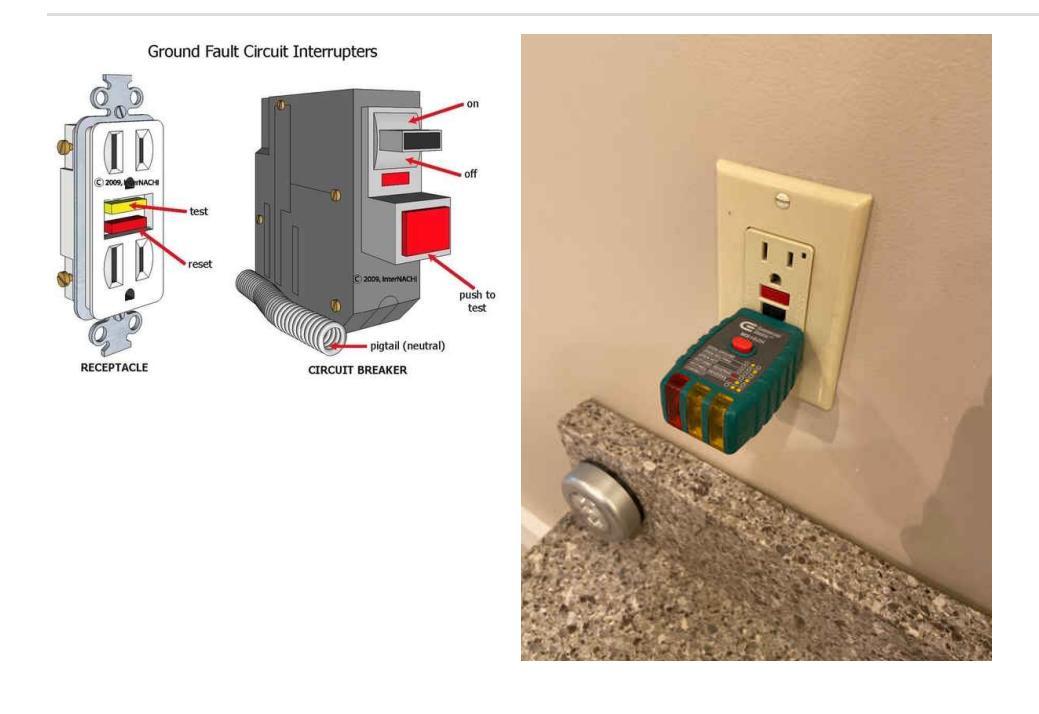
8.6.1 GFCI & AFCI **GFCI RECEPTACLE - WOULD NOT RESET AFTER TESTED**

A GFCI receptacle did not reset after it was tested. I recommend having this evaluated and repaired as necessary by a reputable licensed electrical contractor.

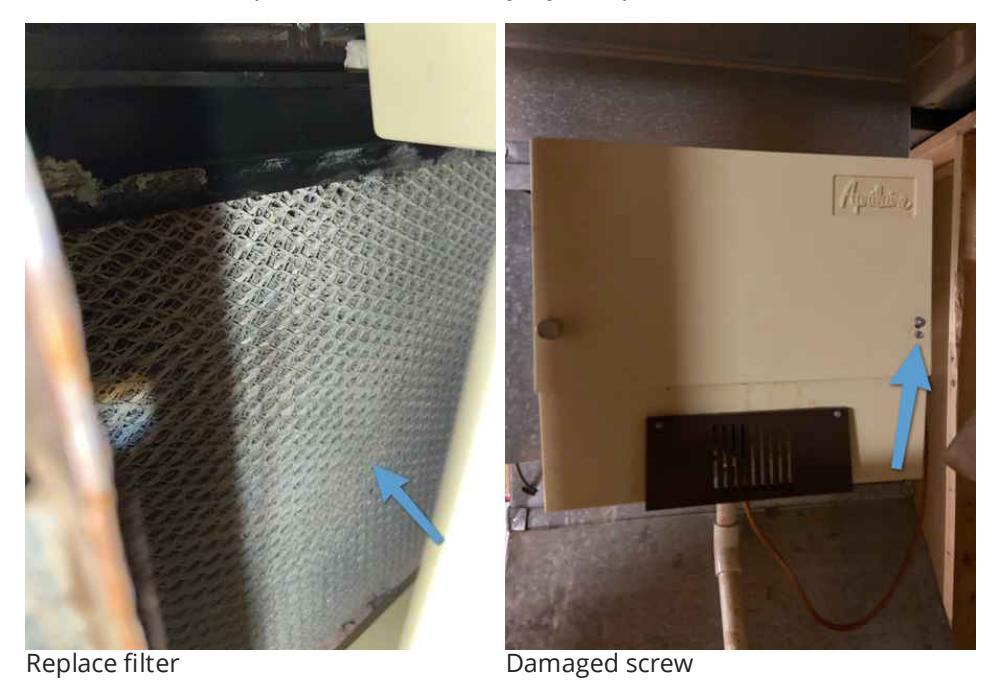
10.1.2 Central Ducted Heat Pump WHOLE HOUSE HUMIDIFIER - REPLACE FILTER

The whole house humidifier on the furnace is in need of repairs/a new filter. I recommend having this evaluated and repaired as necessary by a reputable licensed HVAC contractor.

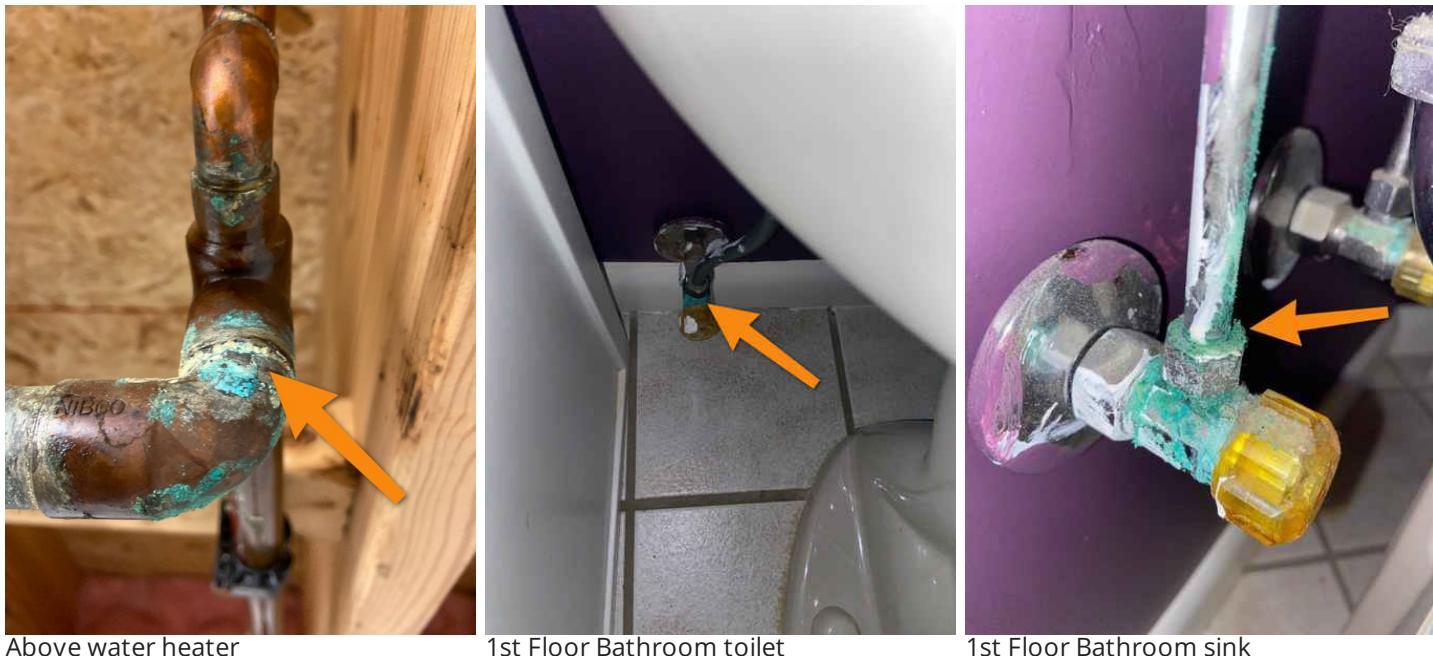
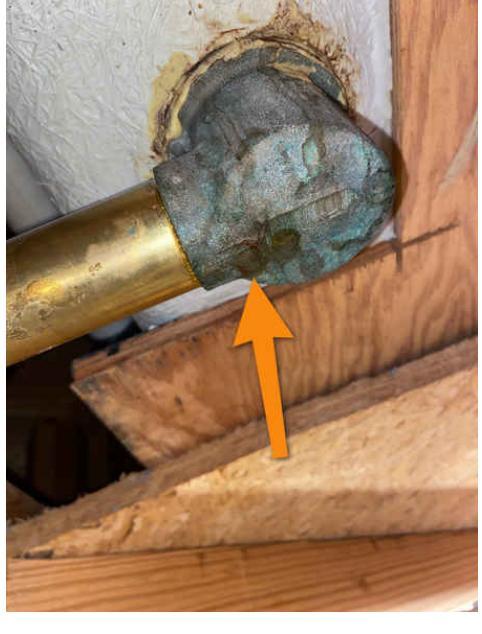
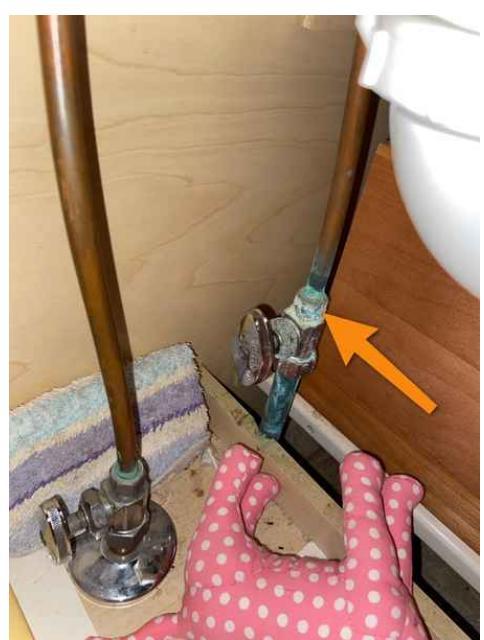
EFFLORESCENCE (MINERAL SALTS)/ CORROSION VARIOUS

Efflorescence (mineral salts)/ corrosion was observed on areas of the supply pipes. Efflorescence (mineral salts)/ corrosion may be an indication that this area has been leaking, or may leak in the future. I recommend having this evaluated and repaired as necessary by a reputable licensed plumbing contractor.

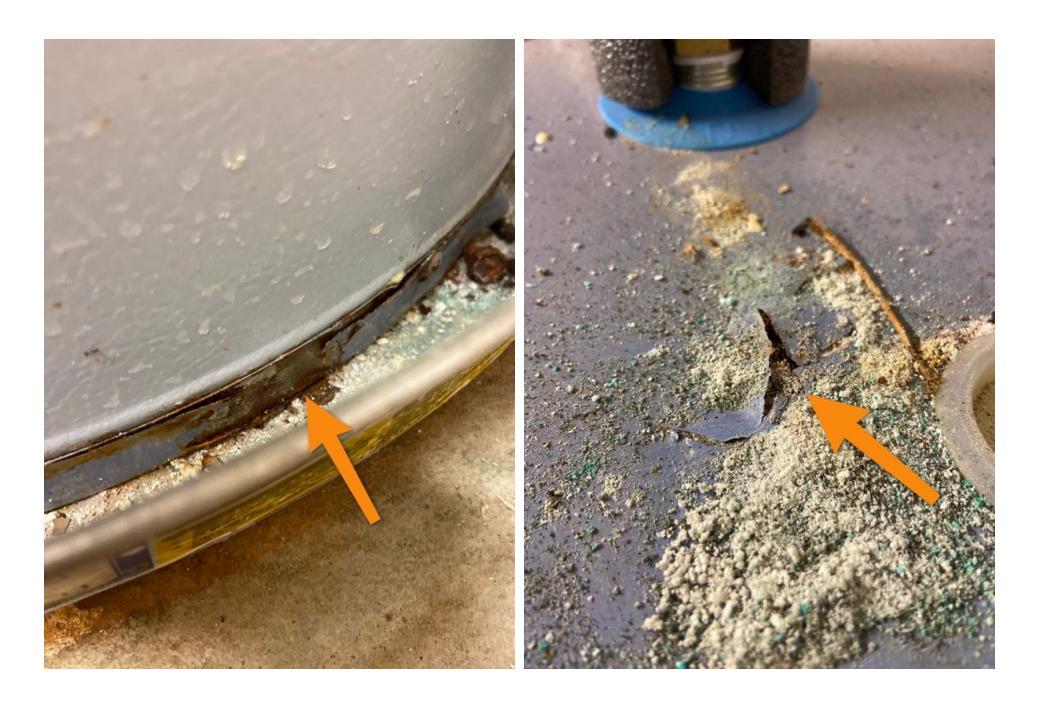
11.4.1 Atmospheric Water Heater **RUST**

Rust was observed on the water heater. In order to maintain the water heater, I recommend having the water heater evaluated and repaired as necessary by a reputable licensed plumbing contractor.

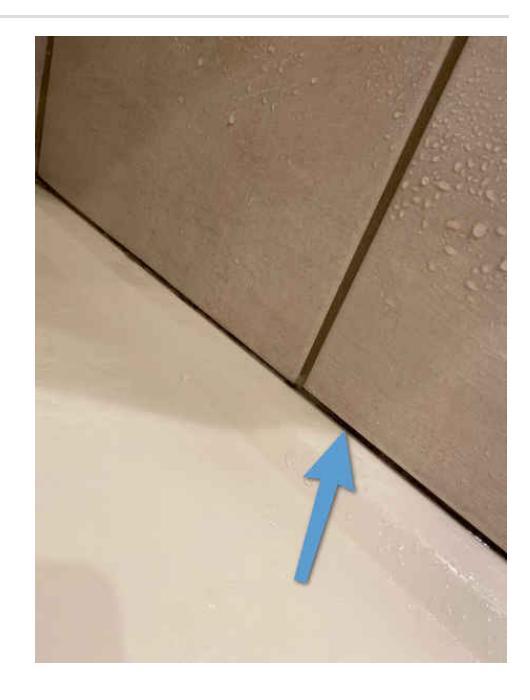
11.5.1 Fixtures

Areas of the shower was observed to have missing/failing caulking. In order to prevent water intrusion, I recommend re-caulking.

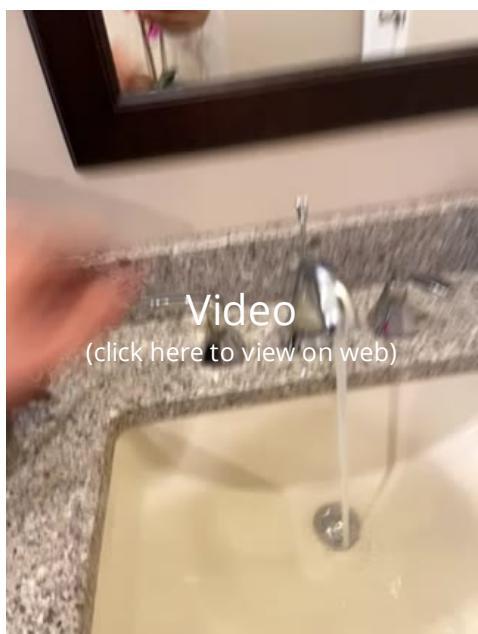
11.5.2 Fixtures **DRAIN STOPPER - INOPERABLE**

A drain stopper was observed to be inoperable. I recommend having the drain stopper evaluated and repaired as necessary by a reputable licensed plumbing contractor.

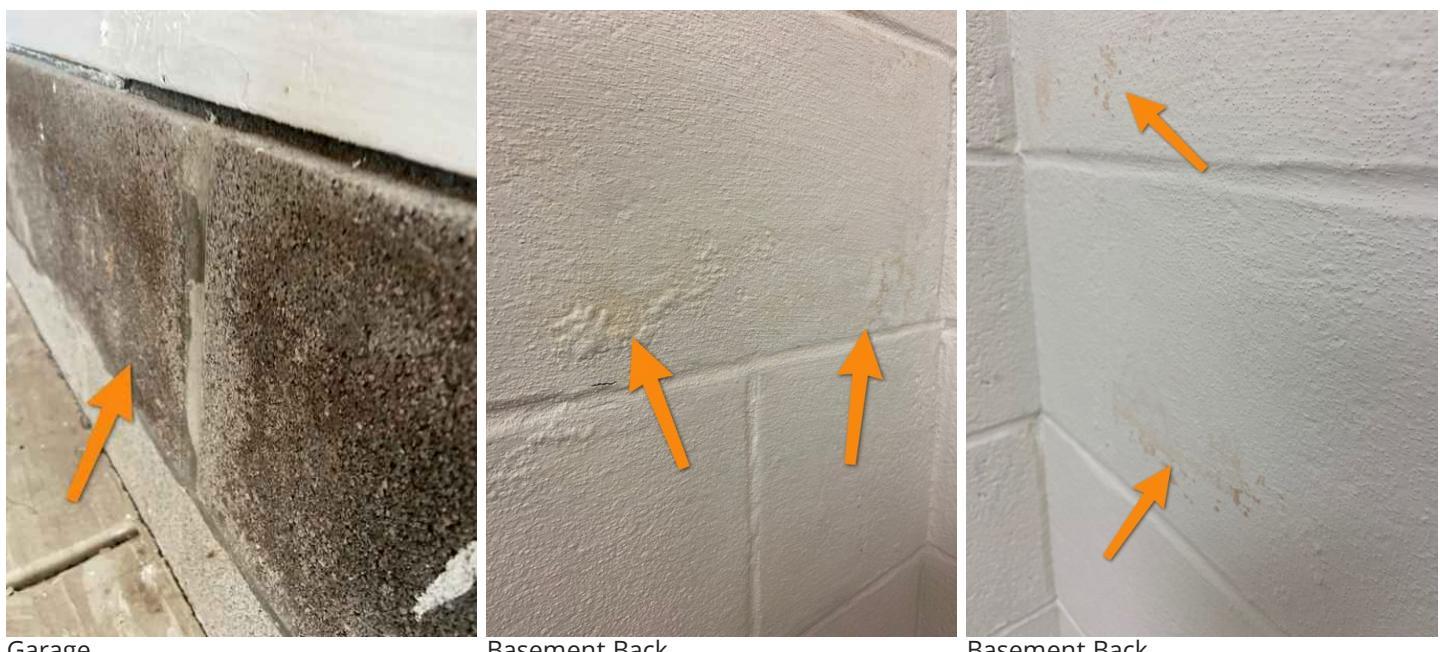
12.1.1 Foundation

Efflorescence (mineral salts) was observed in areas throughout the basement walls/foudnation. Efflorescence is the chalky residue left on concrete, stone, and block when moisture passes through it. I recommend having it evaluated and addressed as necessary by a reputable licensed waterproofing contractor.

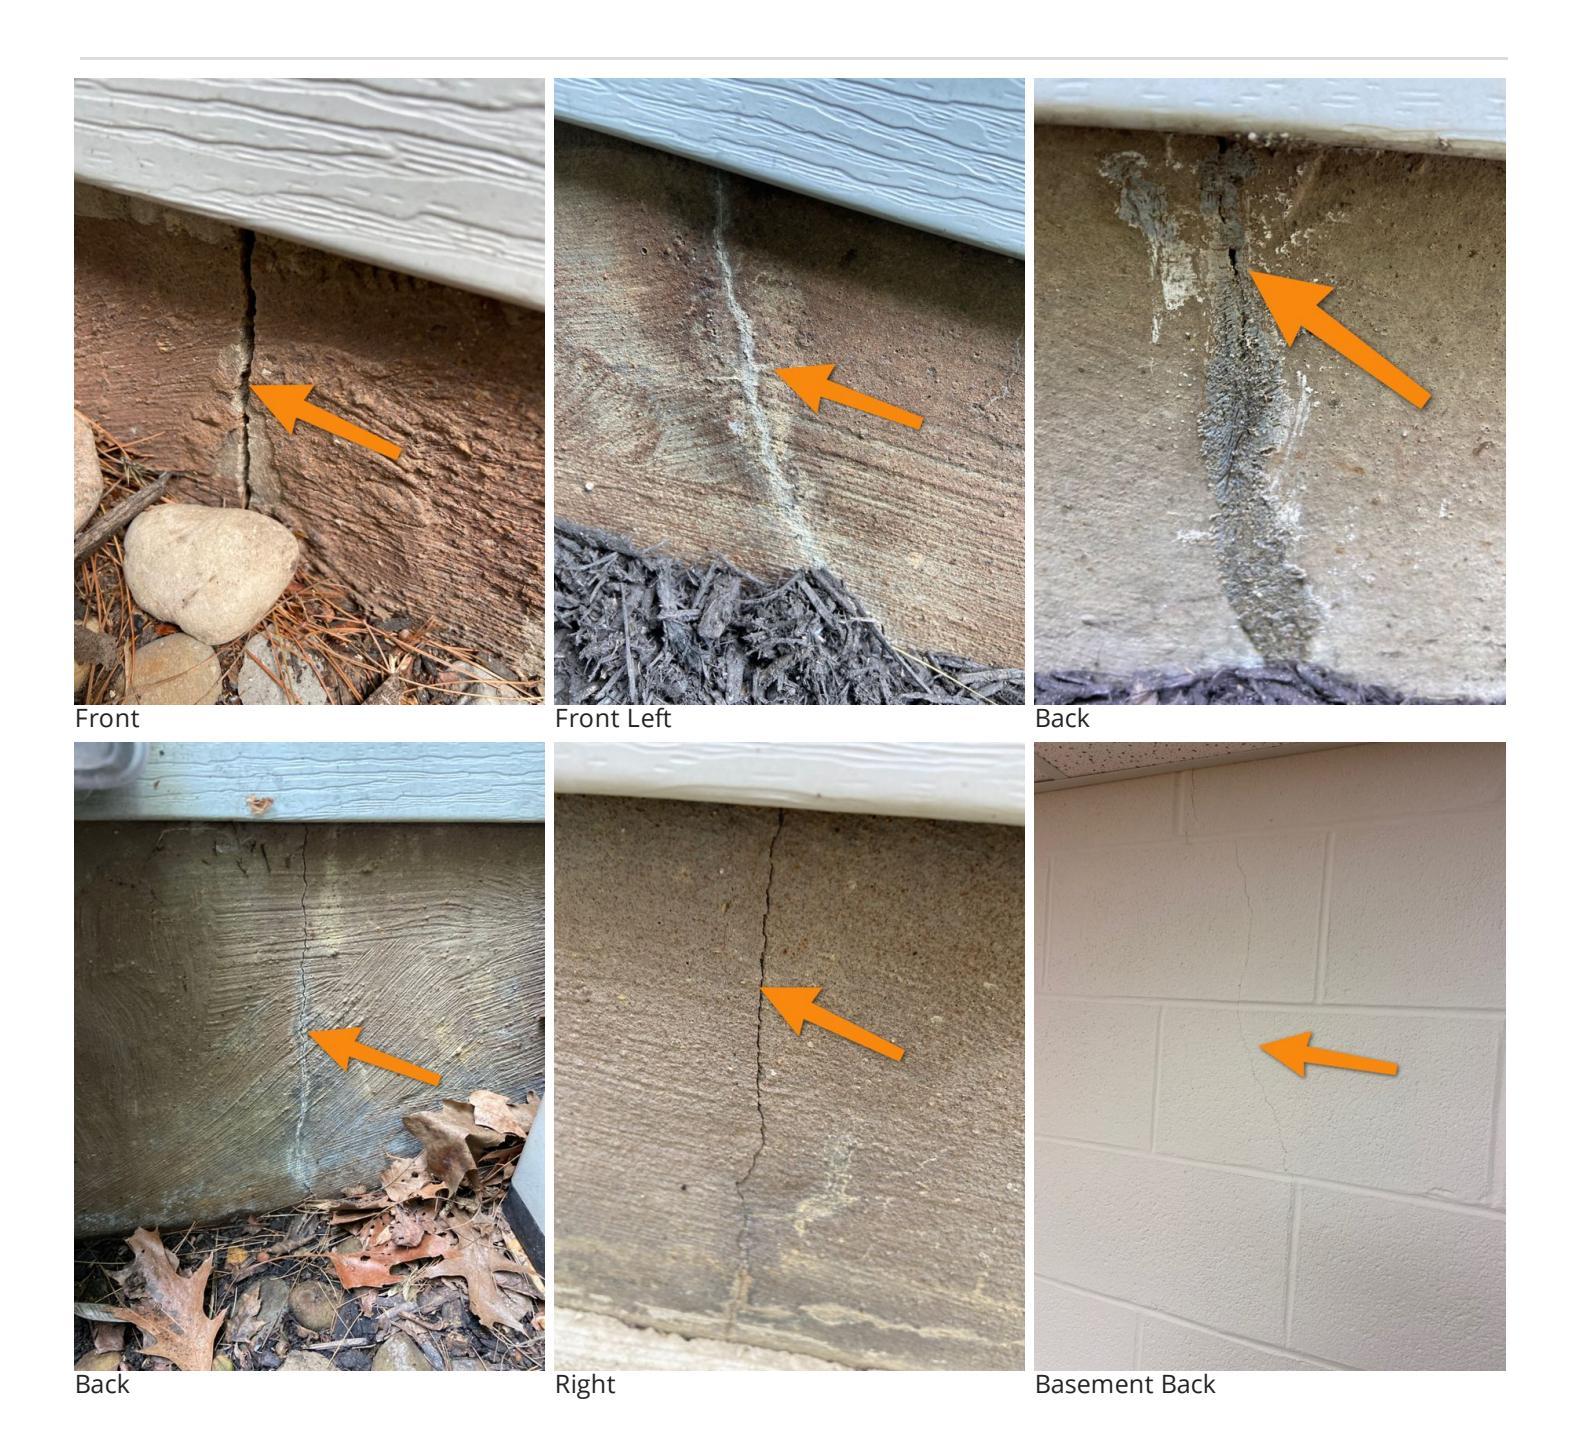
12.1.3 Foundation **FOUNDATION CRACK - FOUNDATION CONTRACTOR**

Cracking was observed on the foundation. This could be due to settlement. I recommend having the cracks evaluated and repaired as necessary by a reputable contractor. Continue to monitor.

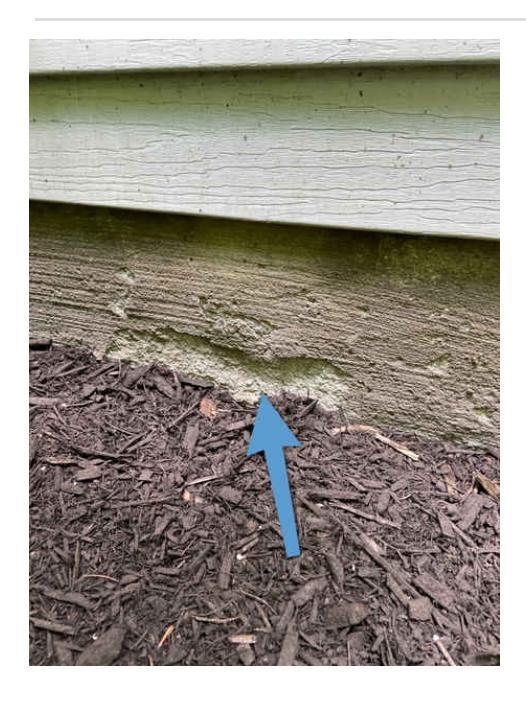
12.1.4 Foundation

Cracking was observed on the exterior foundation concrete skim (parge) coat. This is considered normal for the age of the home but could allow for water intrusion. I recommend having the cracks evaluated and repaired as necessary by a reputable contractor. Continue to monitor.

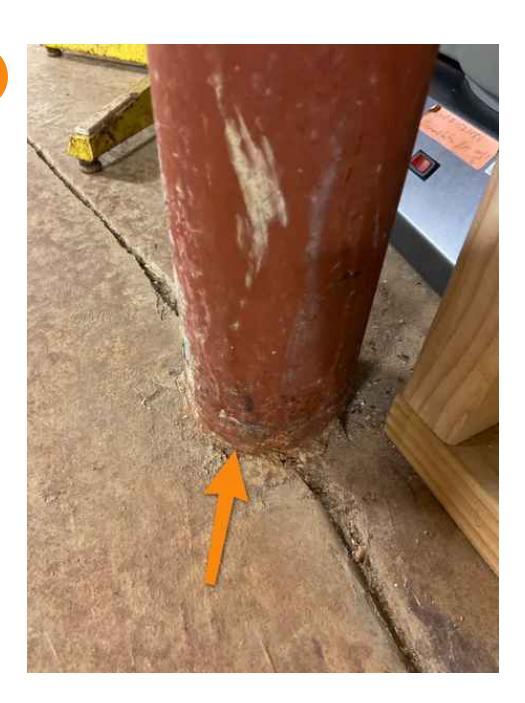
12.2.1 Floor Structure

The bottom of the steel support post(s) in the basement have concrete poured around them. There may be moisture below the concrete, therefore having the steel posts not sit on the concrete instead of going through the concrete may make it susceptible to rust and failure. I recommend having the posts evaluated and repaired as necessary by a reputable contractor.

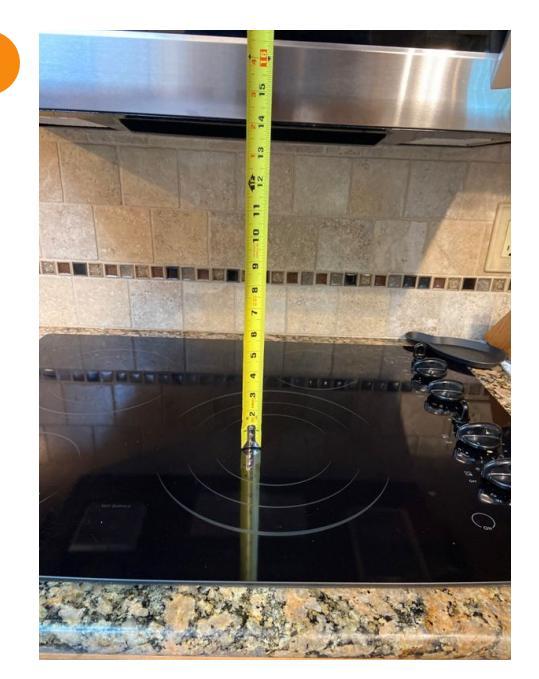
The microwave appears to have improper height clearance from the electric cooktop. I recommend a reputable contractor evaluate and repair as needed.

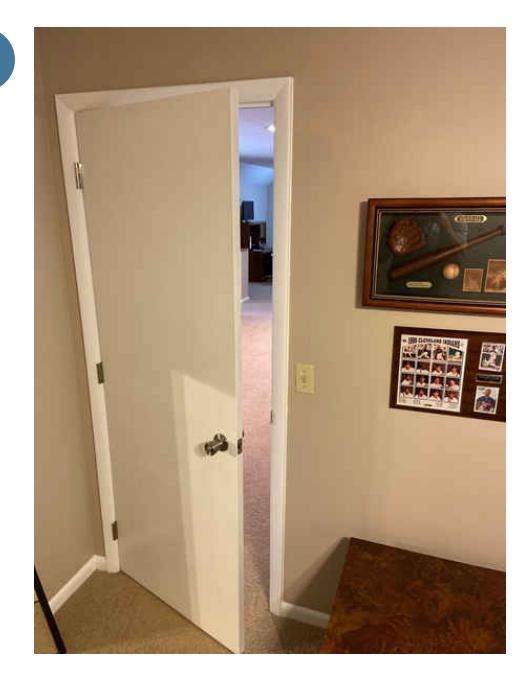
A door did not latch when closed. This could be due to settling. Continue to monitor. I recommend having the door evaluated and repaired as necessary by a reputable contractor.

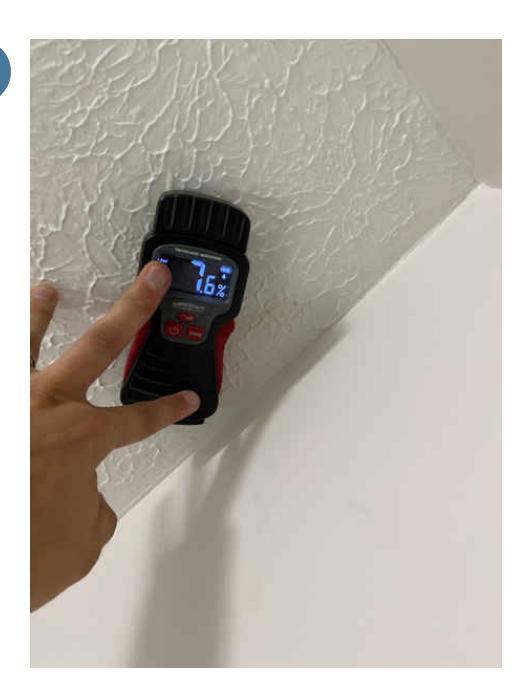
14.5.1 Ceilings EVIDENCE OF A PAST LEAK LAUNDRY

A stain was observed on the ceiling which may have been a past leak. When tested with a moisture meter there were not elevated levels of moisture. I recommend asking the sellers about the history of this area. Continue to monitor.

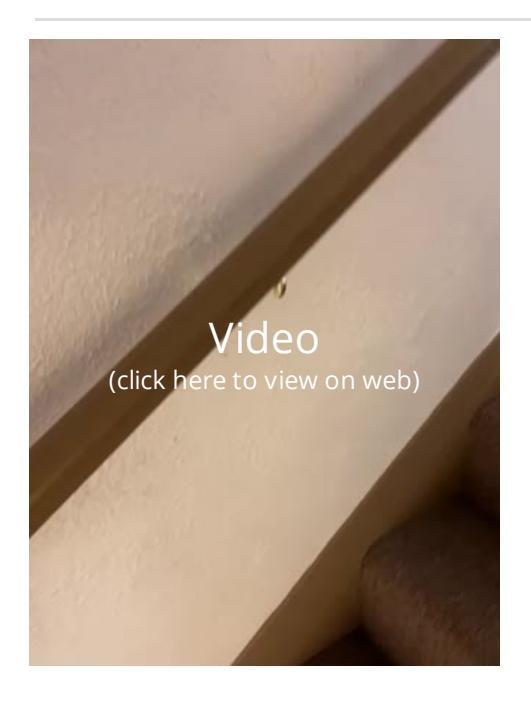
14.6.1 Steps, Stairways & Railings GUARD RAILS/HANDRAILS - LOOSE

A handrail is loose leading to the basement. In order to prevent an accident/injury, I recommend having this evaluated and repaired as necessary by a reputable contractor.

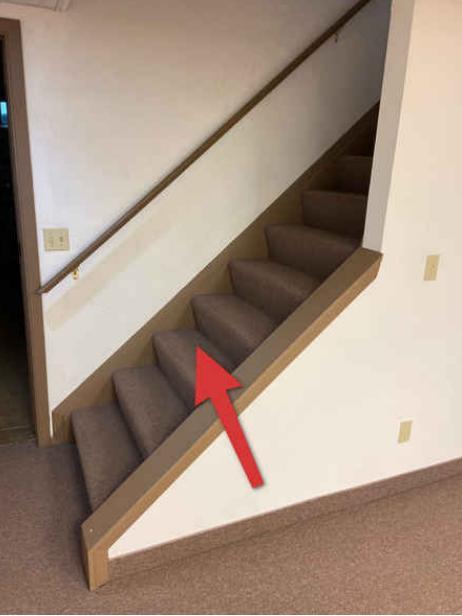
14.6.2 Steps, Stairways & Railings RAILINGS/BALUSTERS - MISSING

The basement steps are in need of proper railings/ balusters in order to increase safety. If a set of steps have 4 or more risers, it's recommended to have railings/ balusters present in order to increase the safety of the steps. I recommend having railings/ balusters installed by a reputable contractor.
